# RockSpot

## Revision of RF module board (AS07017)

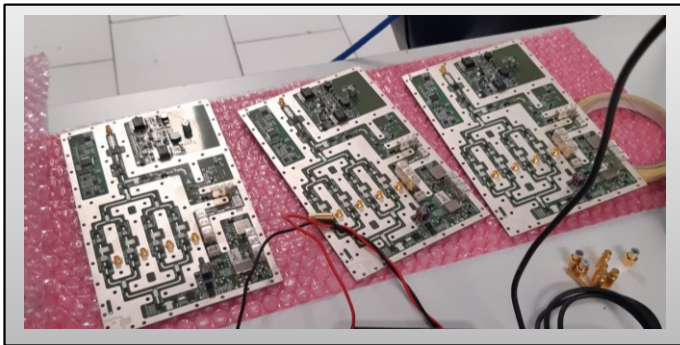
Concerning RF Module inside RockSpot Survey Unit, it was necessary to revise the CS and the schematic to solve the problem of 1/f-like (flicker) noise of which the board was affected. The problem was solved by replacing the receiver mixers and the variable attenuator with its control circuit, with models that introduced less noise.

- The PCB has been modified from 4 to 6 layer.
- The variable attenuator (UT50) RFSA2113 has been replaced by the MMAT-010521-L1.

While the RFSA2113 attenuator needed a single control voltage, the MMAT-010521-L1 model needs two control voltages, it was therefore necessary to add a portion of the circuit that performed this function.

- The receiving mixers (UT32, UT46, UT56, UT72) HMC412 have been replaced by the CMD177C3.

- Replaced RT55 with 10 k $\Omega$  (0402)
- BLT20, BLT25, BLT35, BLT45: replaced with PCB trace
- Replaced all regulators AP2204 (obsolete) with AP2205
- RT50: select case 0805 (1/2W) instead of 0603 (1/3W)
- Removed ON circuit in sequence of -4V\_VIDEO (RB33, RB34, RB35, QB1, QB2)
- Replaced CB16, CB46, CB70, CB98 with 10 pF
- Removed output filter from UB9: CT174, CT158 and BLT29
- Removed CT155 and CT154
- Removed CT157, CT156, CT173 and BLT28
- Added C1013
- Added C1014, C1015, C1016, C1017
- Added D100, D101
- Added R1015, R1016, R1017, R1018, R1019, R1020
- Replaced RB25 with 0 $\Omega$
