## Appendix B: photographs of test setup

Reference to the test report no. BLA-EMC-202505-A2301

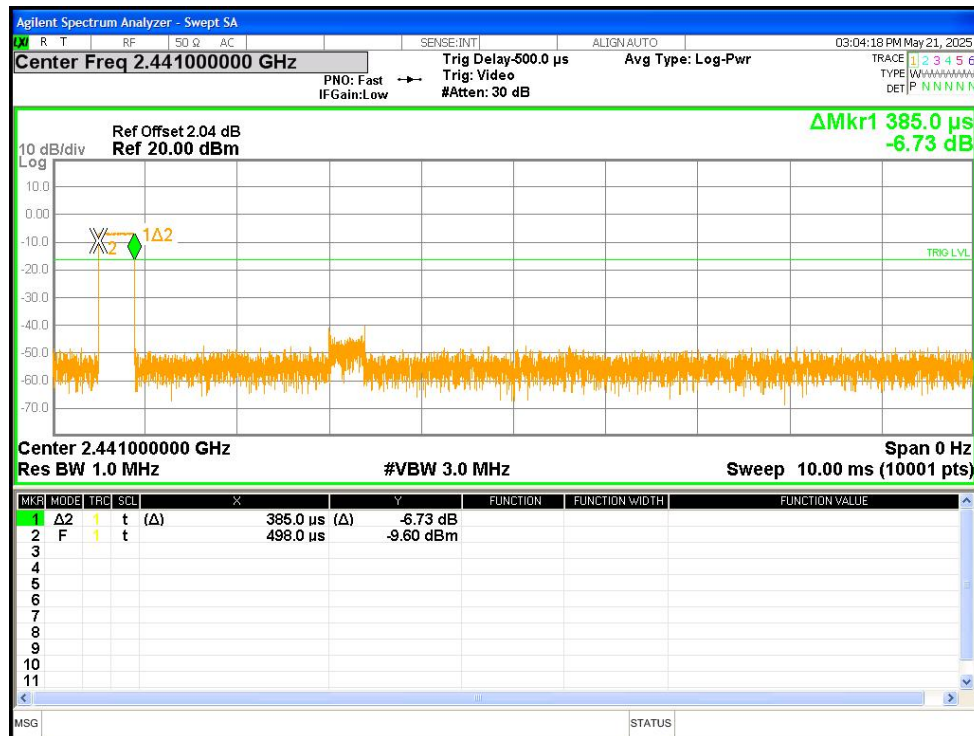
### Dwell NVNT 1-DH1 2441MHz Ant1 One Burst

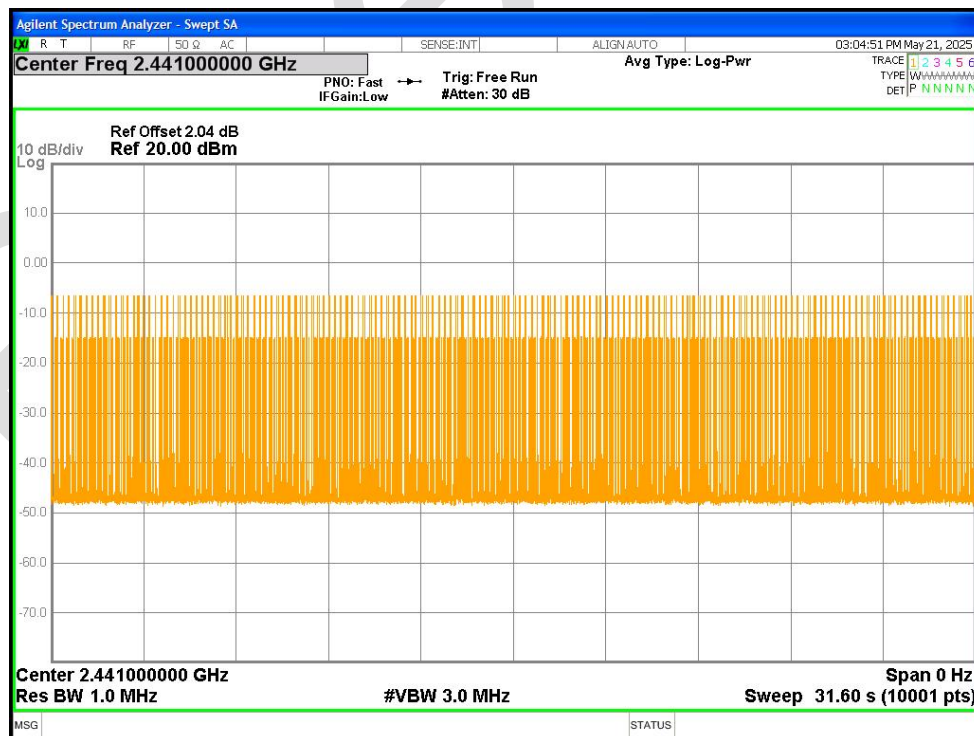
### Dwell NVNT 1-DH1 2441MHz Ant1 Accumulated

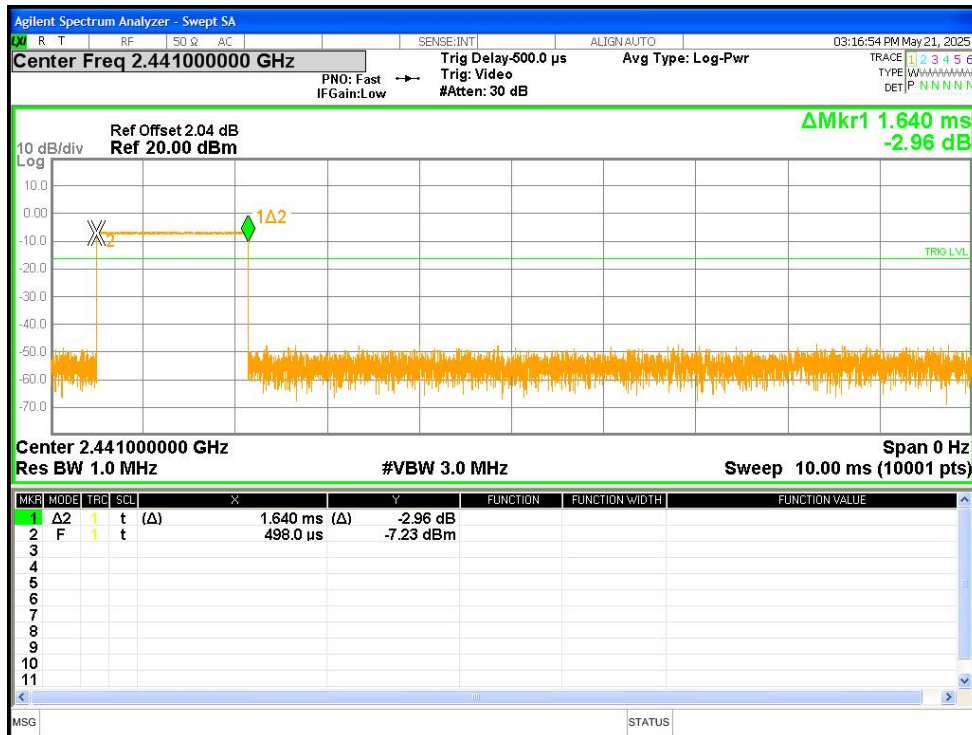
### Dwell NVNT 1-DH3 2441MHz Ant1 One Burst

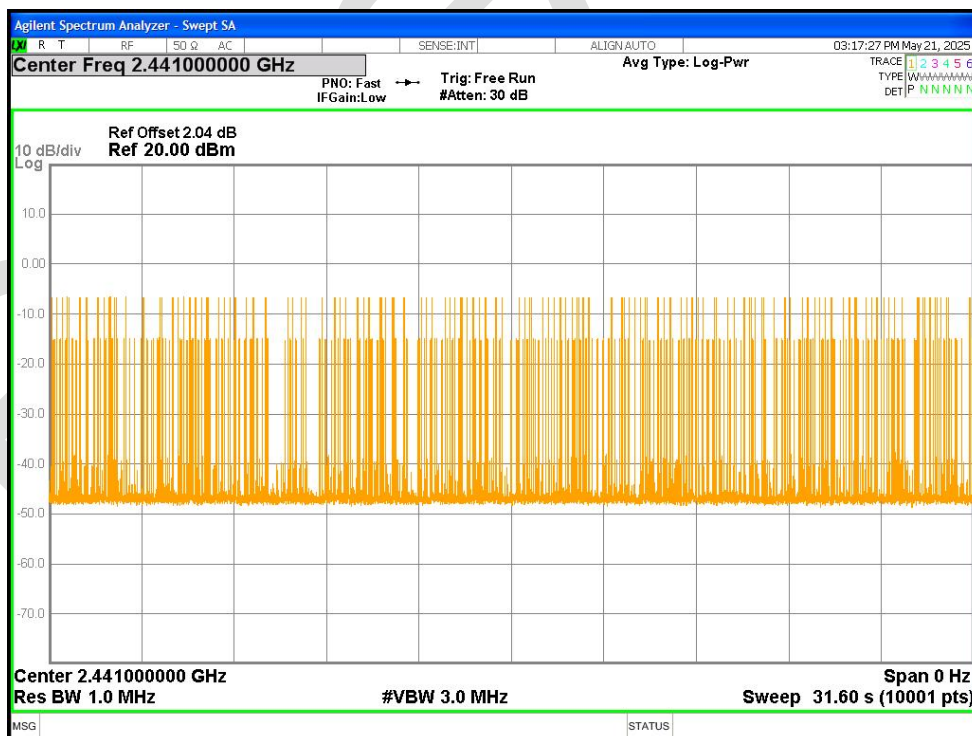
### Dwell NVNT 1-DH3 2441MHz Ant1 Accumulated

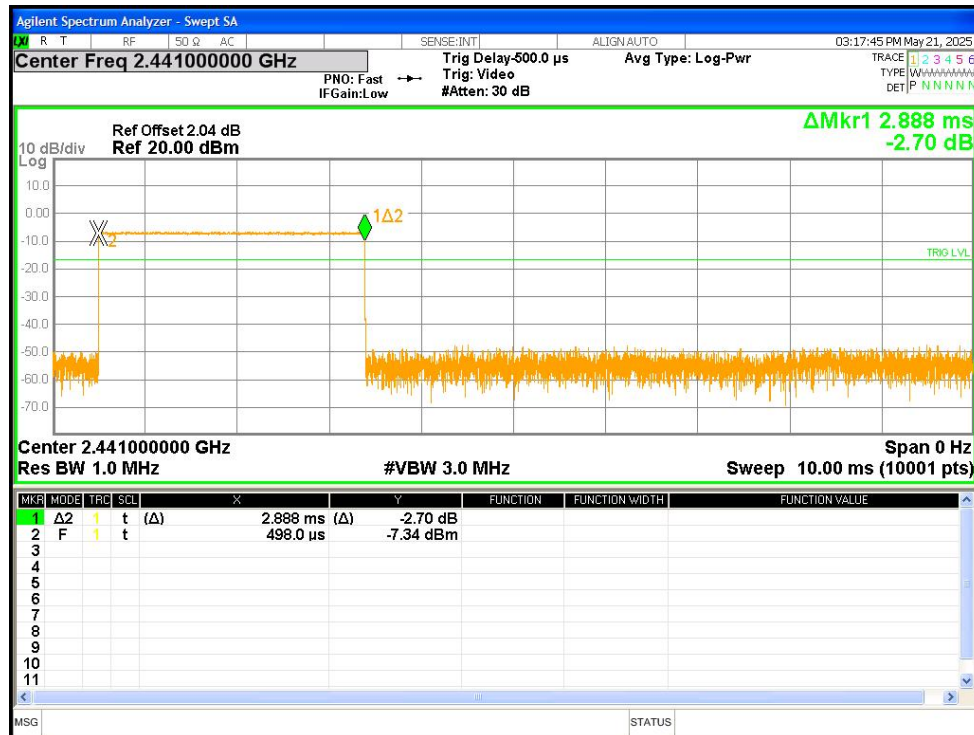
### Dwell NVNT 1-DH5 2441MHz Ant1 One Burst

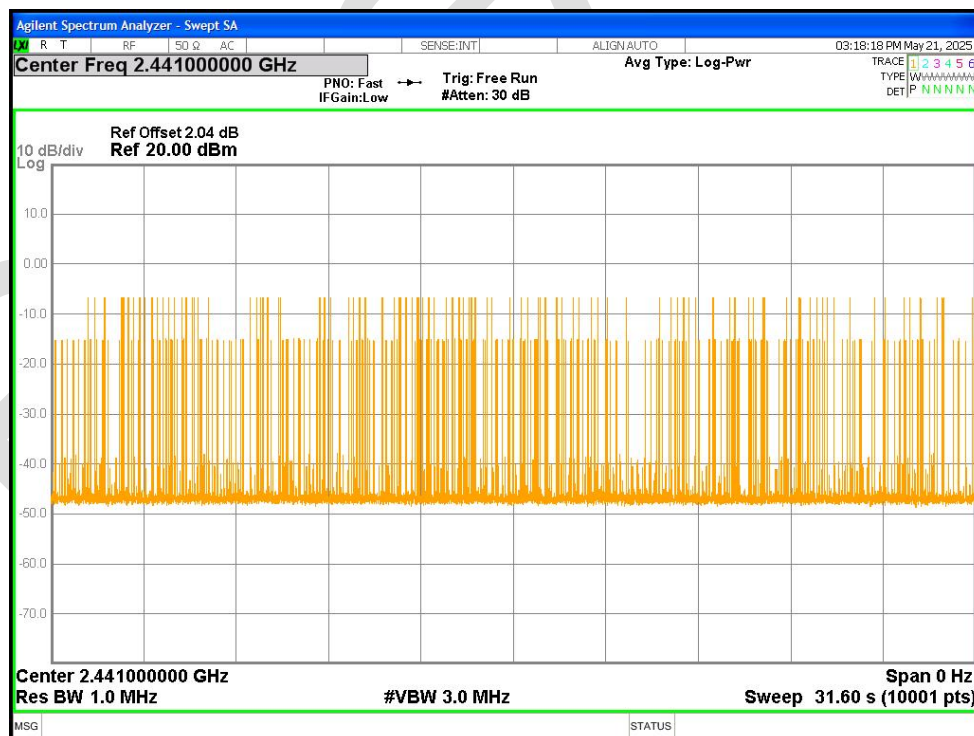
### Dwell NVNT 1-DH5 2441MHz Ant1 Accumulated

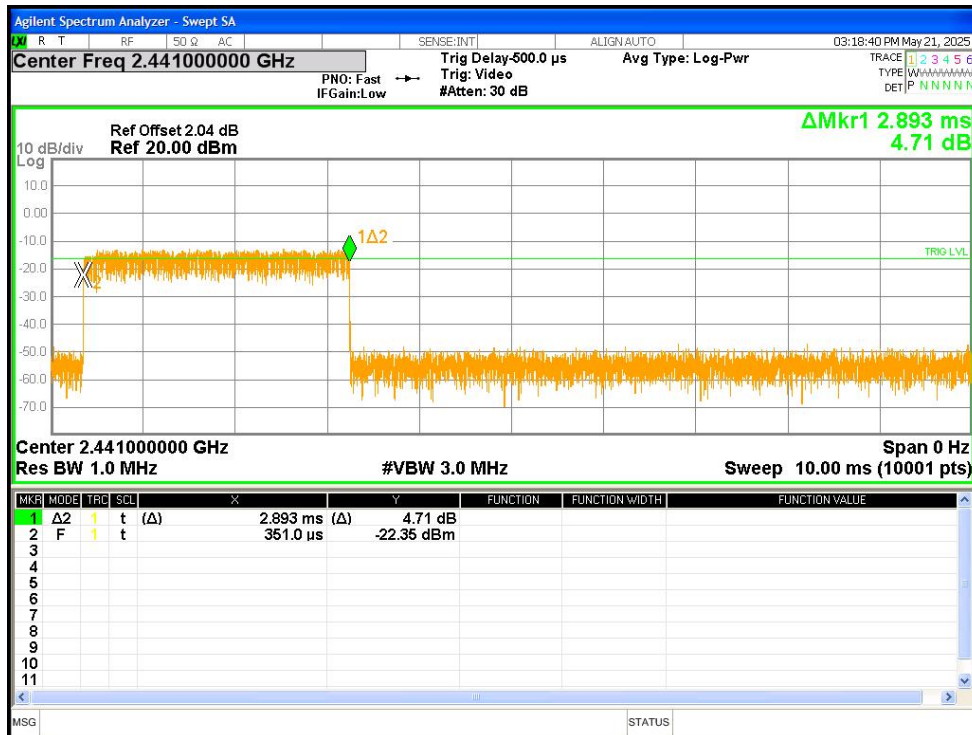
### Dwell NVNT 2-DH5 2441MHz Ant1 One Burst

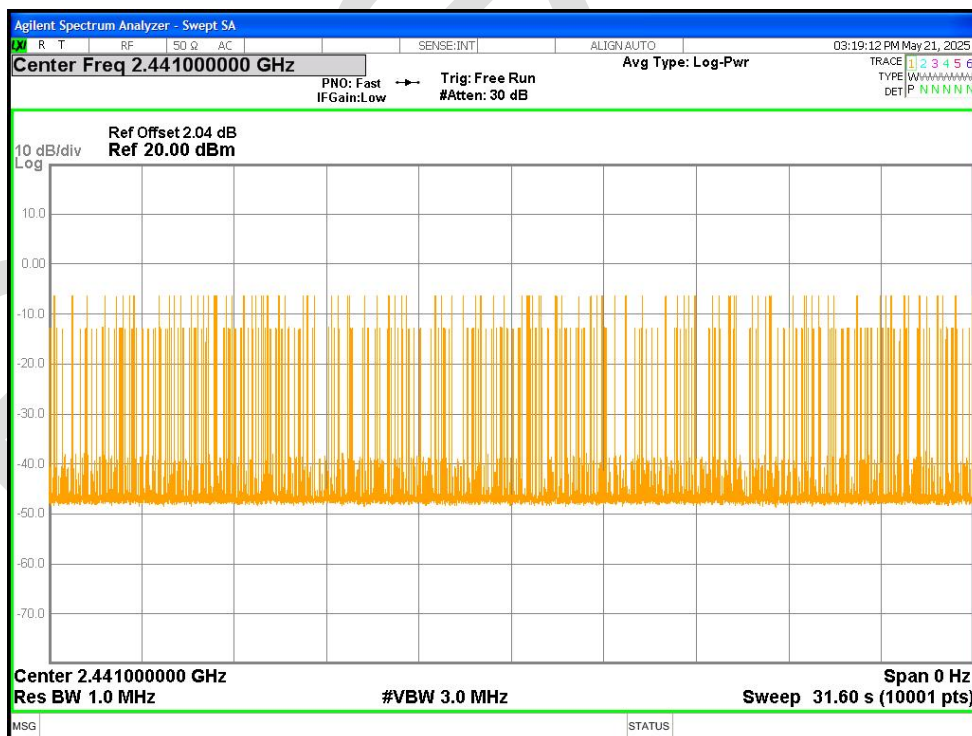
### Dwell NVNT 2-DH5 2441MHz Ant1 Accumulated

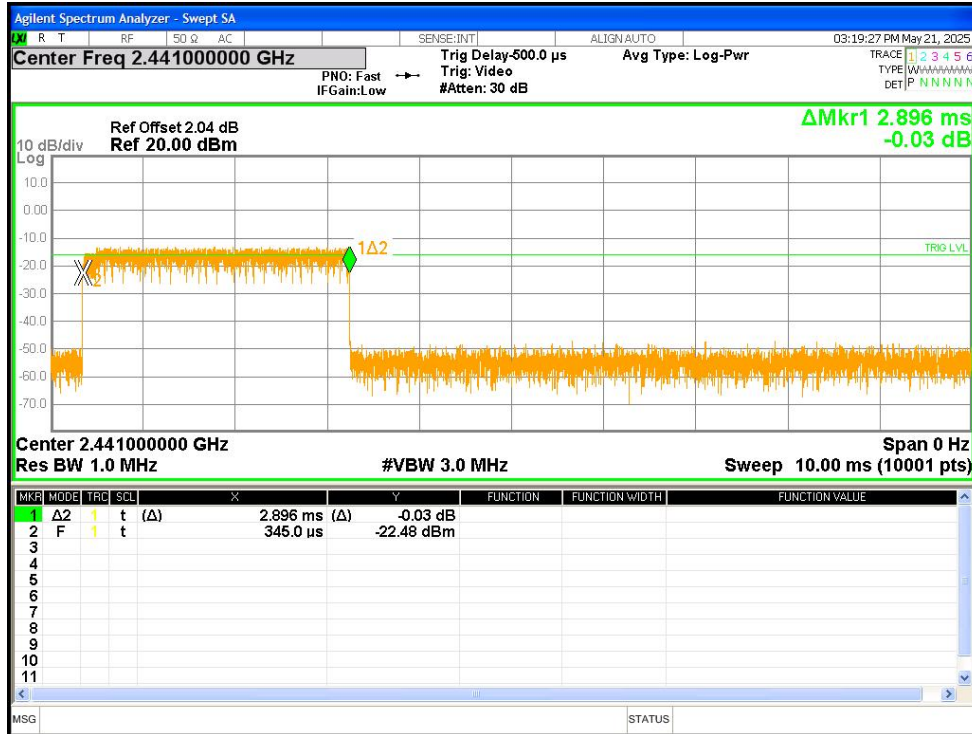
### Dwell NVNT 3-DH5 2441MHz Ant1 One Burst

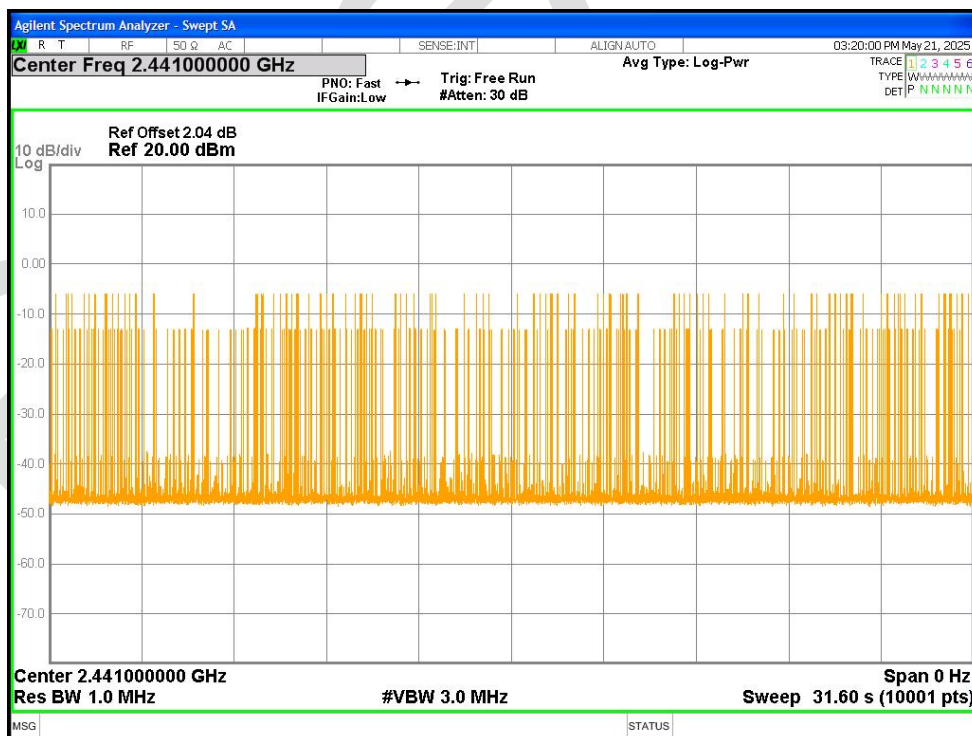
### Dwell NVNT 3-DH5 2441MHz Ant1 Accumulated

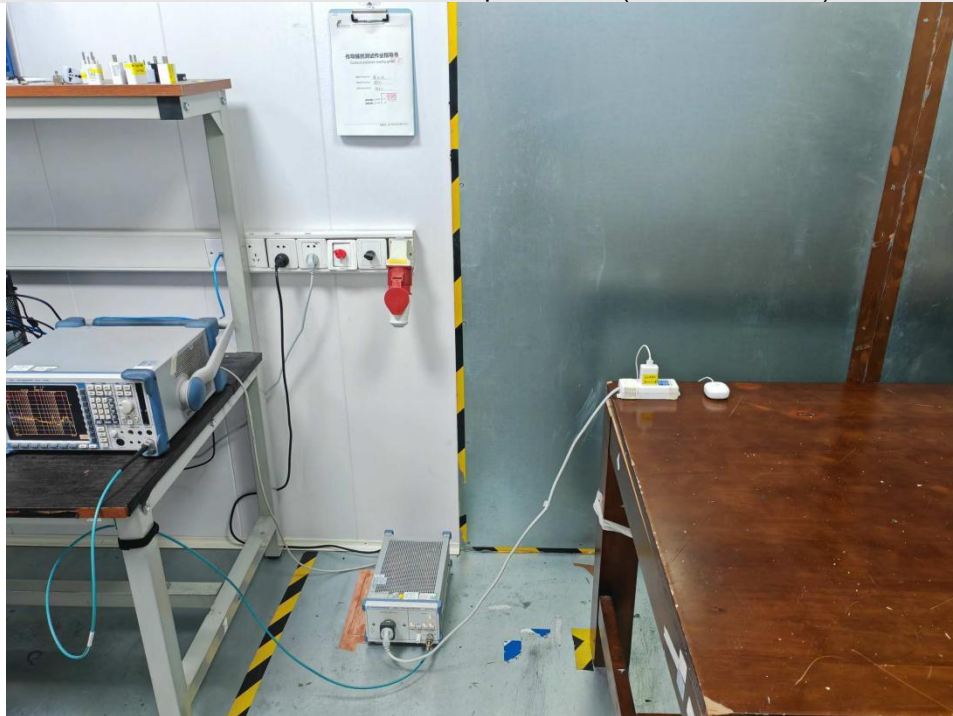
Conducted emissions at AC power line (150kHz-30MHz)

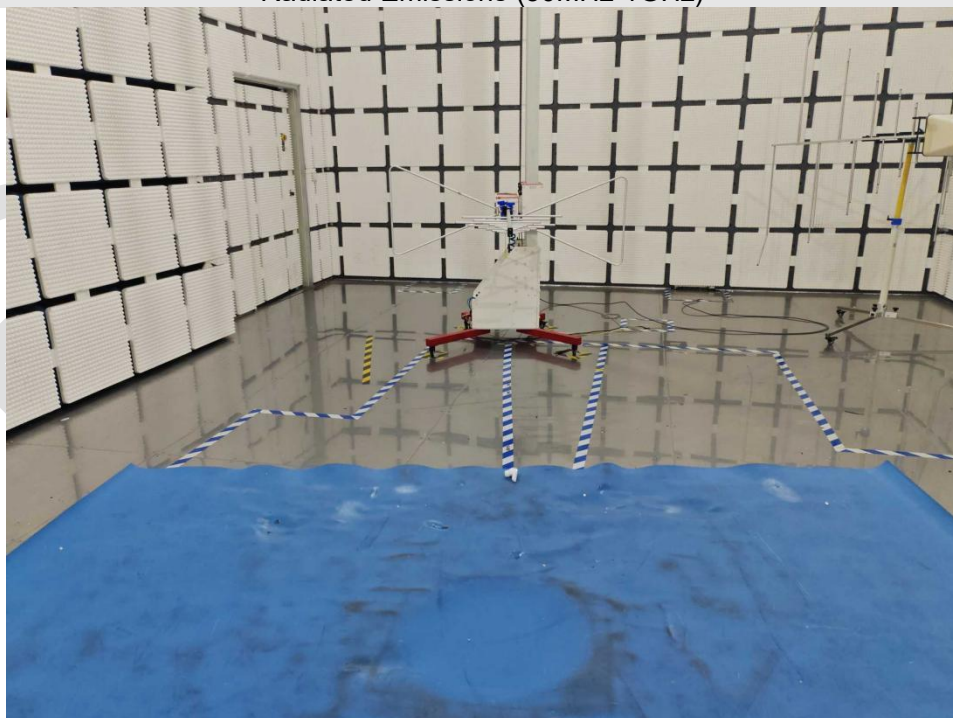
Radiated Emissions (30MHz-1GHz)

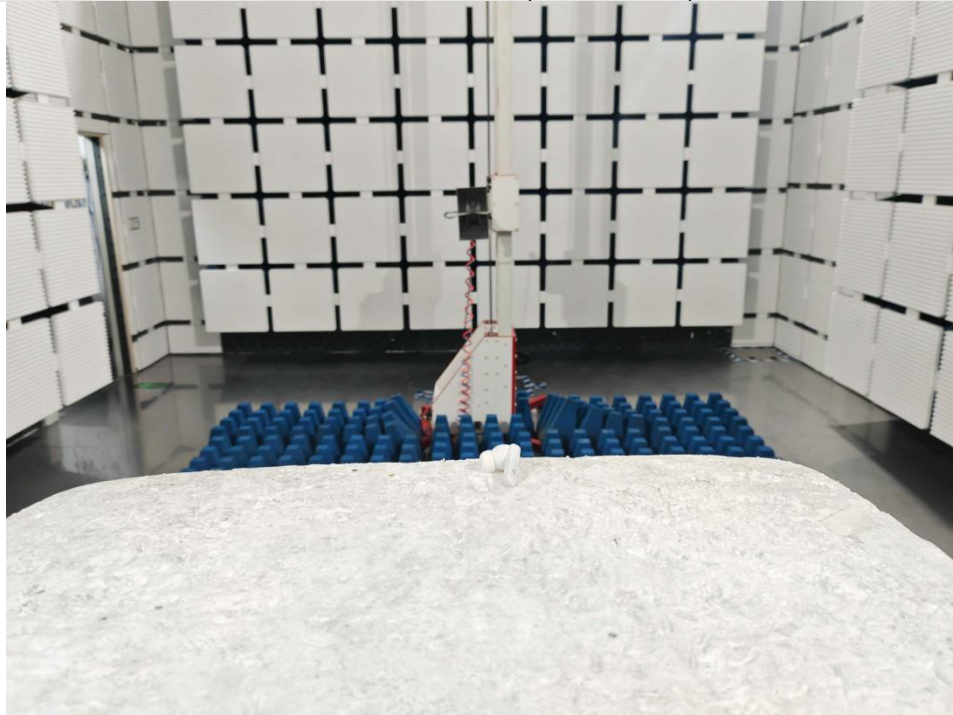
Radiated Emissions (above 1GHz)
