# Radiated Emission Measurement

Condition : FCC\_part 15 RE-Class C\_Above 1GHz\_PK

EUT : W6M22311-23090

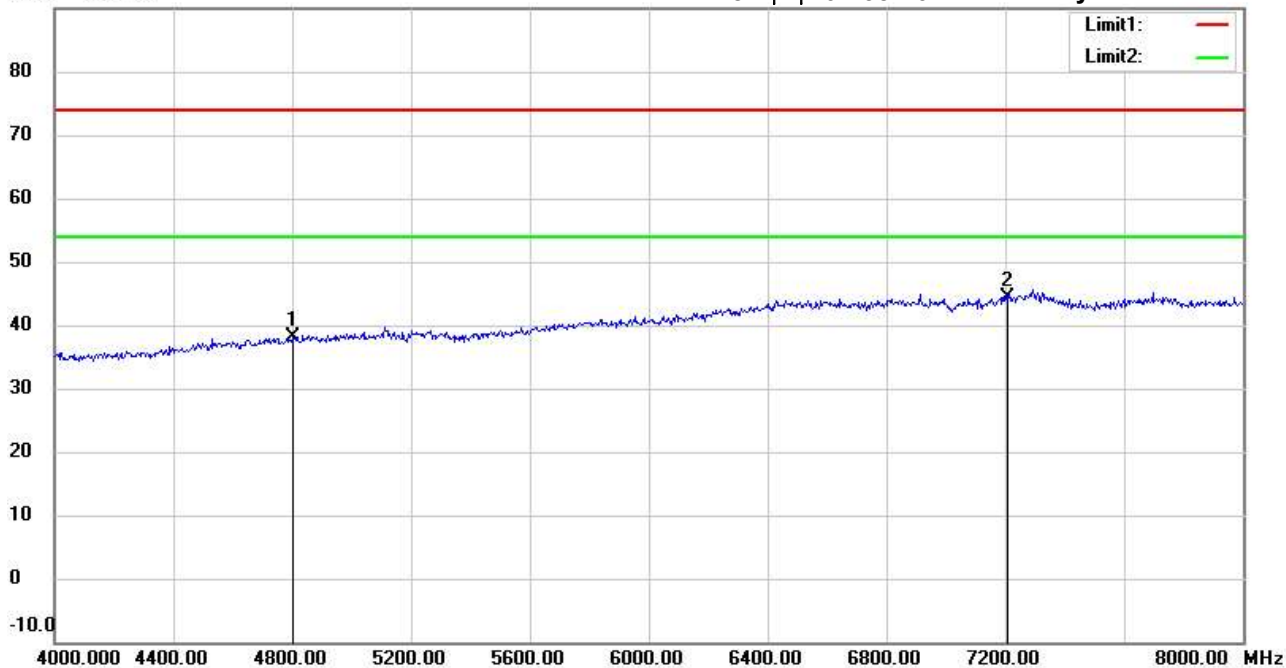
Condition : FCC\_part 15 RE-Class C\_Above 1GHz\_PK

Polarization: **Horizontal**

| Mk. | Frequency (MHz) | Reading (dBuV) | Detector | Corr. factor (dB/m) | Result (dBuV/m) | Limit (dBuV/m) | Ant.Pos (cm) | Tab.Pos (deg.) | Margin (dB) | Comment |
|---|---|---|---|---|---|---|---|---|---|---|
| | 4804.000 | 33.08 | peak | 5.03 | 38.11 | 74.00 | 150 | 125 | -35.89 | |
| * | 7206.000 | 33.08 | peak | 11.38 | 44.46 | 74.00 | 150 | 206 | -29.54 | |

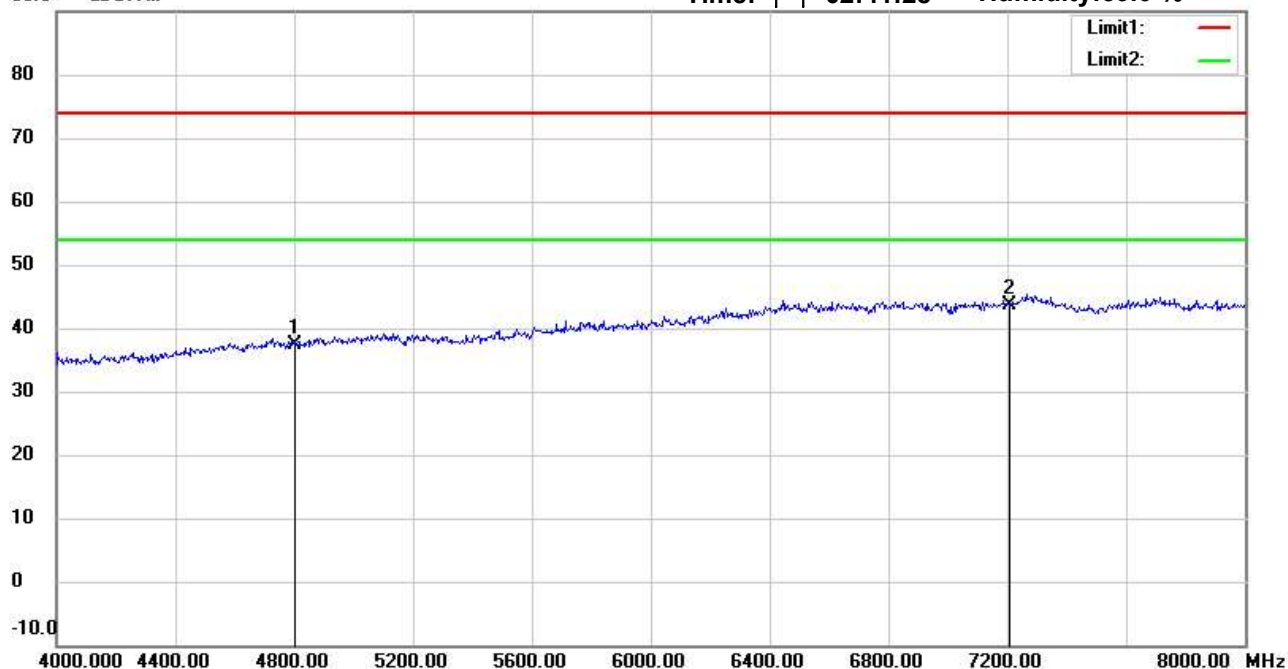
Condition : FCC\_part 15 RE-Class C\_Above 1GHz\_PK

Polarization: **Vertical**

| Mk. | Frequency (MHz) | Reading (dBuV) | Detector | Corr. factor (dB/m) | Result (dBuV/m) | Limit (dBuV/m) | Ant.Pos (cm) | Tab.Pos (deg.) | Margin (dB) | Comment |
|---|---|---|---|---|---|---|---|---|---|---|
| | 4804.000 | 32.32 | peak | 5.03 | 37.35 | 74.00 | 150 | 331 | -36.65 | |
| * | 7206.000 | 32.25 | peak | 11.38 | 43.63 | 74.00 | 150 | 21 | -30.37 | |

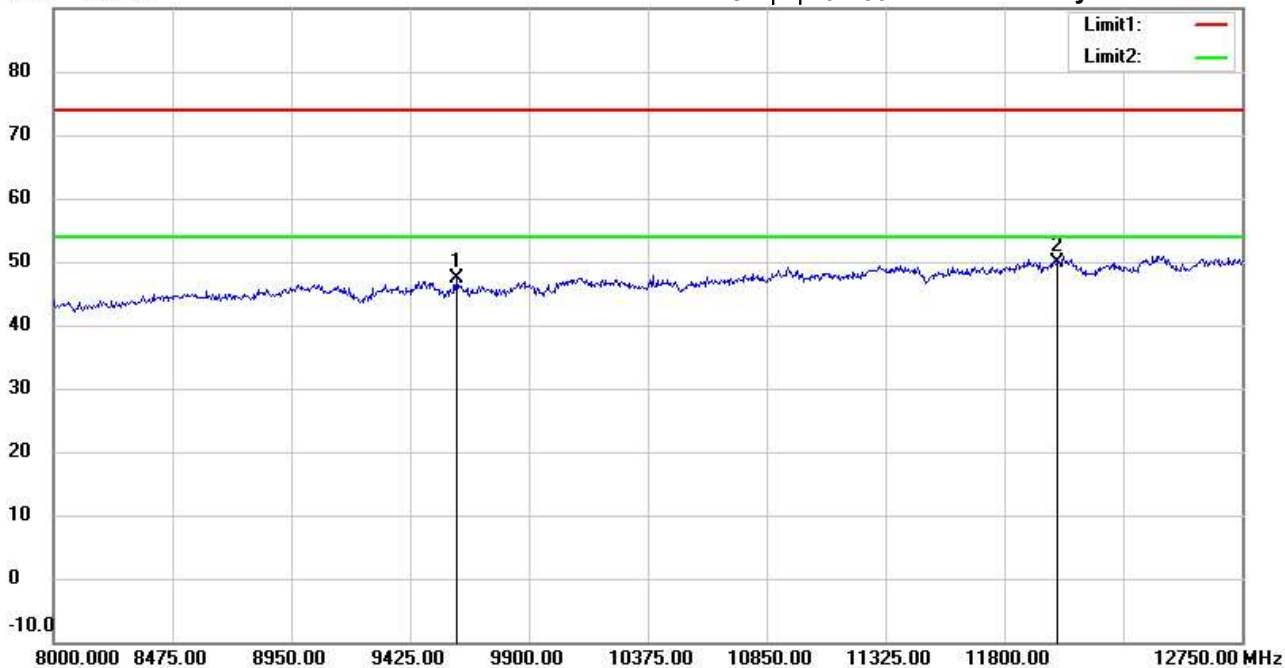
Condition : FCC\_part 15 RE-Class C\_Above 1GHz\_PK

Polarization: **Horizontal**

| Mk. | Frequency (MHz) | Reading (dBuV) | Detector | Corr. factor (dB/m) | Result (dBuV/m) | Limit (dBuV/m) | Ant.Pos (cm) | Tab.Pos (deg.) | Margin (dB) | Comment |
|---|---|---|---|---|---|---|---|---|---|---|
| | 9608.000 | 33.92 | peak | 13.39 | 47.31 | 74.00 | 150 | 217 | -26.69 | |
| * | 12010.000 | 32.56 | peak | 17.28 | 49.84 | 74.00 | 150 | 120 | -24.16 | |

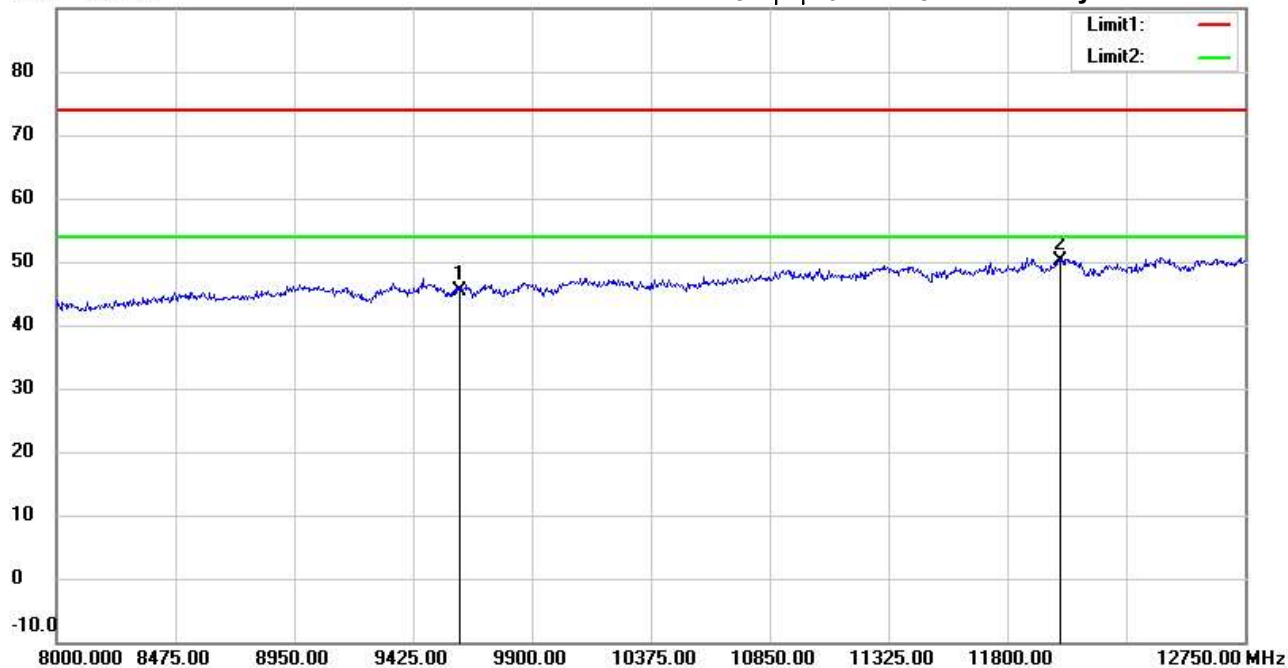
Condition : FCC\_part 15 RE-Class C\_Above 1GHz\_PK

Polarization: Vertical

| Mk. | Frequency (MHz) | Reading (dBuV) | Detector | Corr. factor (dB/m) | Result (dBuV/m) | Limit (dBuV/m) | Ant.Pos (cm) | Tab.Pos (deg.) | Margin (dB) | Comment |
|---|---|---|---|---|---|---|---|---|---|---|
| | 9608.000 | 31.98 | peak | 13.39 | 45.37 | 74.00 | 150 | 178 | -28.63 | |
| * | 12010.000 | 32.90 | peak | 17.28 | 50.18 | 74.00 | 150 | 111 | -23.82 | |

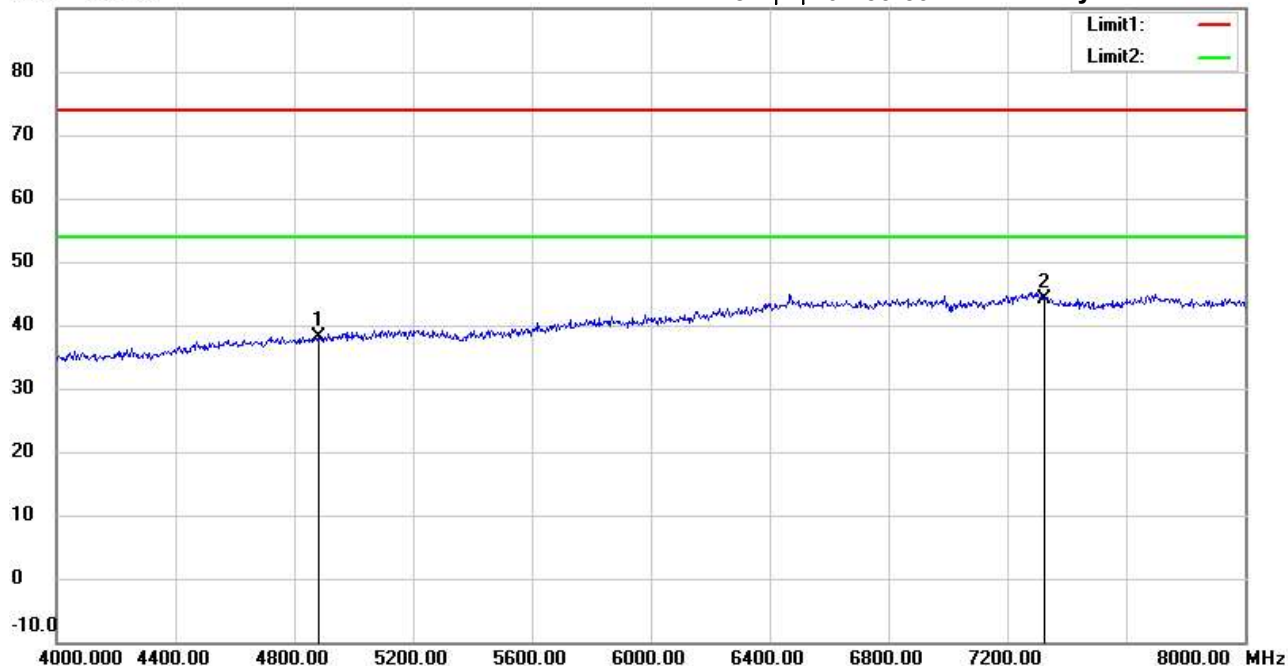
Condition : FCC\_part 15 RE-Class C\_Above 1GHz\_PK

Polarization: **Horizontal**

| Mk. | Frequency (MHz) | Reading (dBuV) | Detector | Corr. factor (dB/m) | Result (dBuV/m) | Limit (dBuV/m) | Ant.Pos (cm) | Tab.Pos (deg.) | Margin (dB) | Comment |
|---|---|---|---|---|---|---|---|---|---|---|
| | 4882.000 | 32.79 | peak | 5.23 | 38.02 | 74.00 | 150 | 17 | -35.98 | |
| * | 7323.000 | 32.42 | peak | 11.65 | 44.07 | 74.00 | 150 | 90 | -29.93 | |

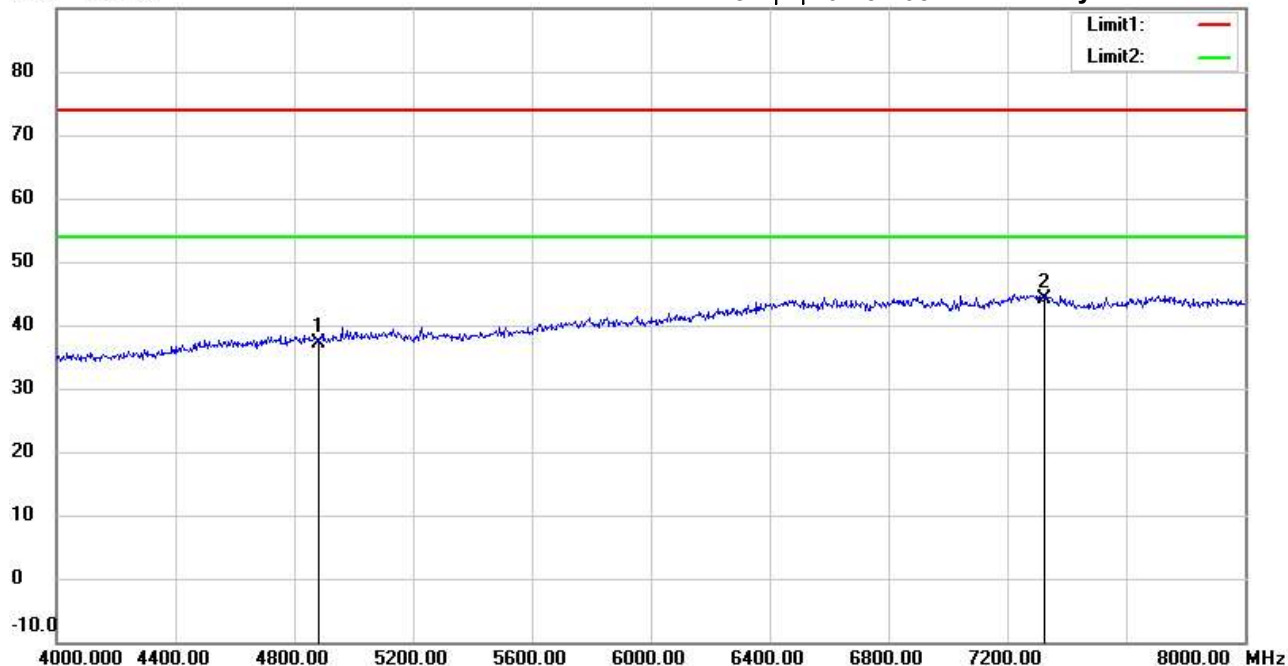
Condition : FCC\_part 15 RE-Class C\_Above 1GHz\_PK

Polarization: Vertical

| Mk. | Frequency (MHz) | Reading (dBuV) | Detector | Corr. factor (dB/m) | Result (dBuV/m) | Limit (dBuV/m) | Ant.Pos (cm) | Tab.Pos (deg.) | Margin (dB) | Comment |
|---|---|---|---|---|---|---|---|---|---|---|
| | 4882.000 | 32.00 | peak | 5.23 | 37.23 | 74.00 | 150 | 41 | -36.77 | |
| * | 7323.000 | 32.58 | peak | 11.65 | 44.23 | 74.00 | 150 | 321 | -29.77 | |

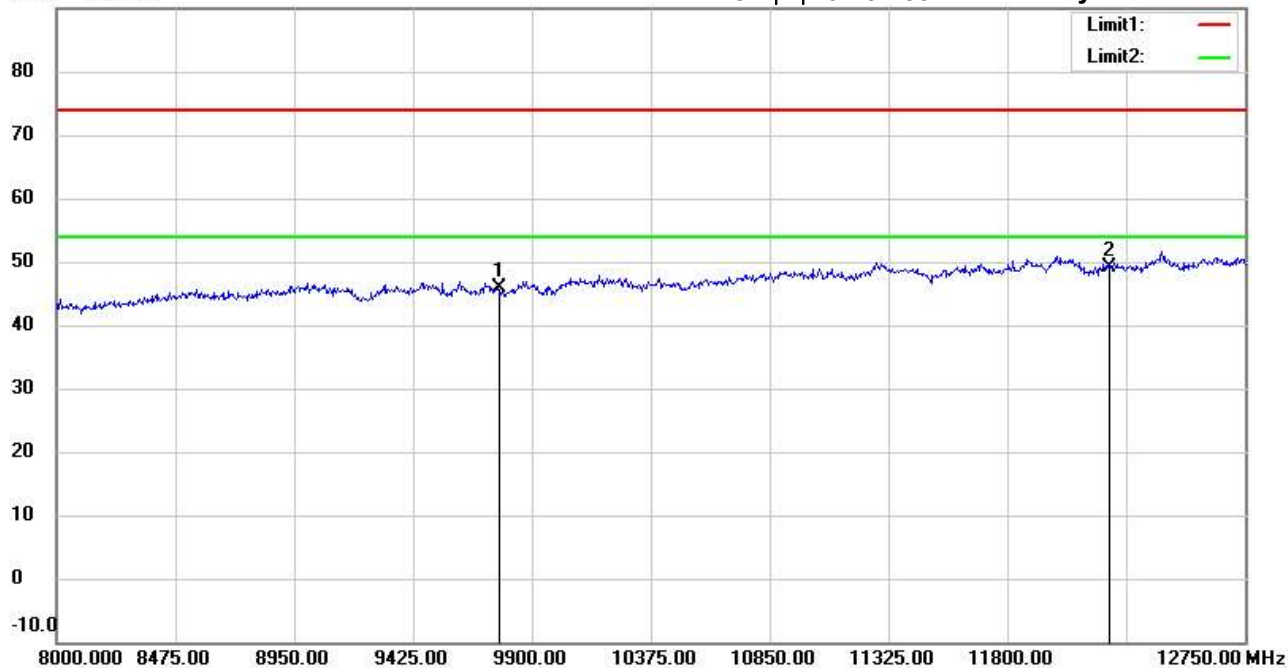
Condition : FCC\_part 15 RE-Class C\_Above 1GHz\_PK

Polarization: **Horizontal**

| Mk. | Frequency (MHz) | Reading (dBuV) | Detector | Corr. factor (dB/m) | Result (dBuV/m) | Limit (dBuV/m) | Ant.Pos (cm) | Tab.Pos (deg.) | Margin (dB) | Comment |
|---|---|---|---|---|---|---|---|---|---|---|
| | 9764.000 | 32.15 | peak | 13.76 | 45.91 | 74.00 | 150 | 148 | -28.09 | |
| * | 12205.000 | 32.01 | peak | 17.00 | 49.01 | 74.00 | 150 | 141 | -24.99 | |

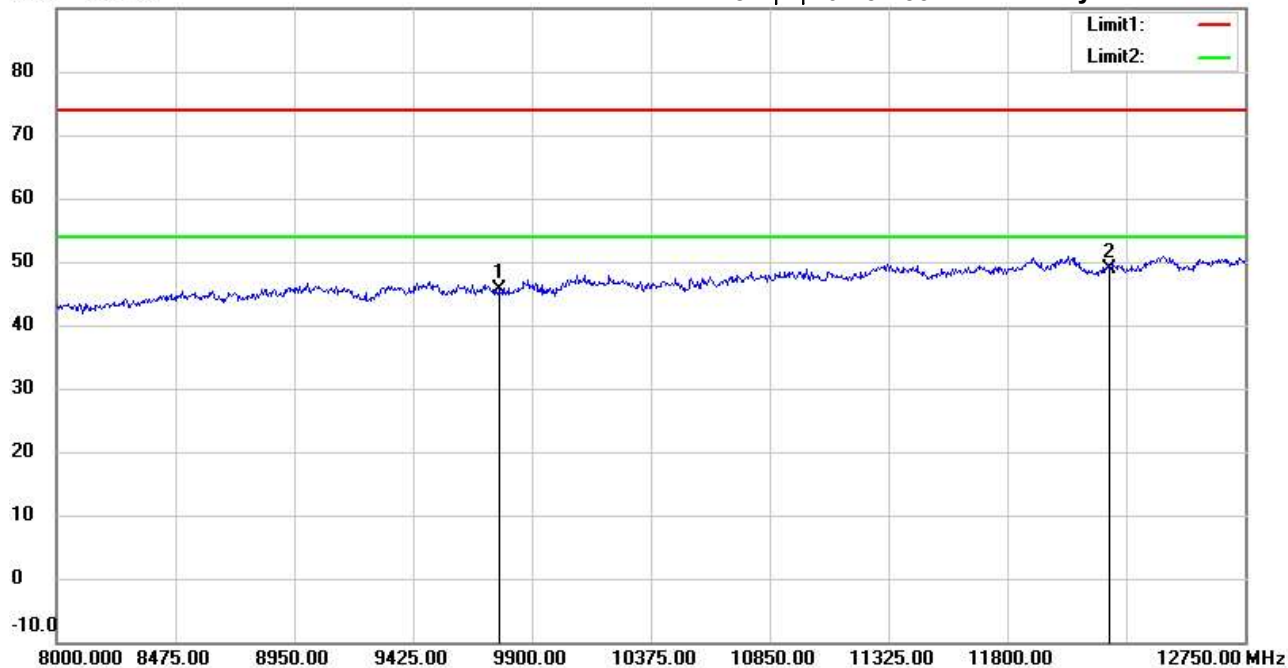
Condition : FCC\_part 15 RE-Class C\_Above 1GHz\_PK

Polarization: Vertical

| Mk. | Frequency (MHz) | Reading (dBuV) | Detector | Corr. factor (dB/m) | Result (dBuV/m) | Limit (dBuV/m) | Ant.Pos (cm) | Tab.Pos (deg.) | Margin (dB) | Comment |
|---|---|---|---|---|---|---|---|---|---|---|
| | 9764.000 | 31.84 | peak | 13.76 | 45.60 | 74.00 | 150 | 55 | -28.40 | |
| * | 12205.000 | 31.93 | peak | 17.00 | 48.93 | 74.00 | 150 | 186 | -25.07 | |

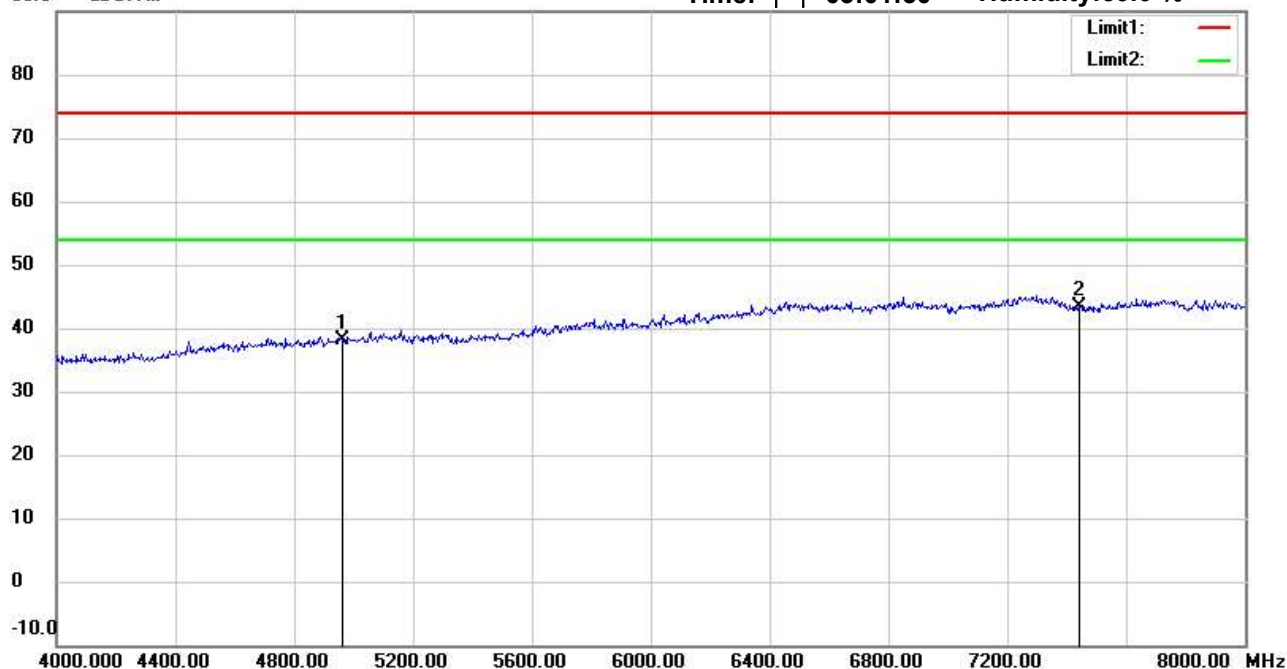
Condition : FCC\_part 15 RE-Class C\_Above 1GHz\_PK

Polarization: **Horizontal**

| Mk. | Frequency (MHz) | Reading (dBuV) | Detector | Corr. factor (dB/m) | Result (dBuV/m) | Limit (dBuV/m) | Ant.Pos (cm) | Tab.Pos (deg.) | Margin (dB) | Comment |
|---|---|---|---|---|---|---|---|---|---|---|
| | 4960.000 | 32.50 | peak | 5.53 | 38.03 | 74.00 | 150 | 4 | -35.97 | |
| * | 7440.000 | 32.04 | peak | 11.41 | 43.45 | 74.00 | 150 | 81 | -30.55 | |
