# Antenna Part Specification

| Project name: | DH30-D |
| Material category: | BT antenna |
| Version: | V1.0 |

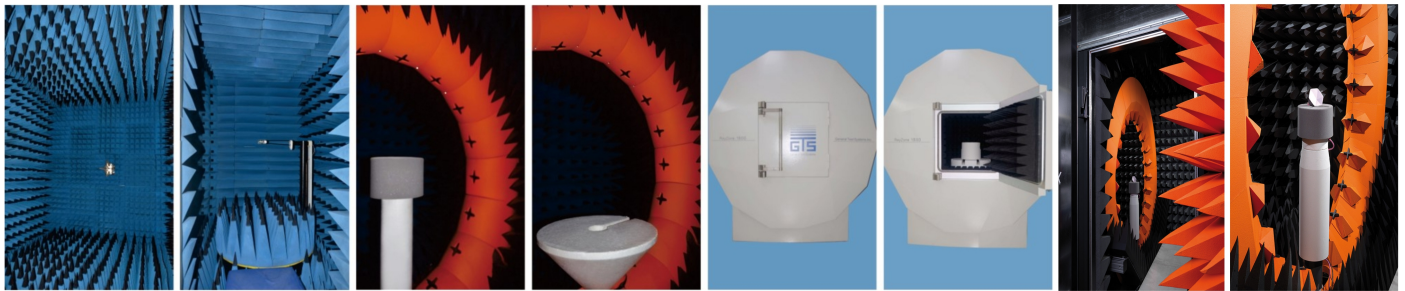
OTA Standard Chamber

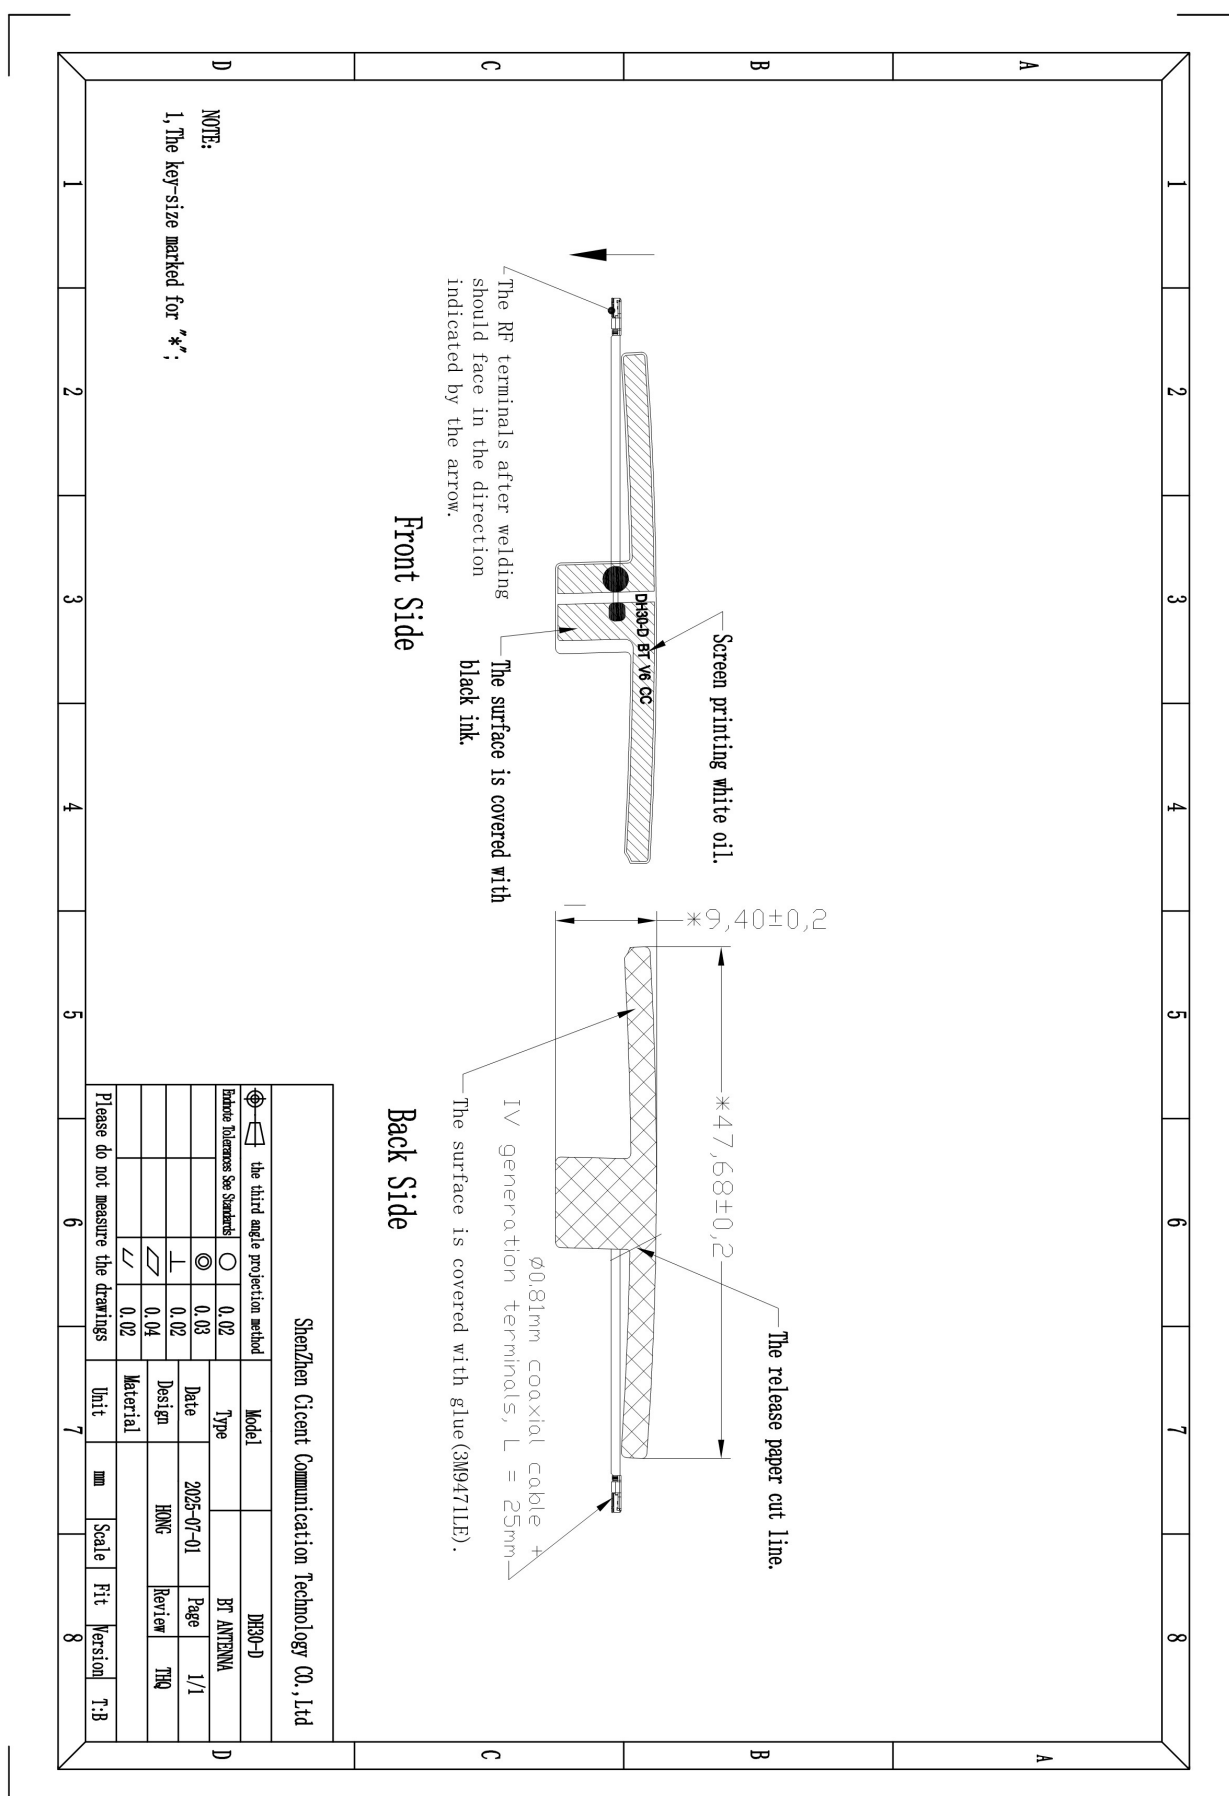
V: Antenna structure diagram file
