APPENDIX 3: Photographs of test setup

Conducted Emission

Radiated Spurious Emission

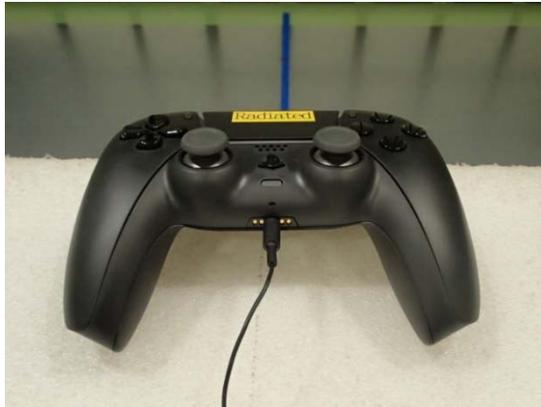
X-axis

Worst Case Position
Below 1GHz (Horizontal: X-axis/ Vertical: X-axis)
Above 1GHz (Horizontal: Y-axis/ Vertical: Z-axis)

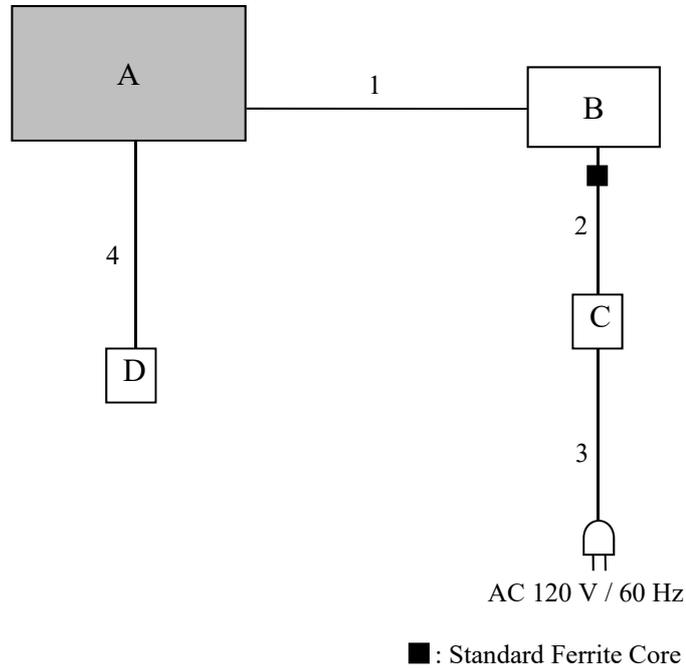
Test Configuration and peripherals

* Cabling and setup(s) were taken into consideration and test data was taken under worse case conditions.

No.	Item	Model number	Serial number	Manufacturer	Remark
A	Wireless Controller	CFI-ZCT1W	47 for CE*, RE* 46 for AT*	Sony Interactive Entertainments Inc.	EUT
B	Laptop PC	X230	R9-X86LK	Lenovo	-
C	AC Adapter	92P1156	11S92P1156Z1ZDXN88CUJM	Lenovo	-
D	IN-EAR HEAD SET	-	-	Sony Interactive Entertainments Inc.	-

No.	Name	Length (m)	Shield		Remark
			Cable	Connector	
1	USB Cable	1.5	Shielded	Shielded	-
2	DC Cable	1.8	Unshielded	Unshielded	-
3	AC Cable	0.8	Unshielded	Unshielded	-
4	Headset Cable	1.2	Unshielded	Unshielded	-
