APPENDIX 3: Photographs of test setup

Radiated Spurious Emission

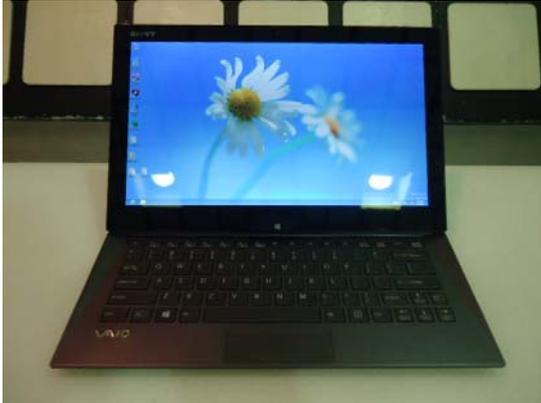
Laptop Style

Band 4 :Horizontal: Laptop X-axis / Vertical:Laptop Z-axis

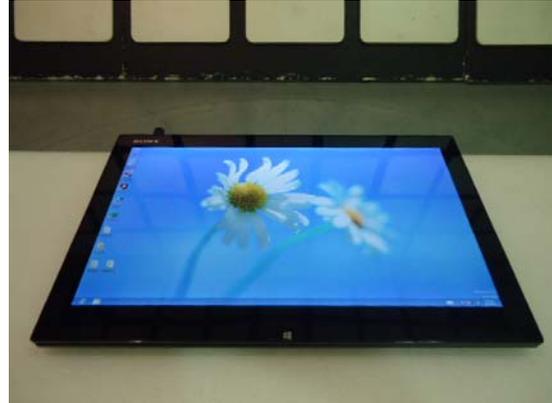
X-axis

Tablet Style
