### **APPENDIX 3: Photographs of test setup**

#### **Conducted Emission**

### Radiated Spurious Emission

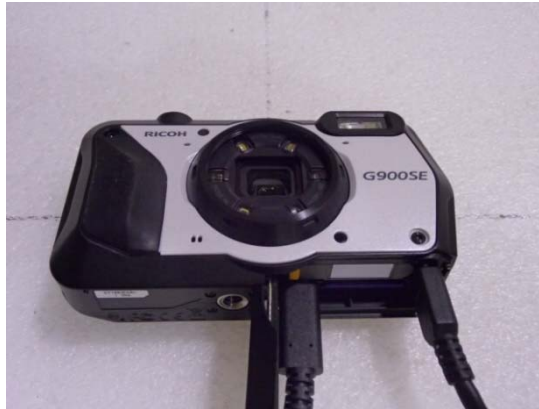
**X-axis**

### **Worst Case Position**

Above 1GHz : (Horizontal: Z-axis/ Vertical: X-axis)

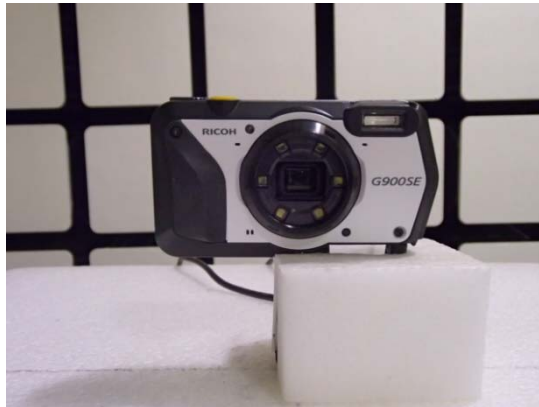
**Y-axis**

Below 1GHz : (Horizontal: Z-axis/ Vertical: Y-axis)
