### **APPENDIX 3: Photographs of test setup**

#### **Radiated Spurious Emission**

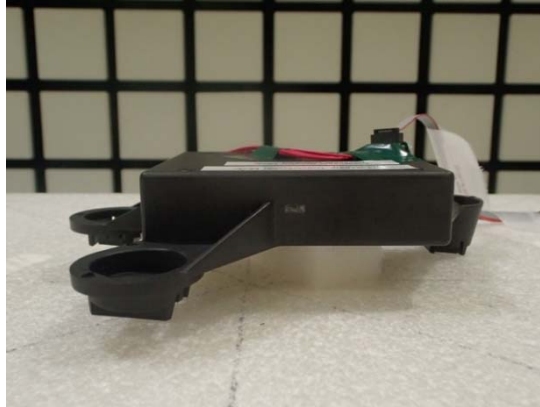
#### **X-axis**

Below 1 GHz (Horizontal: X-axis / Vertical: X-axis)

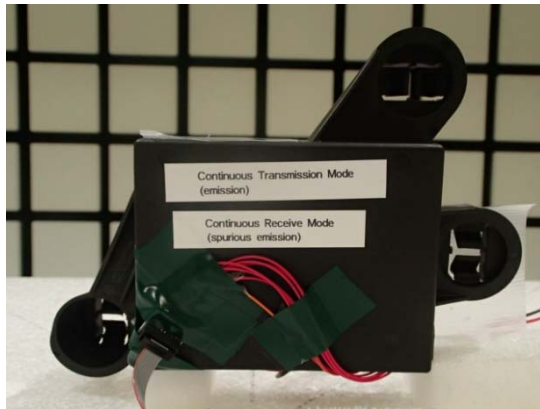
#### **Y-axis**

Above 1 GHz (Horizontal: Y-axis / Vertical: Z-axis)
