APPENDIX 3: Photographs of Test Setup

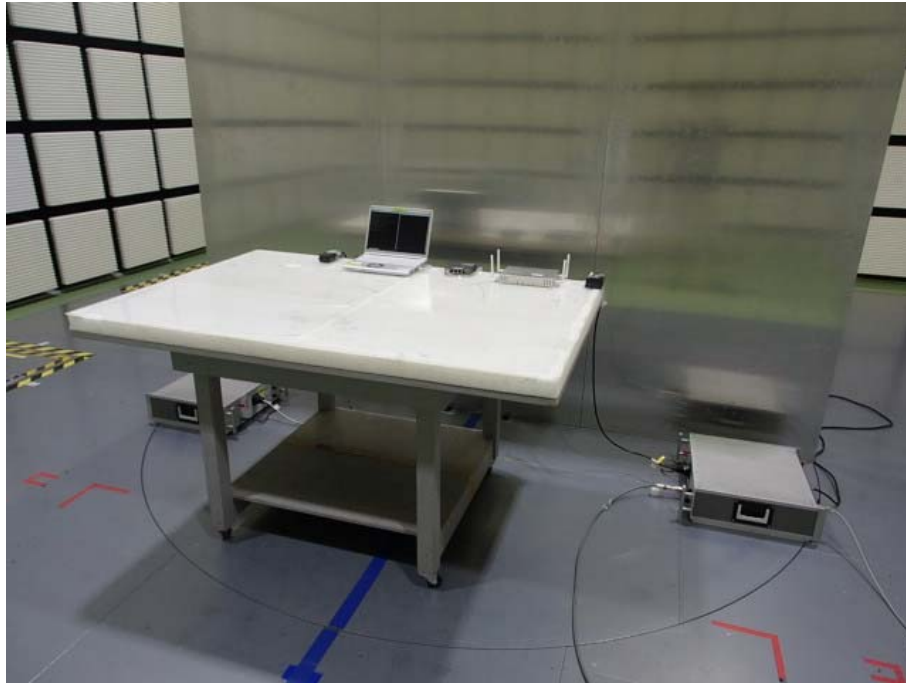
Photo 1

Conducted Emission

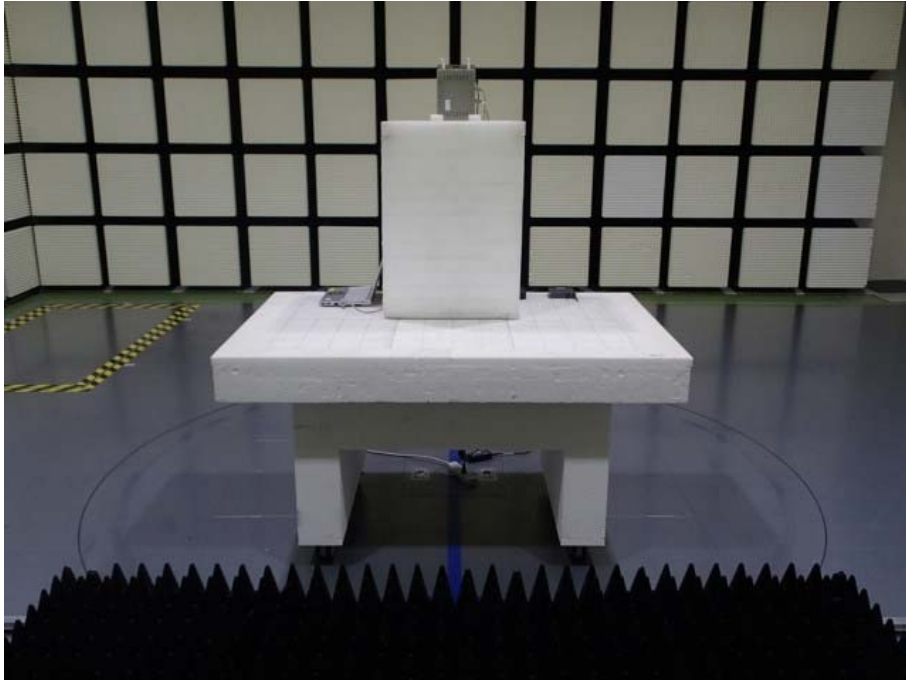
Photo 1

Radiated Spurious Emission

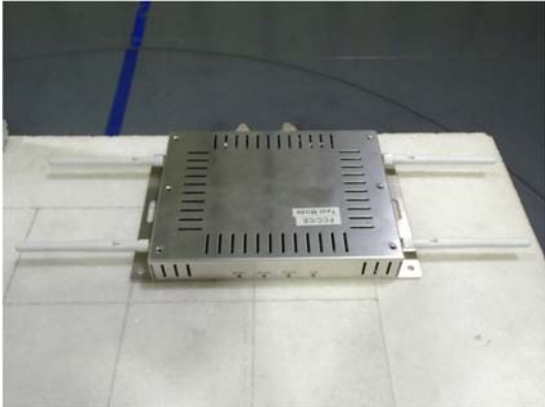
**EUT X-axis
Antenna 0 deg**

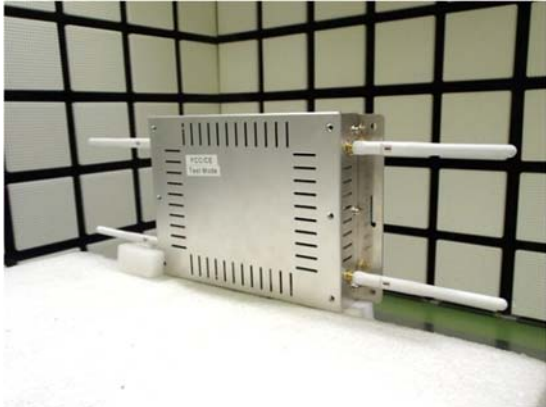
**EUT Y-axis
Antenna 0 deg**

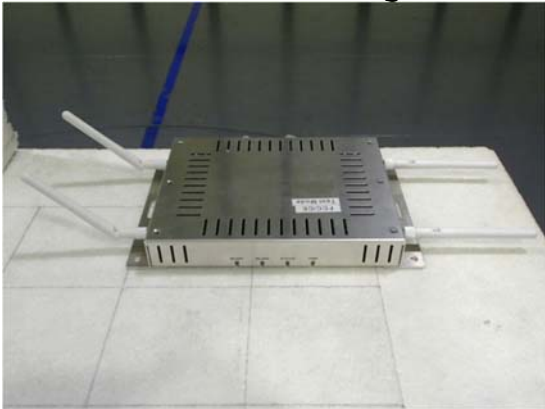
**EUT X-axis
Antenna 45 deg**

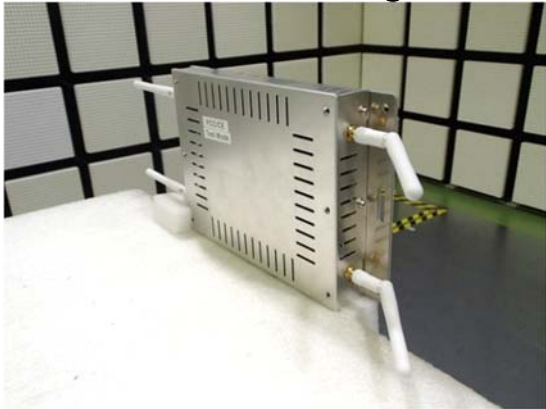
**EUT Y-axis
Antenna 45 deg**

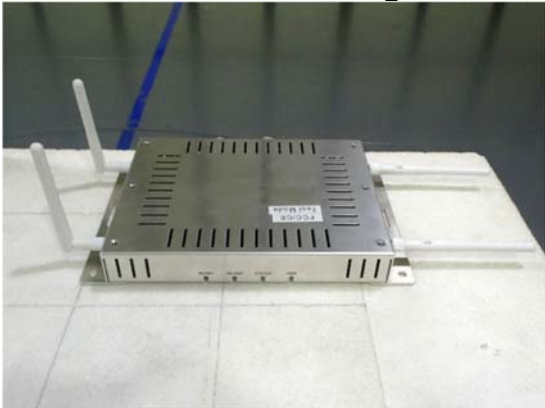
**EUT X-axis
Antenna 90 deg**

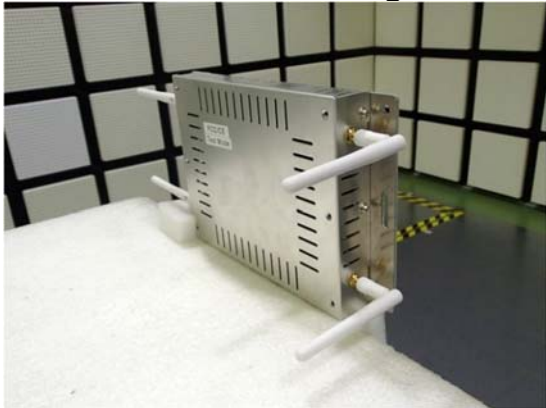
**EUT Y-axis
Antenna 90 deg**

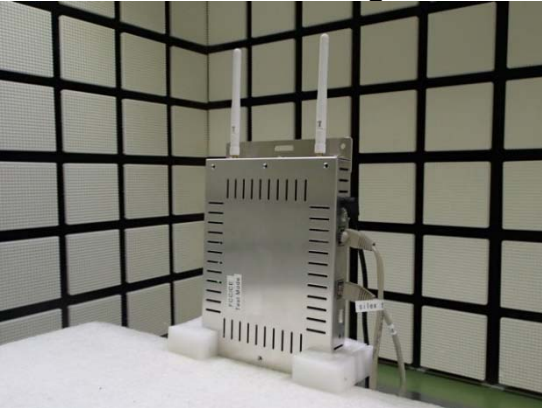
**EUT Z-axis
Antenna 0 deg.**

Test Range	Horizontal	Vertical
Below 1 GHz	EUT Z-axis Antenna 0 deg	EUT Z-axis Antenna 0 deg
Above 1 GHz	EUT Z-axis Antenna 90 deg	EUT Z-axis Antenna 45 deg

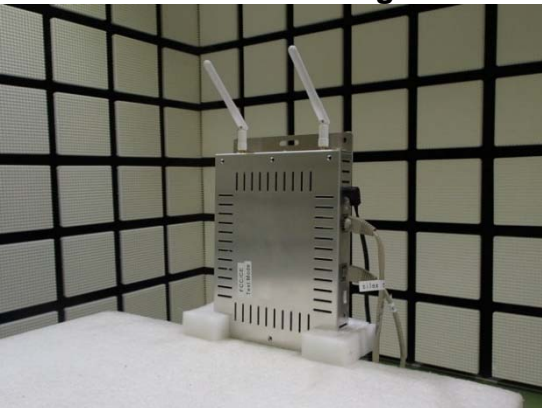
**EUT Z-axis
Antenna 45 deg.**

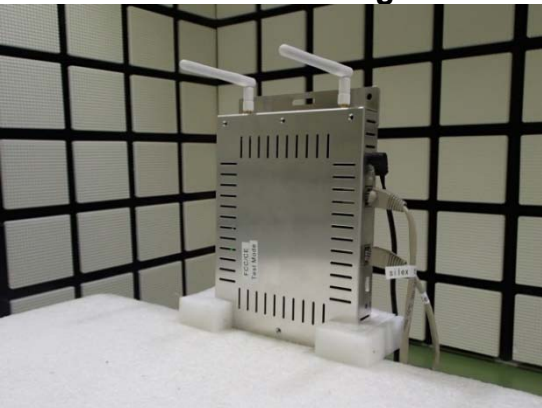
**EUT Z-axis
Antenna 90 deg.**

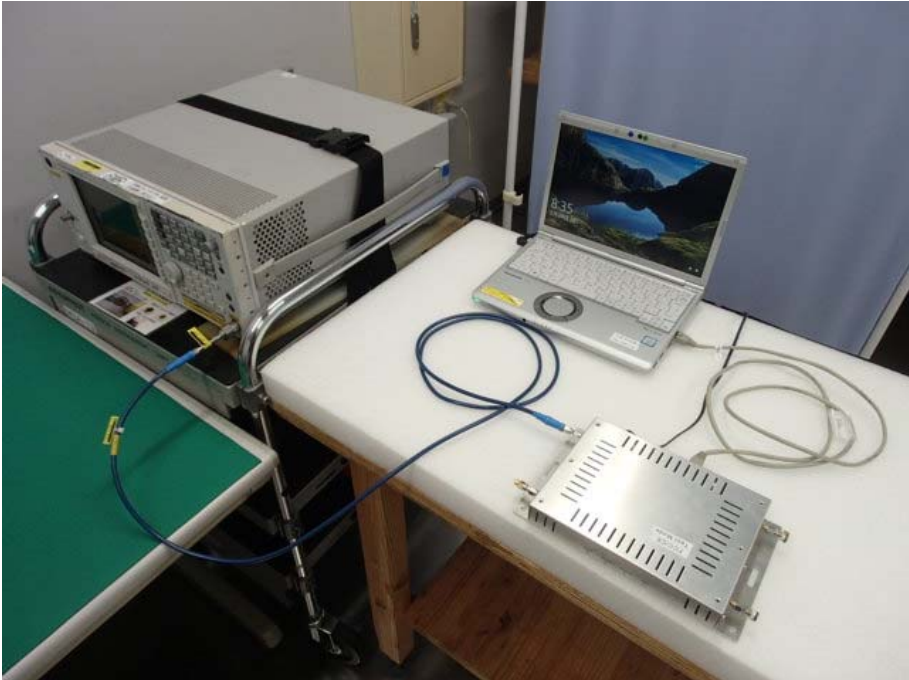
Photo 1

Antenna Terminal Conducted Tests
