**Environmental Testing**  
**For**  
**SRT Marine Technology Limited**  
**On**  
**Iris AIS700 Class B AIS Transceiver/Splitter**  
**Report No. TRA-037294-26-CR-01B**  
**NOVEMBER 2017**

**Environmental Testing**  
**For**  
**SRT Marine Technology Limited**  
**On**  
**Iris AIS700 Class B AIS Transceiver/Splitter**

**SUMMARY**

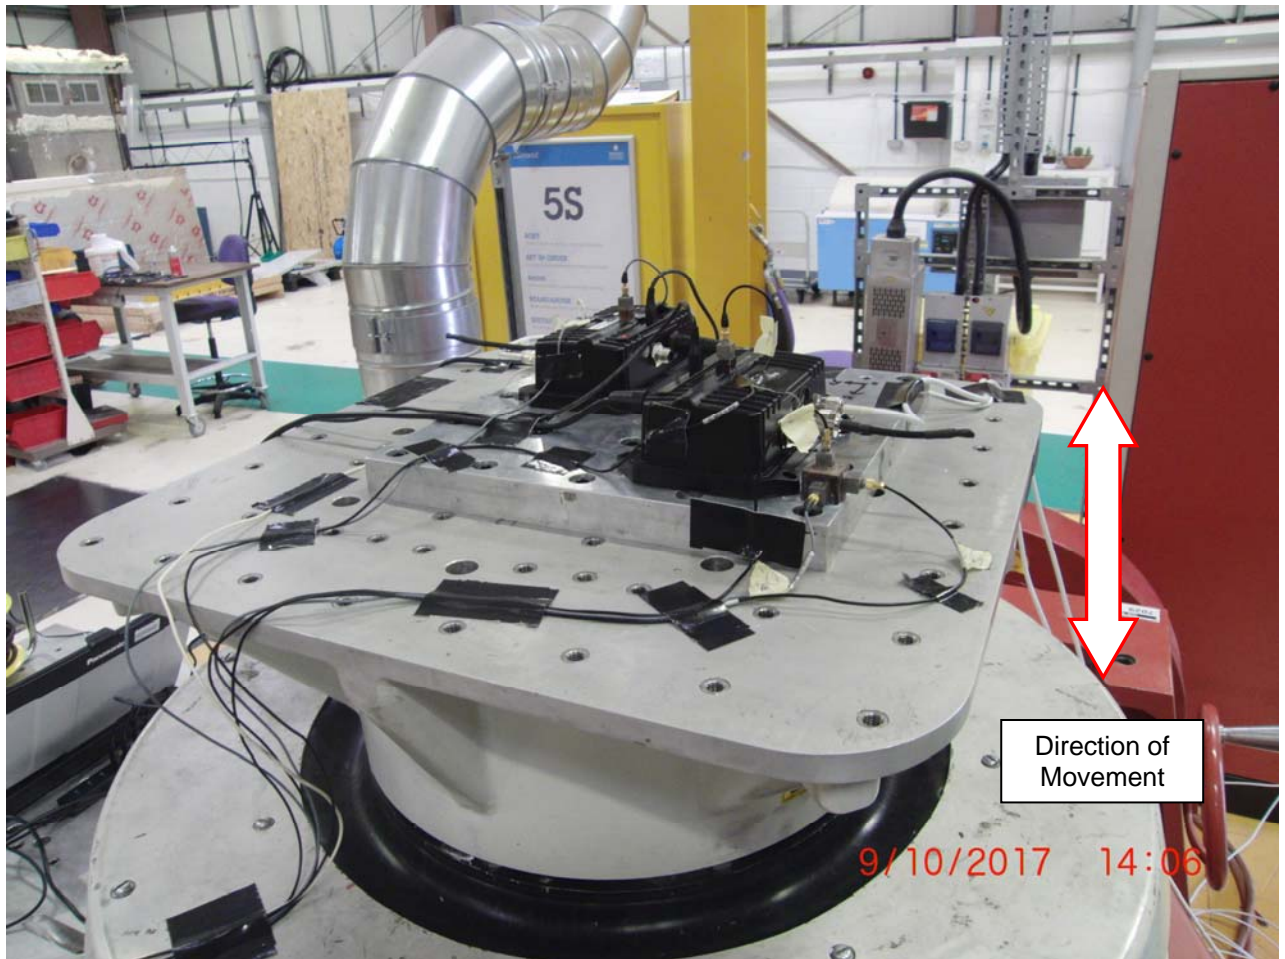
**FIGURE 1.4**

**Z AXIS  
TEST SETUP**

Two powered Iris AIS700 Class B AIS Transceiver/Splitter specimens were secured to a fixture plate which was bolted to a hydrostatic slip plate in the horizontal axes and to a head expander in the vertical axis. A tri-axial and uni-axial control accelerometer, utilising an average control strategy, were mounted at diagonally opposed fixing positions. A monitor accelerometer was also affixed to the top of each specimen to measure any resonances. Setup photographs are shown in Figures 1.2-1.5.

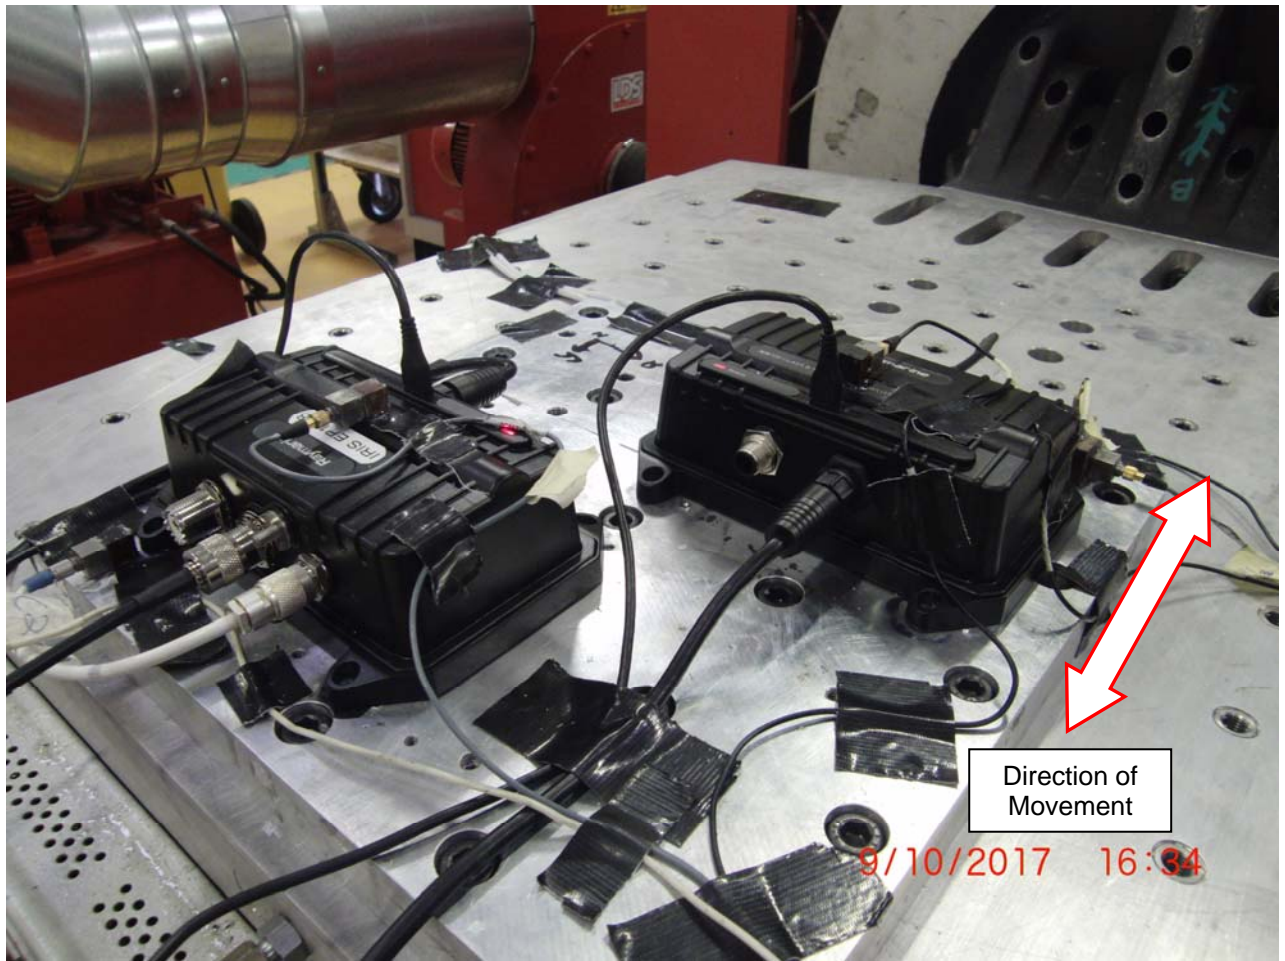
**FIGURE 1.5**

**Y AXIS  
TEST SETUP**

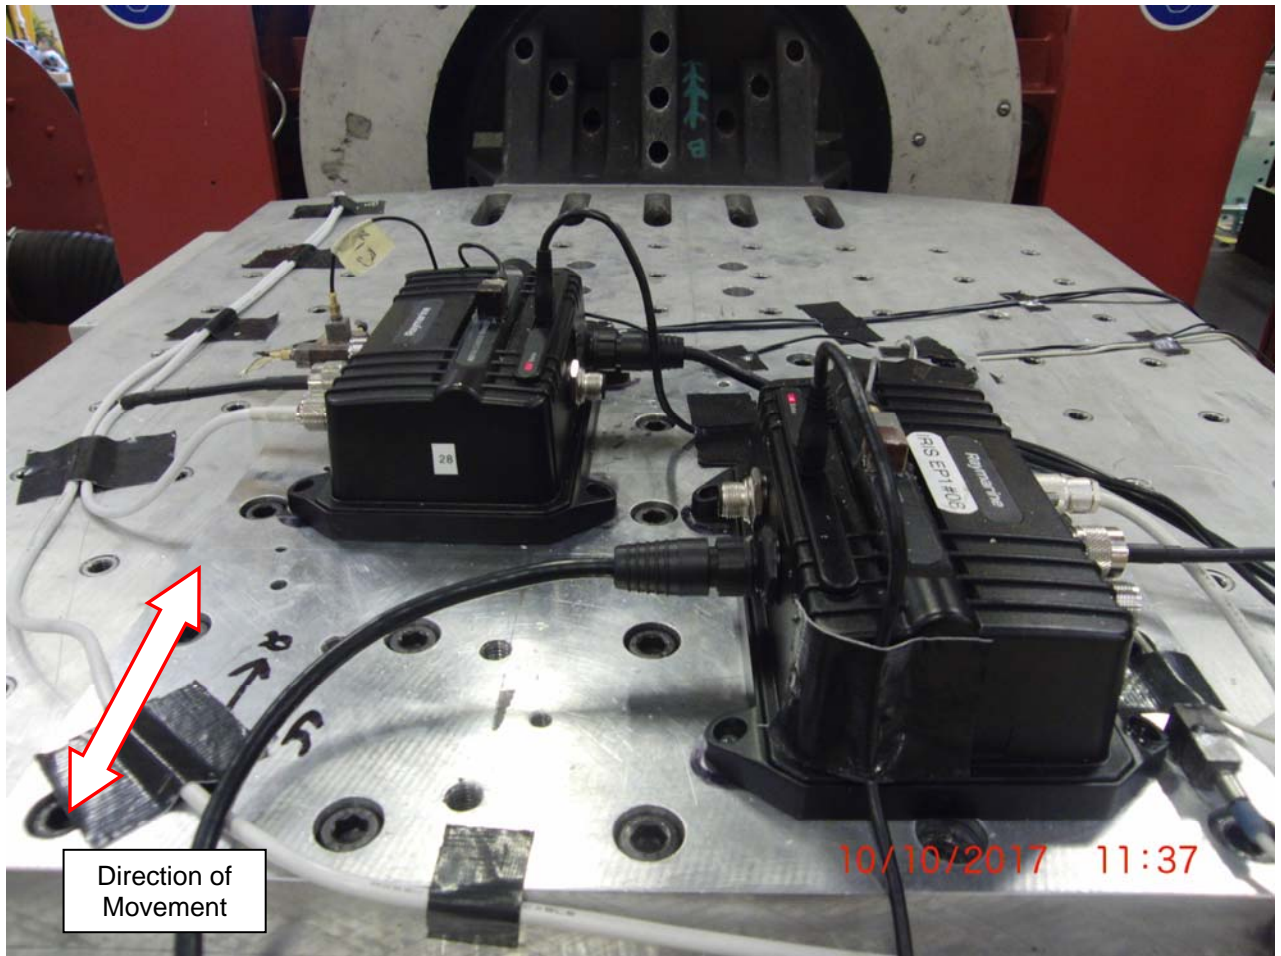
**FIGURE 1.6**

**X AXIS  
TEST SETUP**

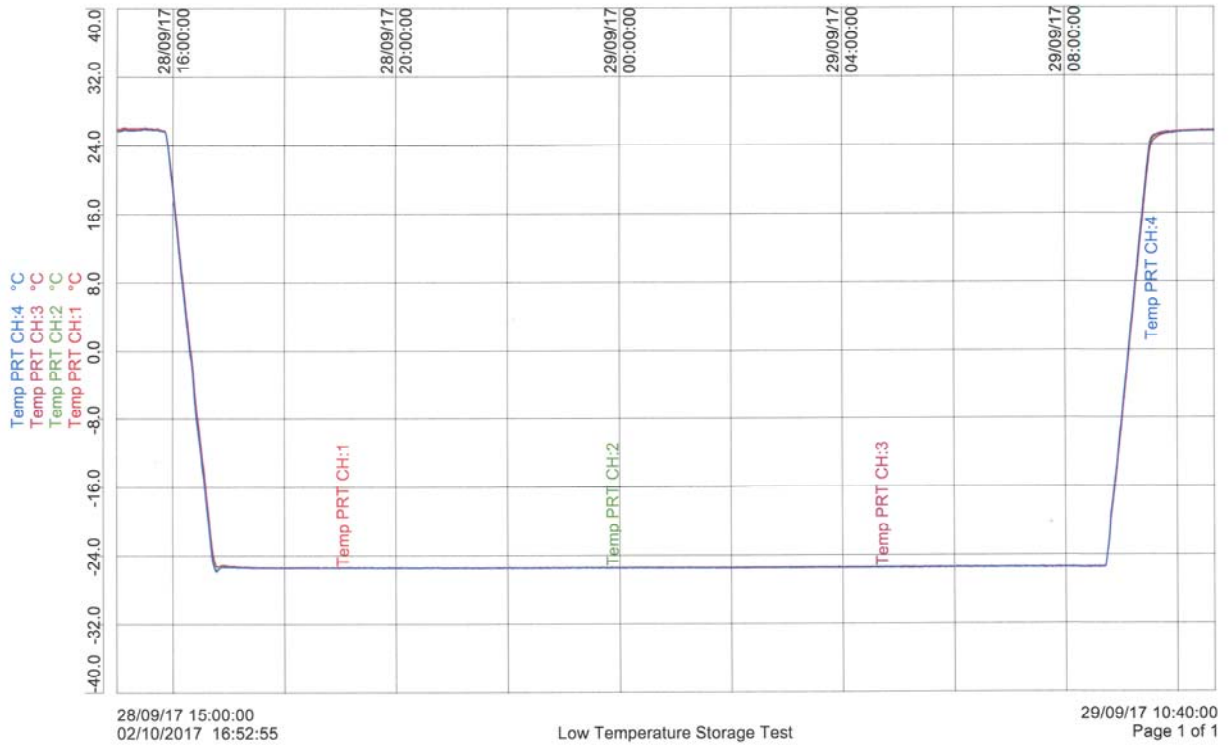
**FIGURE 2.1**

**LOW TEMPERATURE STORAGE TEST  
RESULT TRACE**

The Low Temperature Storage Test was completed. Once the specimens had stabilised at ambient temperature power was applied and a performance check was completed by an Element engineer at a nominal and extreme voltage condition. During the extreme voltage check the LED on the specimens changed from green to red. SRT advised that the indication of a red 'error' condition was not a failure of the product but a Built-In-Integrity-Test report identifying to the operator that an error had occurred. In this case the error report was an excessive voltage at the power supply input.

A result trace is shown in Figure 2.1

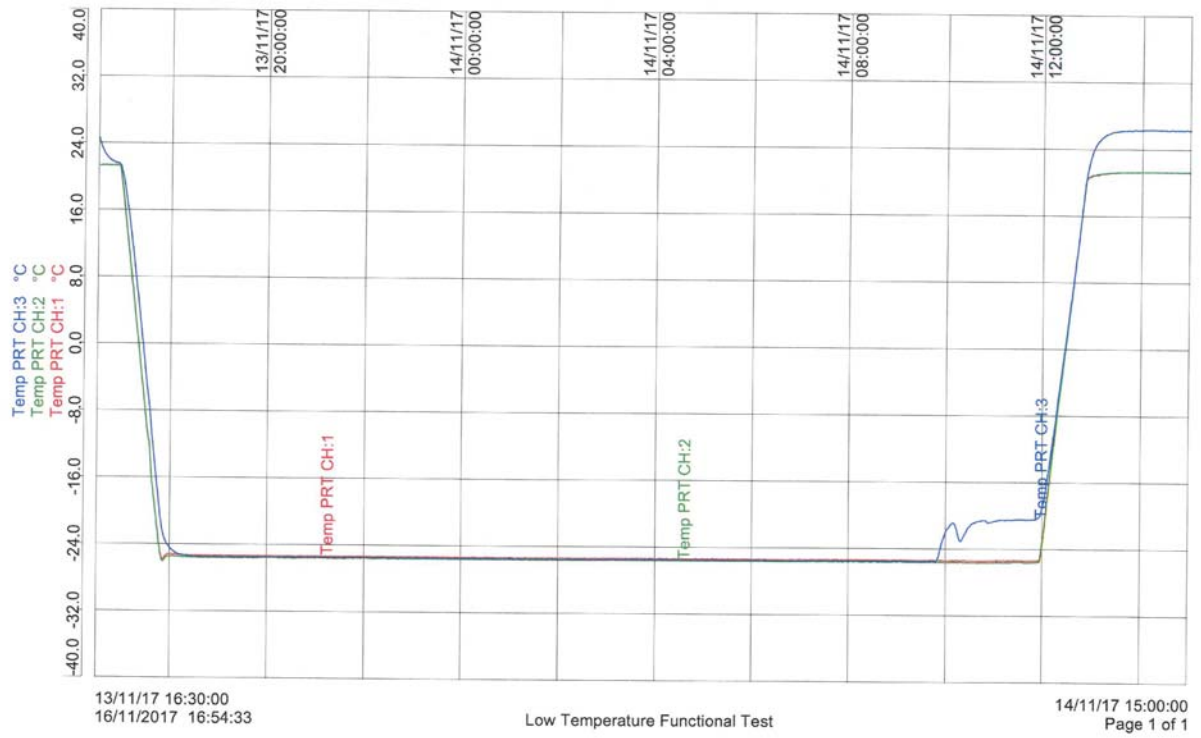
**FIGURE 2.5**

**LOW TEMPERATURE FUNCTIONAL TEST  
RESULT TRACE**

The Low Temperature Functional Test was completed. Once the sixteen hour soak period was concluded power was applied to the specimen which was then left operational for a further two hours at -25°C. Whilst powered a performance check was completed by an Element engineer at a nominal and extreme voltage condition. During the performance checks the specimen LED remained lit and the script on the ProAIS software continued to scroll. At the conclusion of the powered segment the chamber was returned to ambient temperature.

A result trace is shown in Figure 2.5

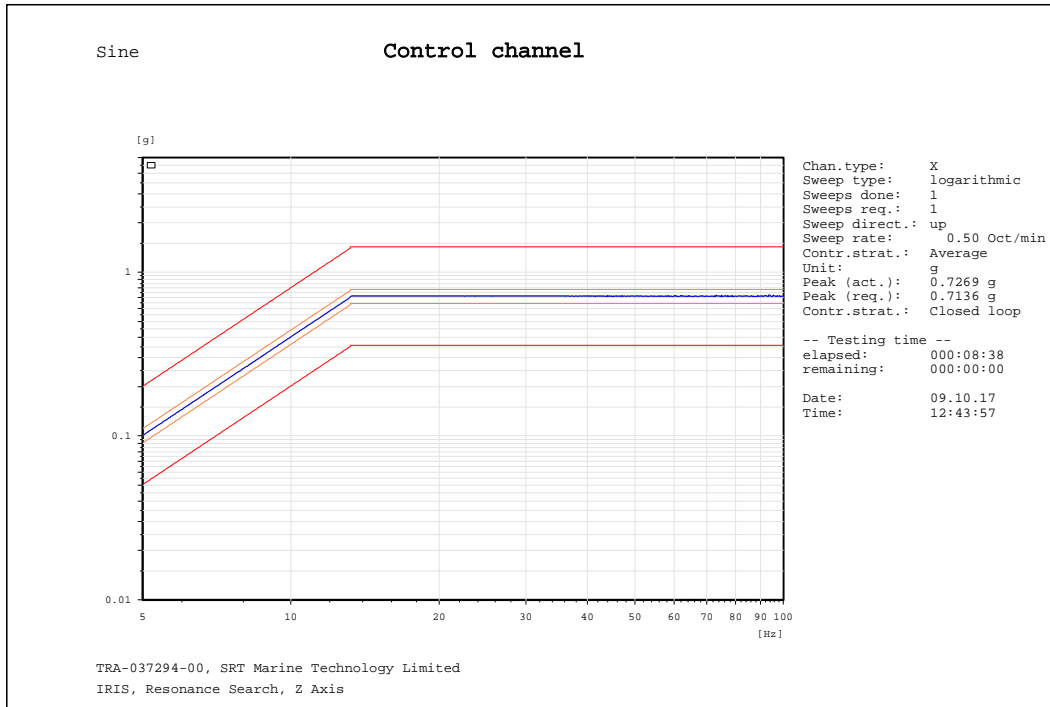
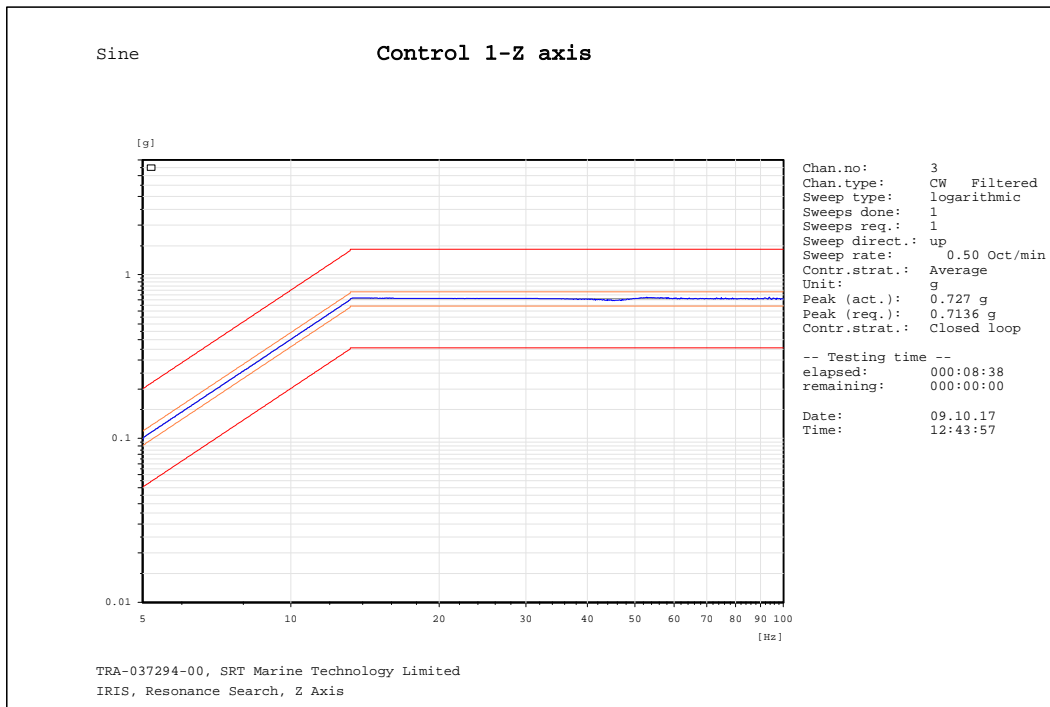
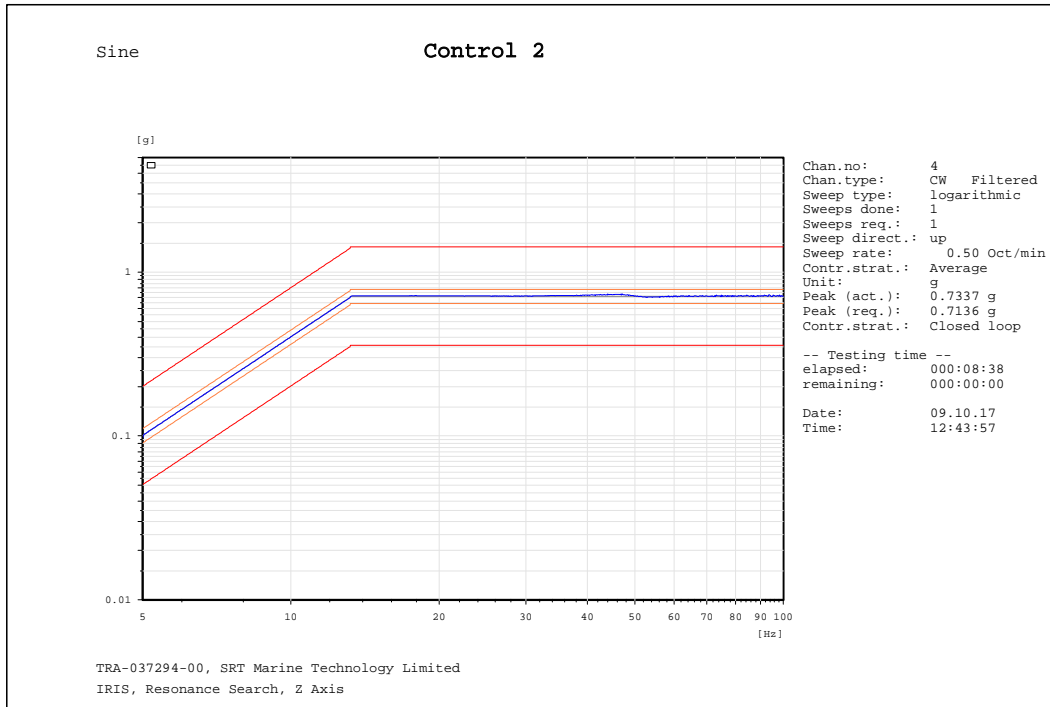
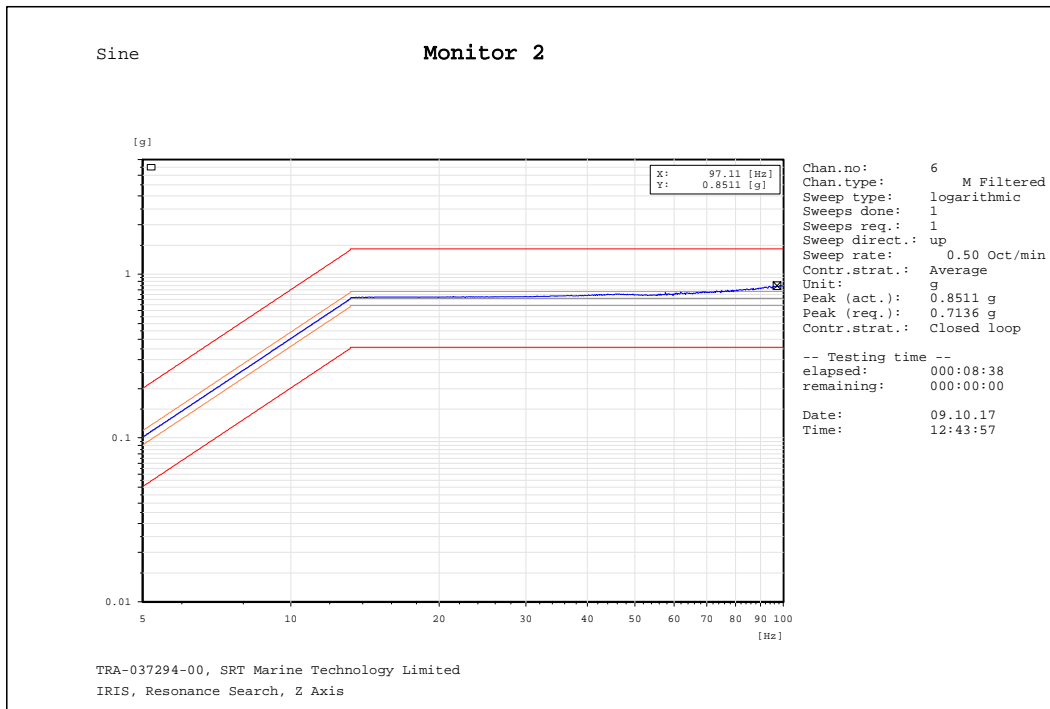
**RUN001 RESONANCE SEARCH  
Z AXIS**

All requested vibration tests were completed. During the resonance searches no resonances were found therefore all endurance tests were performed at a fixed 30Hz frequency for two hours in each axis. The specimen was powered for the duration of all vibration tests whilst performance checks were completed. Checks consisted of checking that the LED on the specimens remained lit and that a script in the ProAIS2 software program continued to scroll.

Result plots for the Z Axis testing are shown in Figures 3 to 5.  
Result plots for the Y Axis testing are shown in Figures 6 to 8.  
Result plots for the Z Axis testing are shown in Figures 9 to 11.

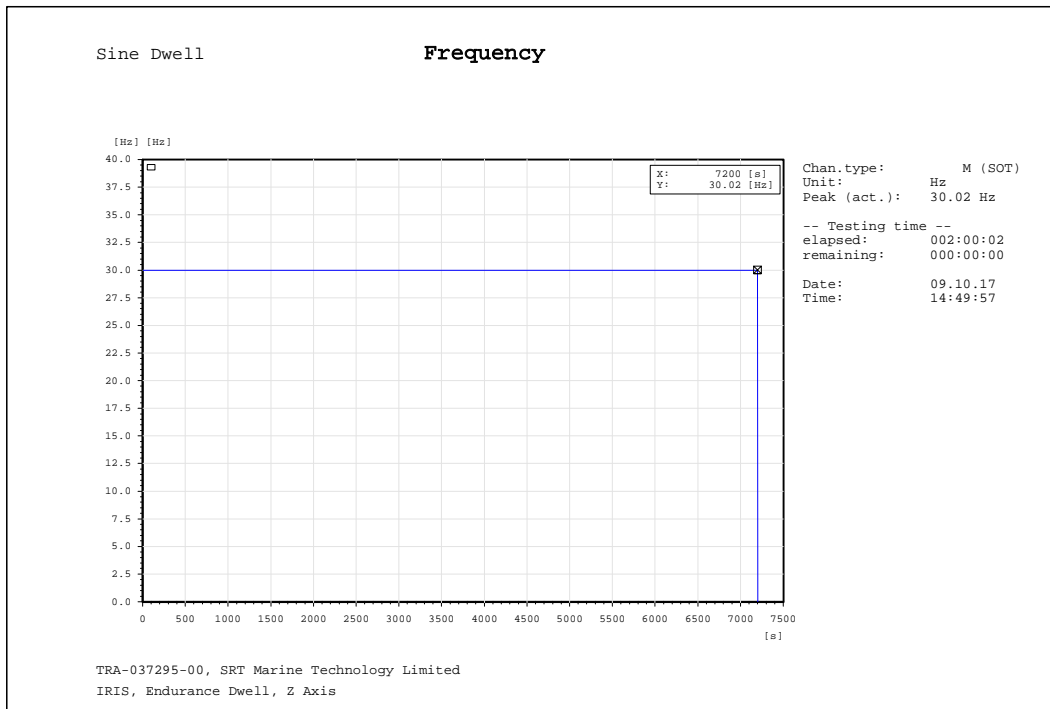
**FIGURE 4**

**RUN002 SINE DWELL- FREQUENCY  
Z AXIS**

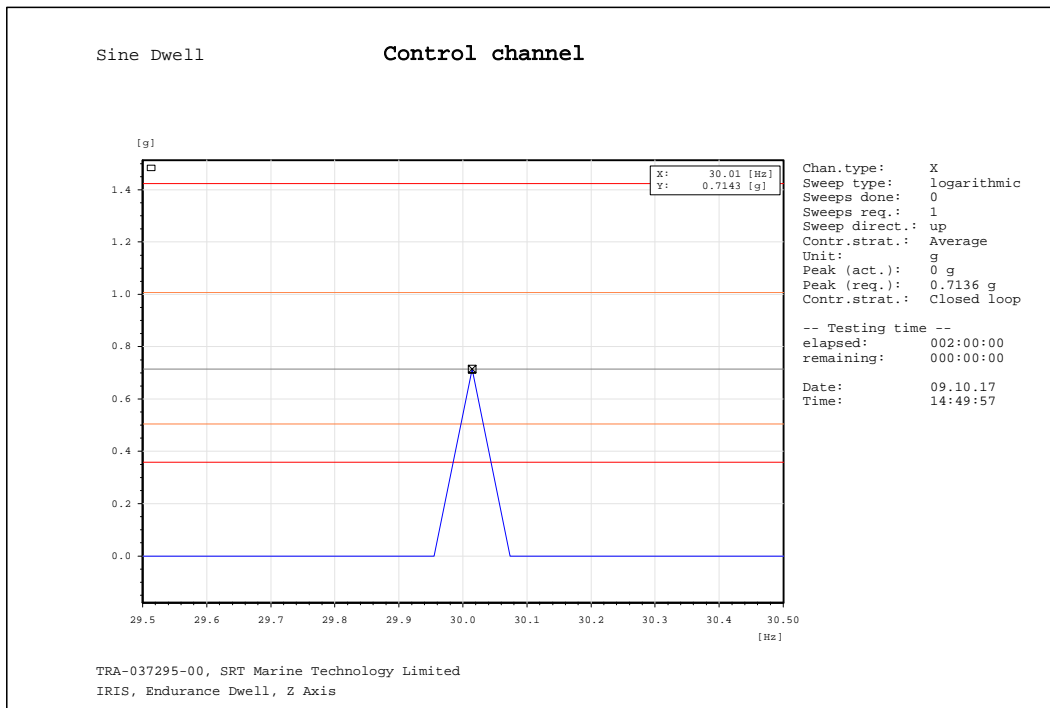
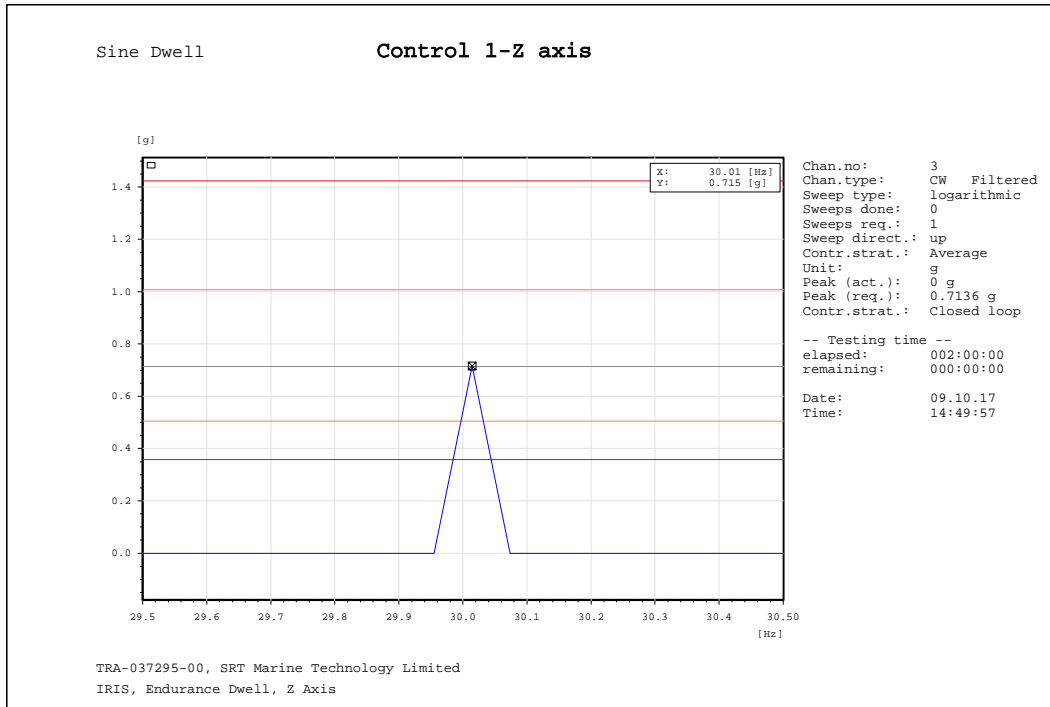
**RUN002 SINE DWELL  
Z AXIS**

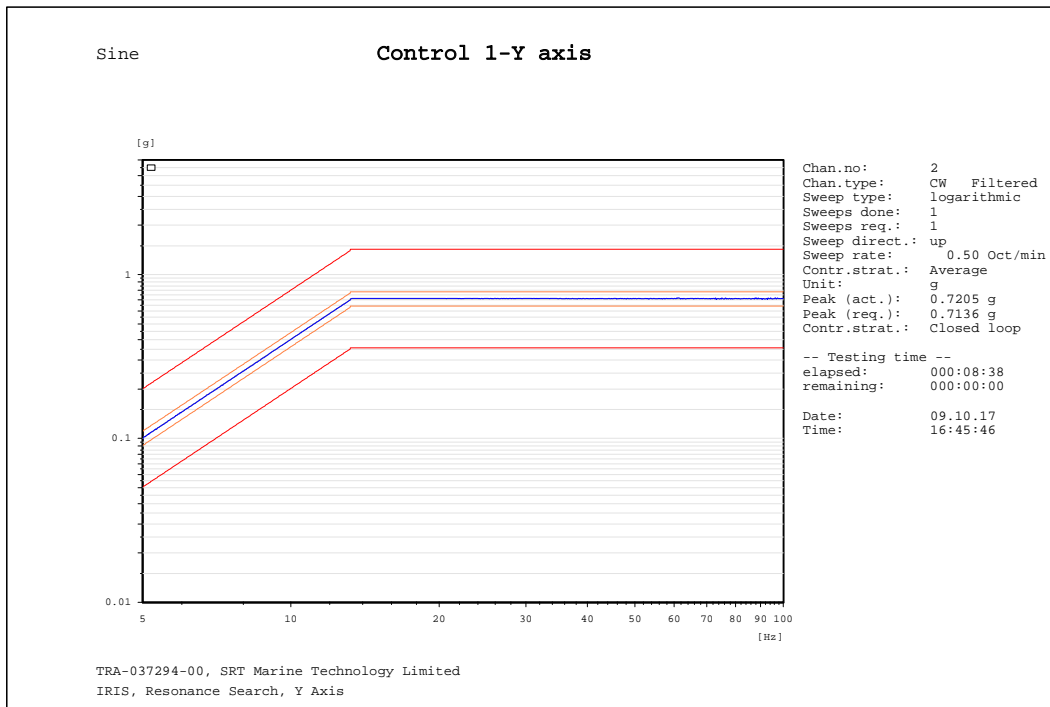
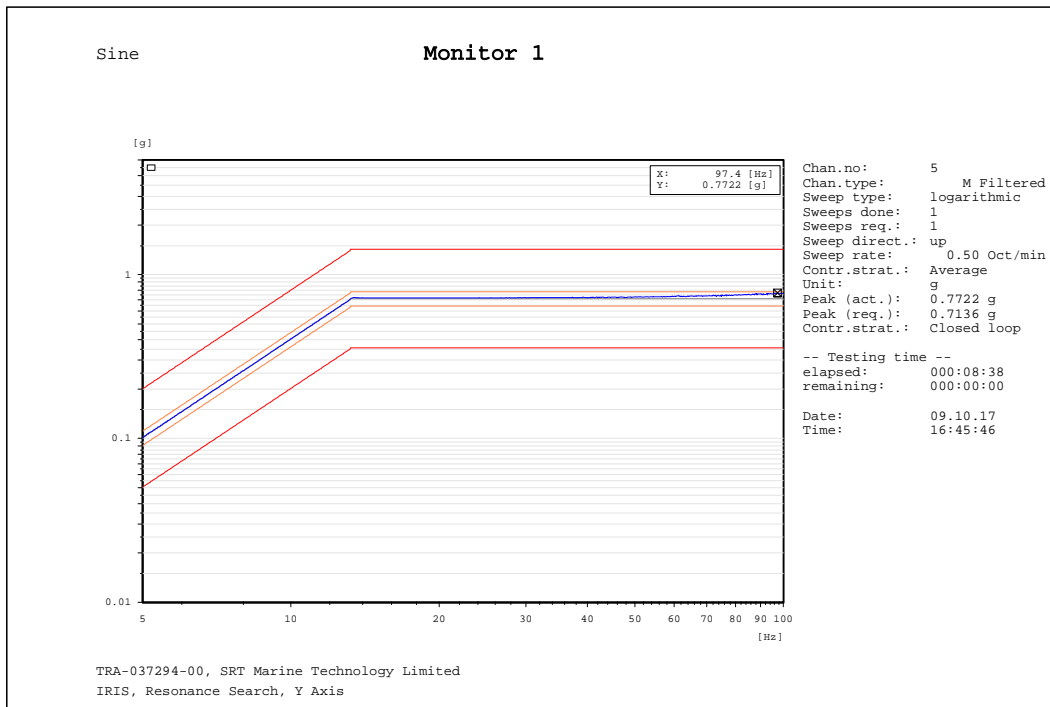
**RUN003 RESONANCE SEARCH  
Y AXIS**

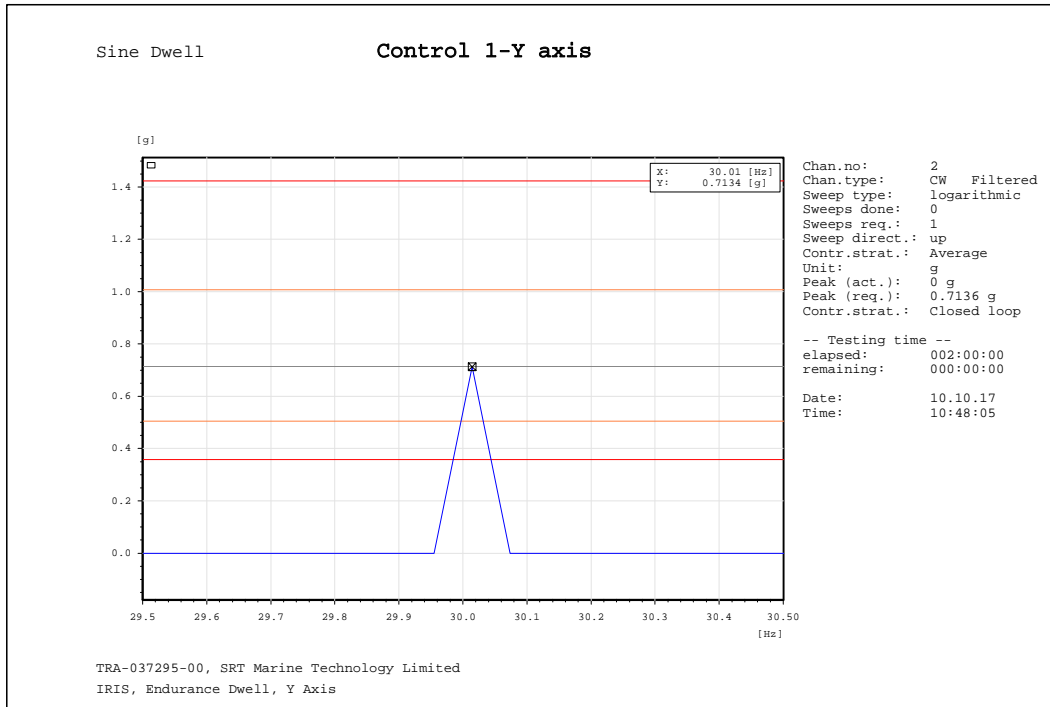
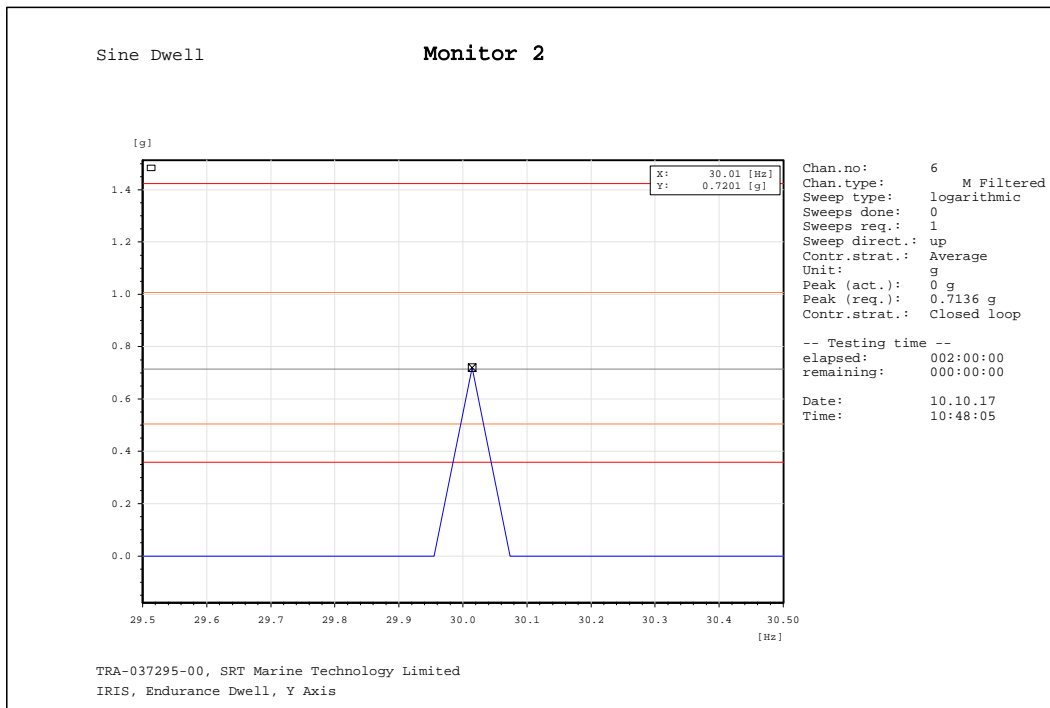
**RUN004 SINE DWELL  
Y AXIS**
