Annex C Photo documentation

Appendix to Test Report No.: 1-4254/12-18-02-A

CETECOM ICT Services GmbH

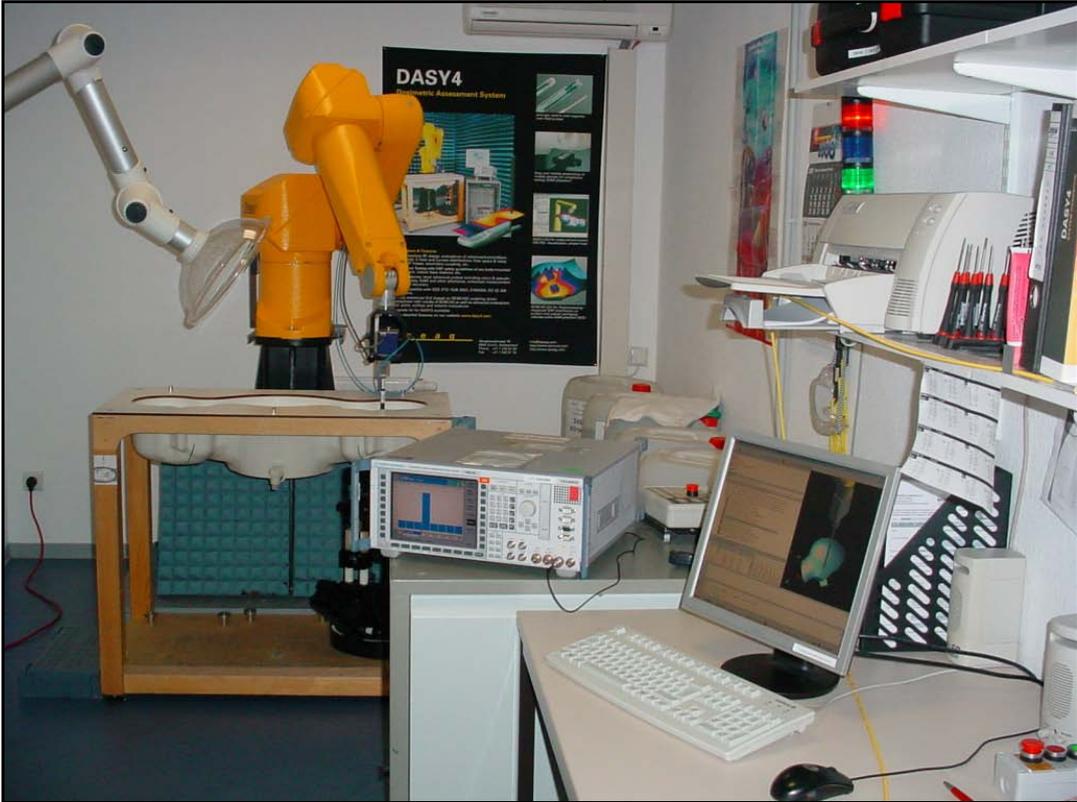
Photo 1: Measurement System DASy 4

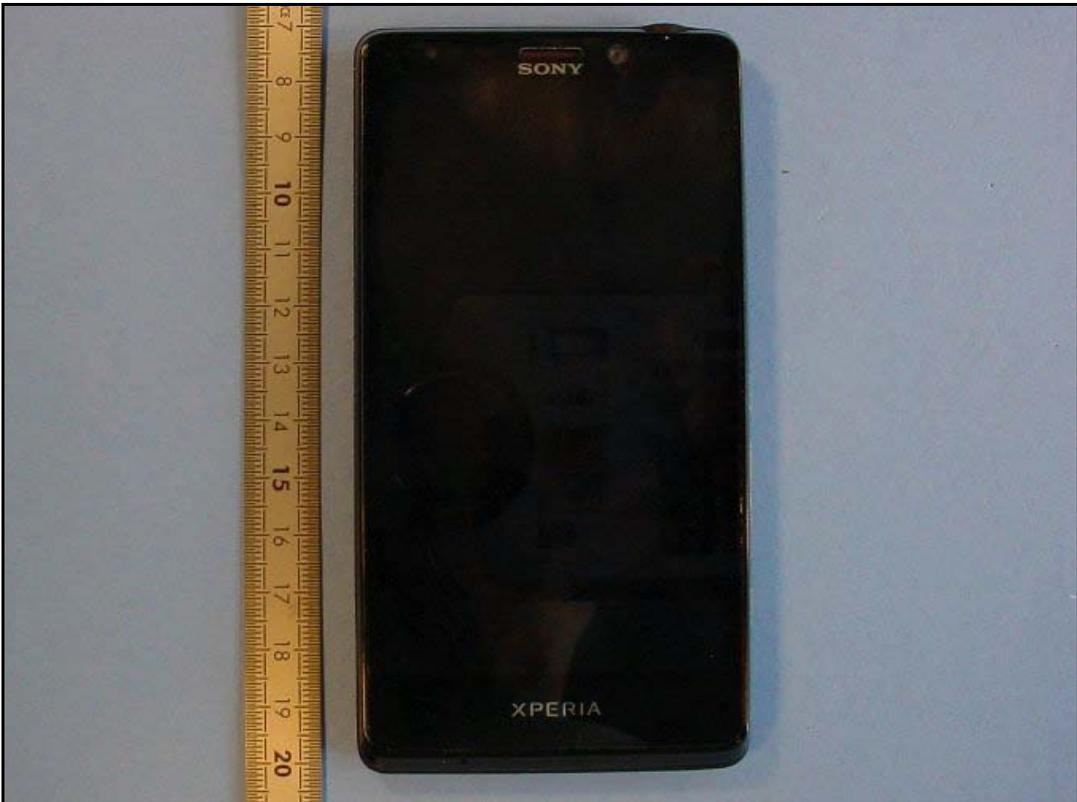
Photo 2: DUT - front view

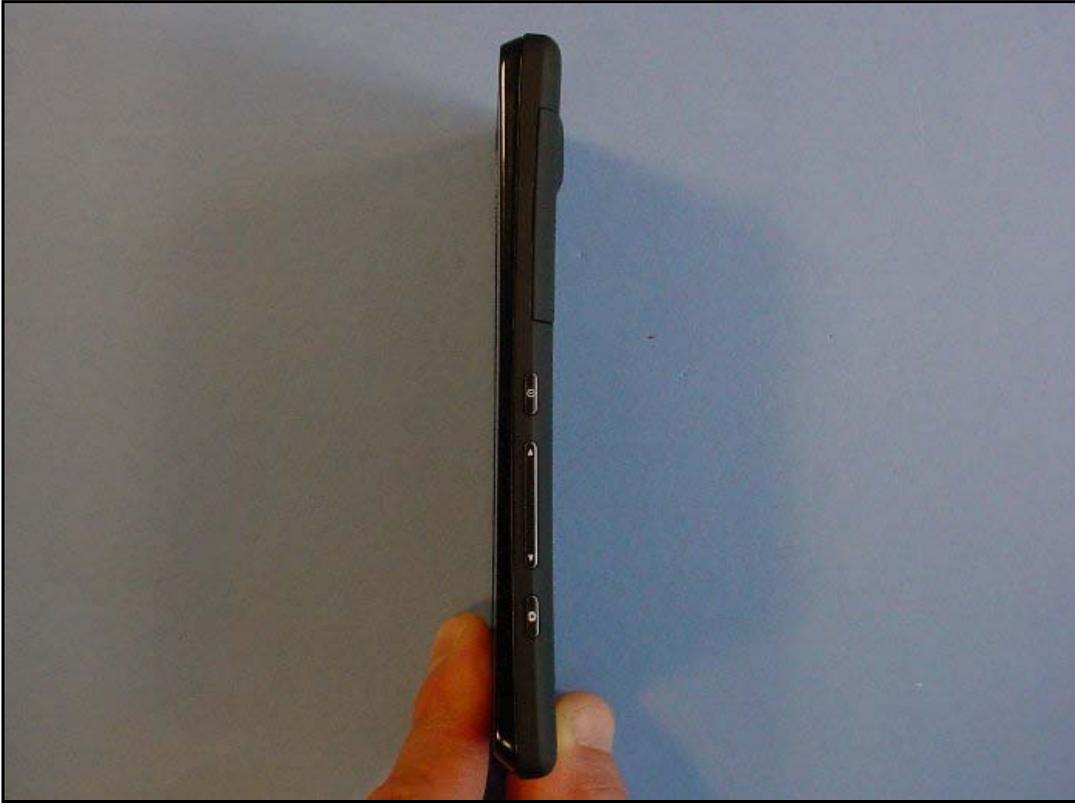
Photo 3: DUT - side view

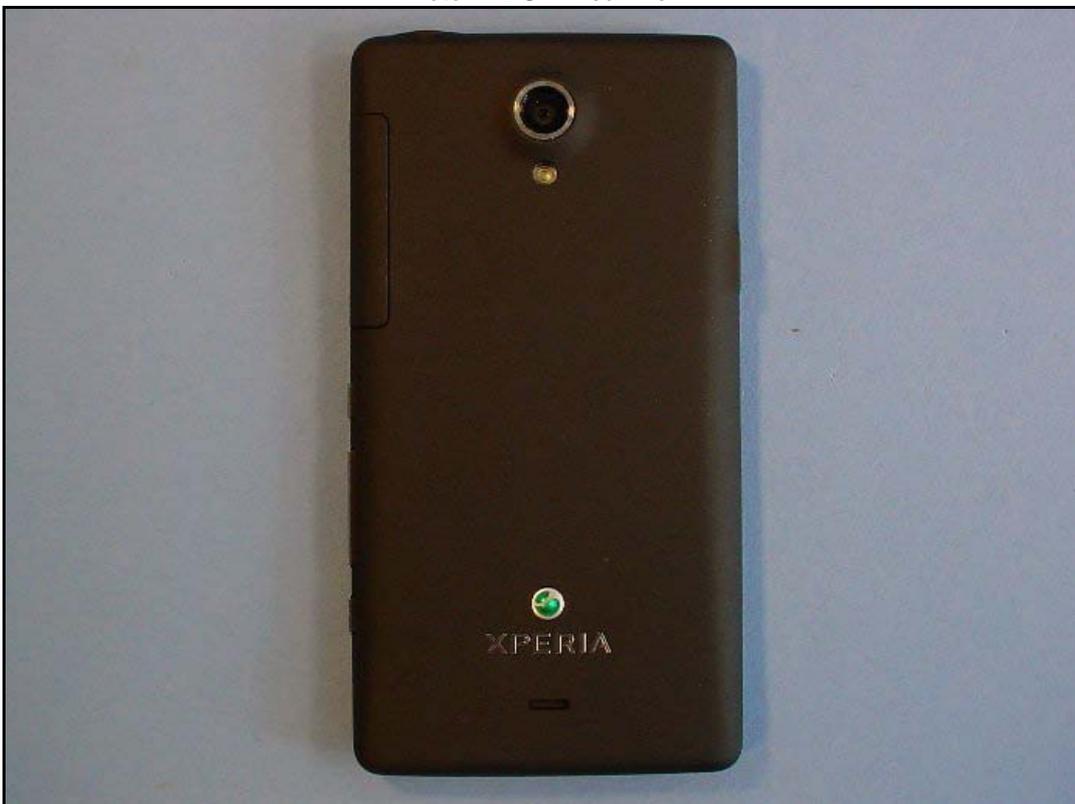
Photo 4: DUT - rear view

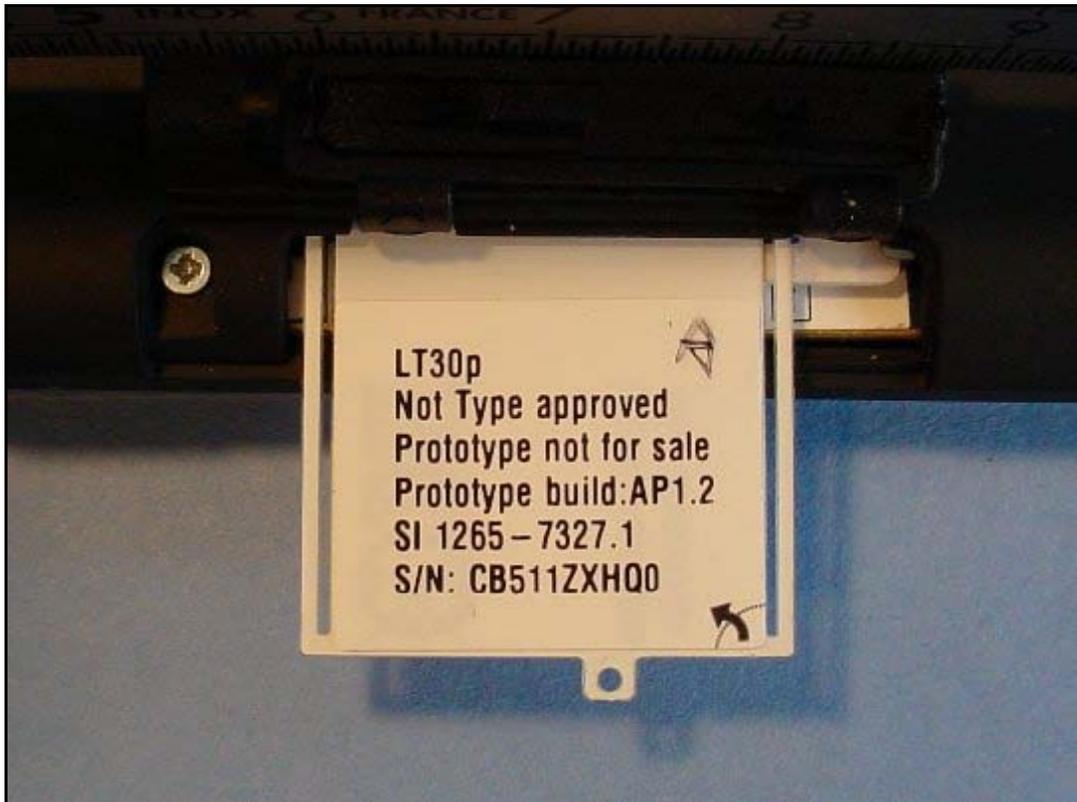
Photo 5: DUT - label

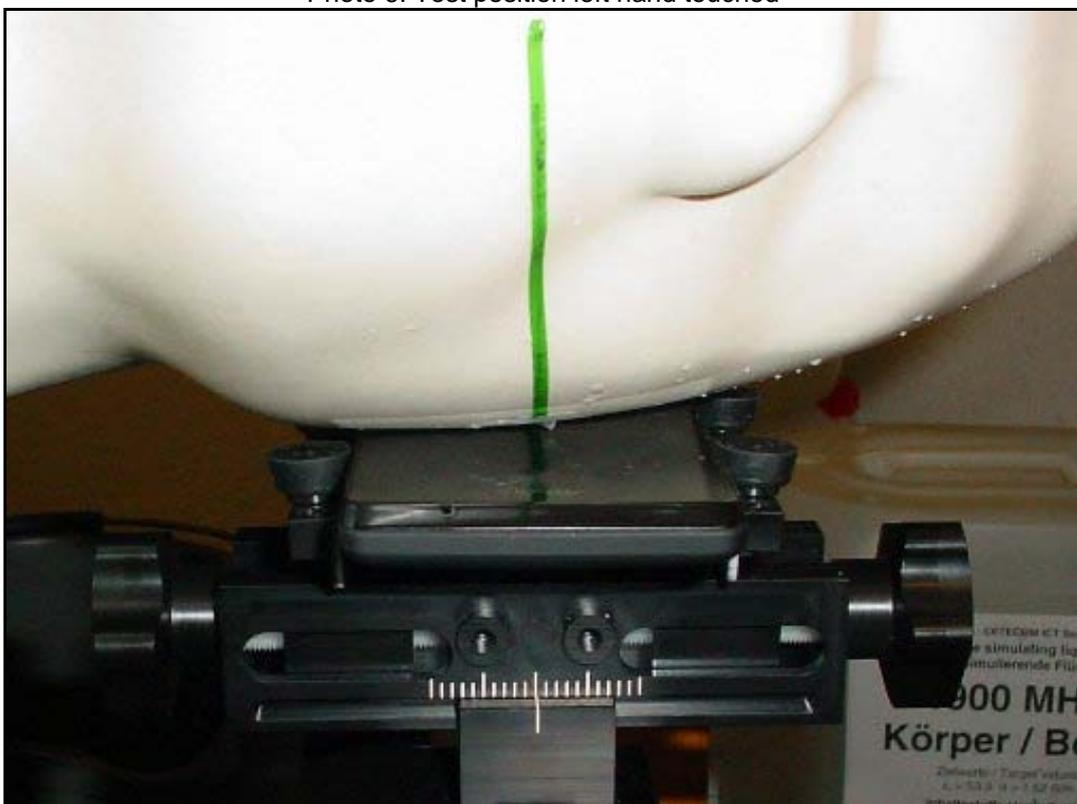
Photo 6: Test position left hand touched

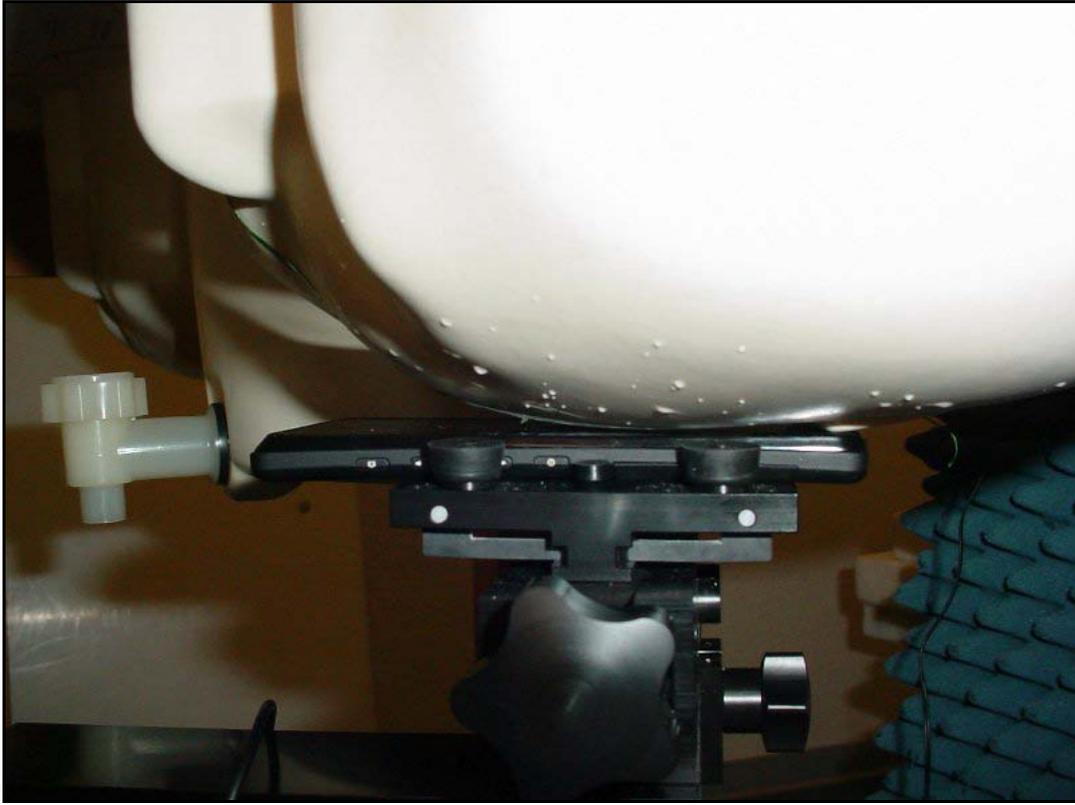
Photo 7: Test position left hand touched

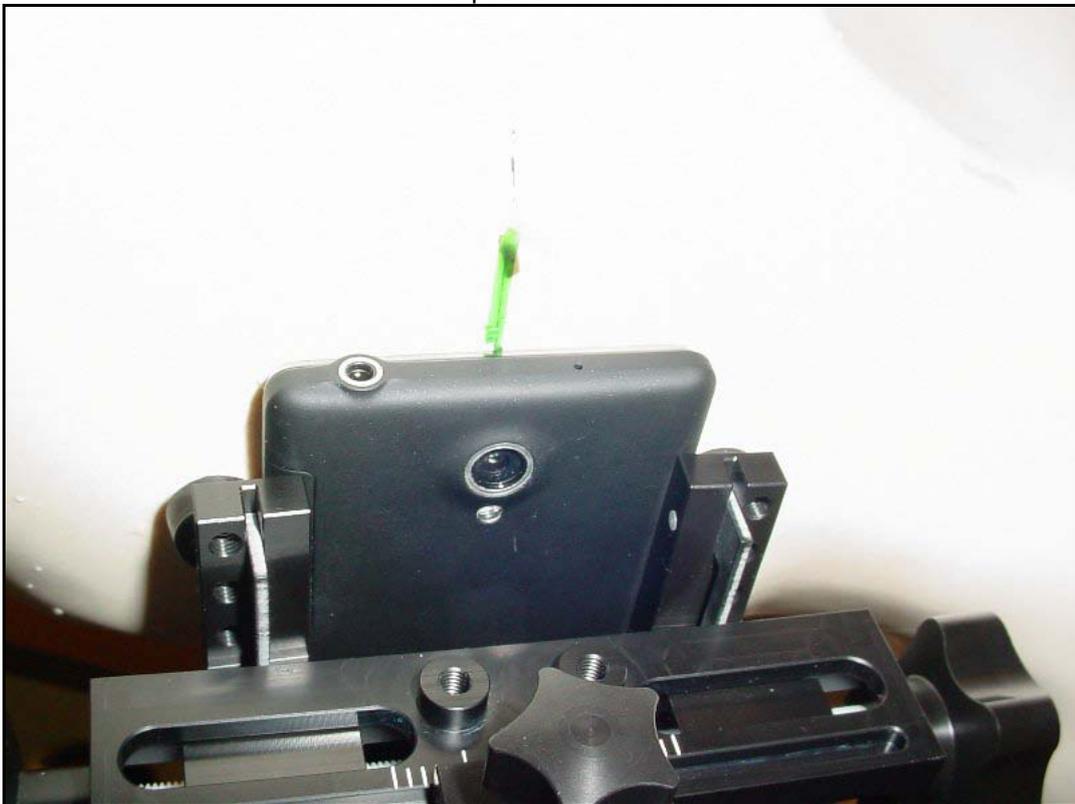
Photo 8: Test position left hand touched

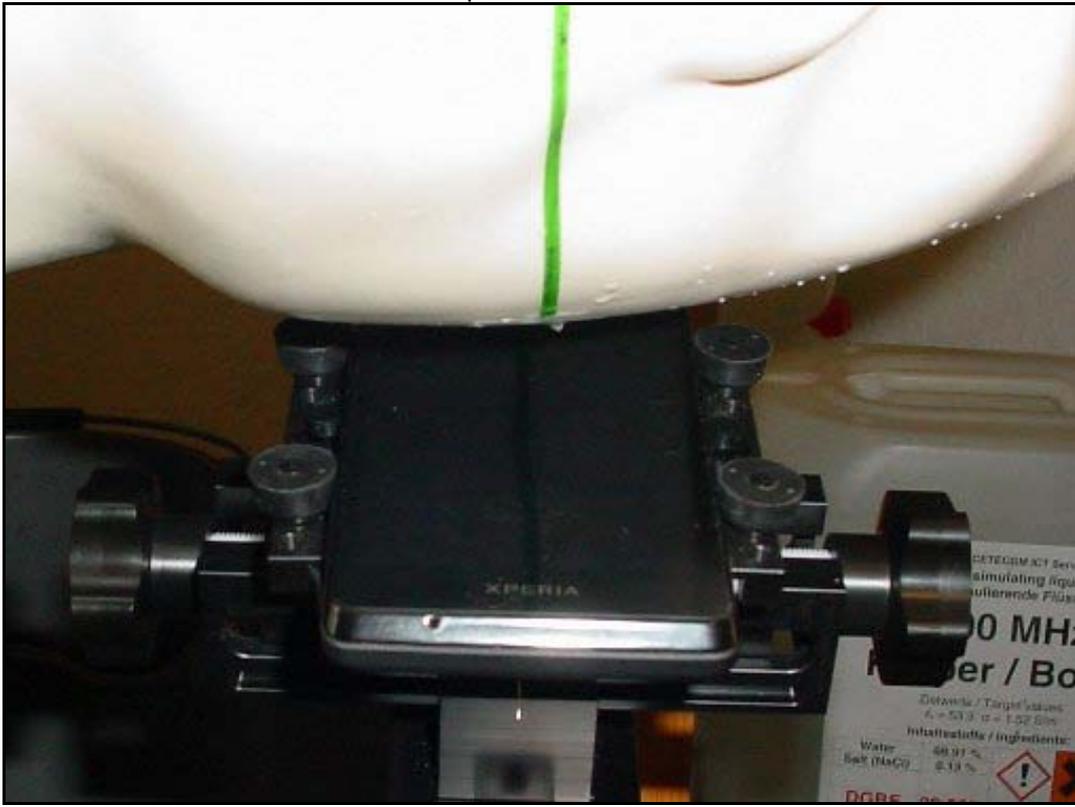
Photo 9: Test position left hand tilted 15°

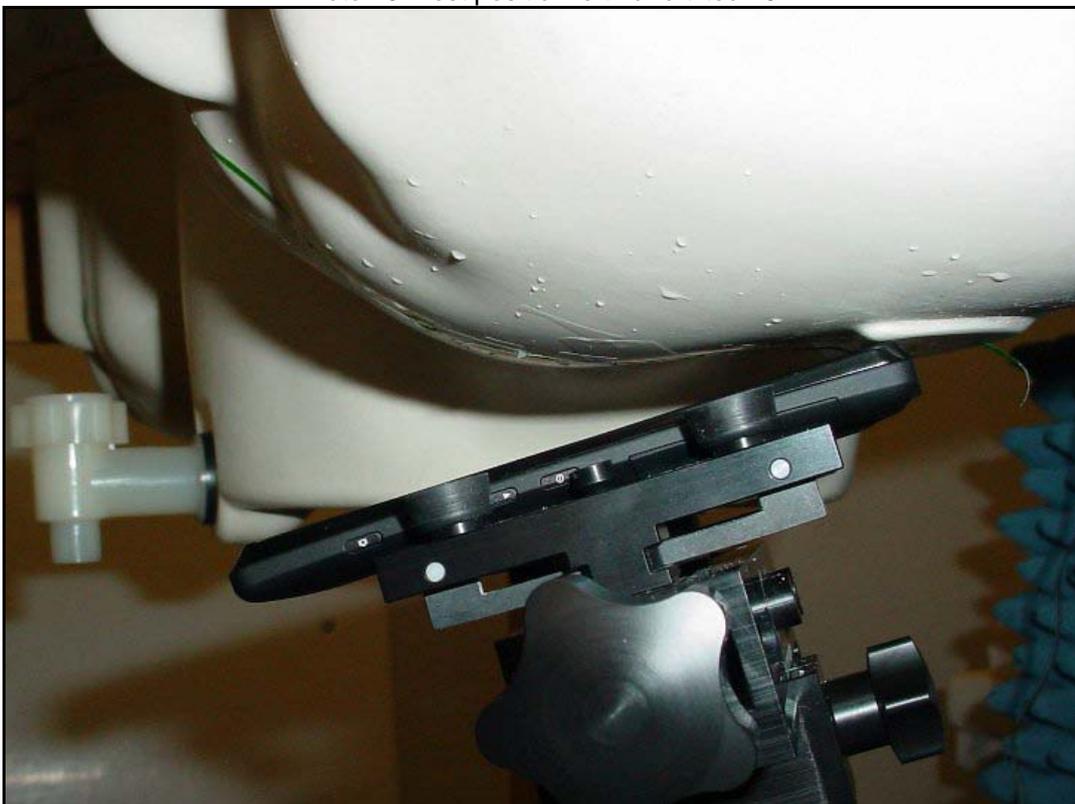
Photo 10: Test position left hand tilted 15°

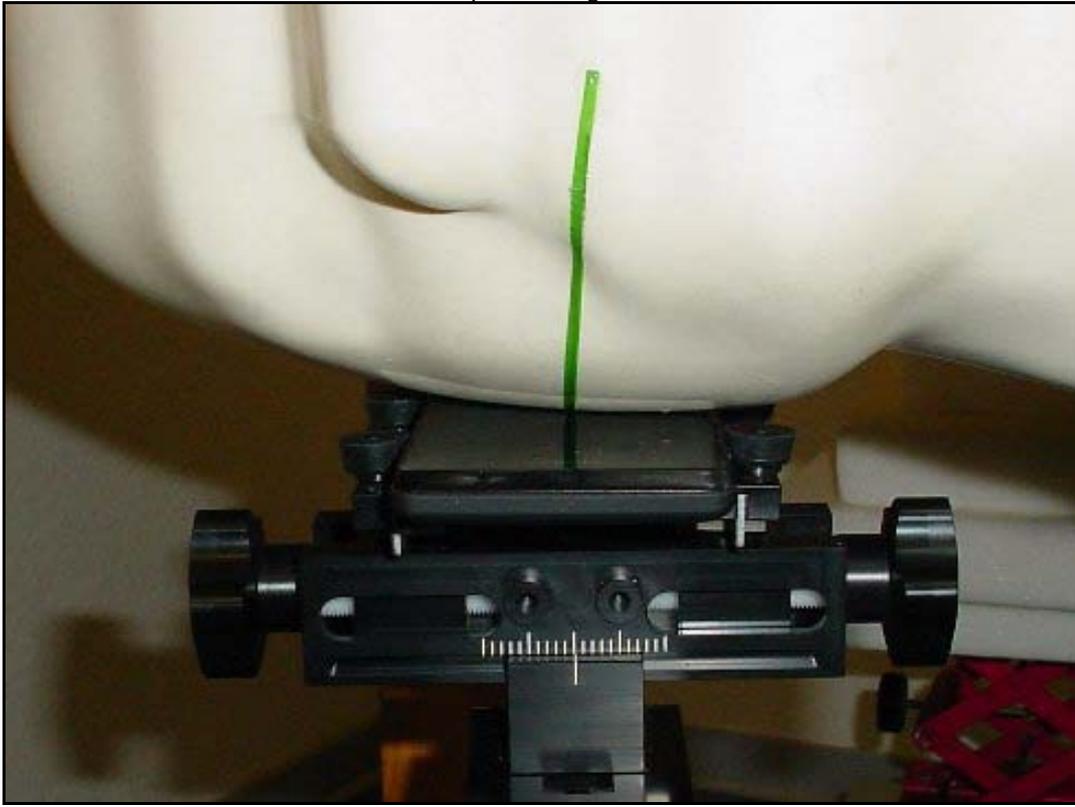
Photo 11: Test position right hand touched

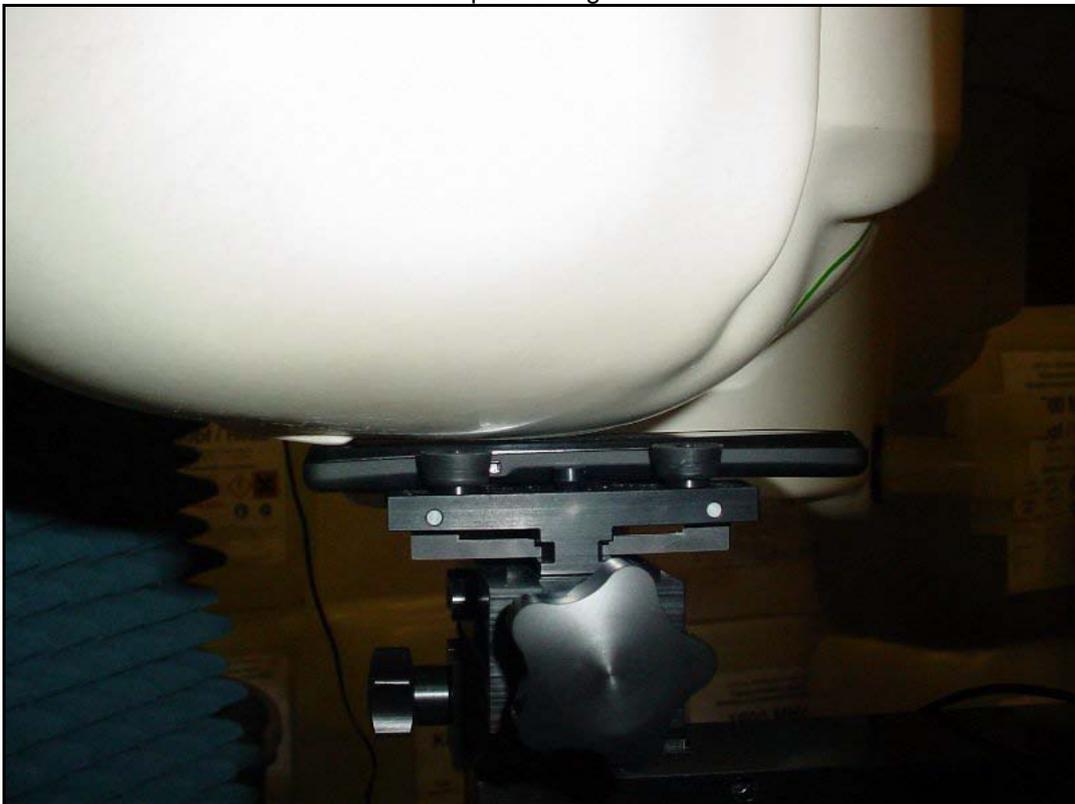
Photo 12: Test position right hand touched

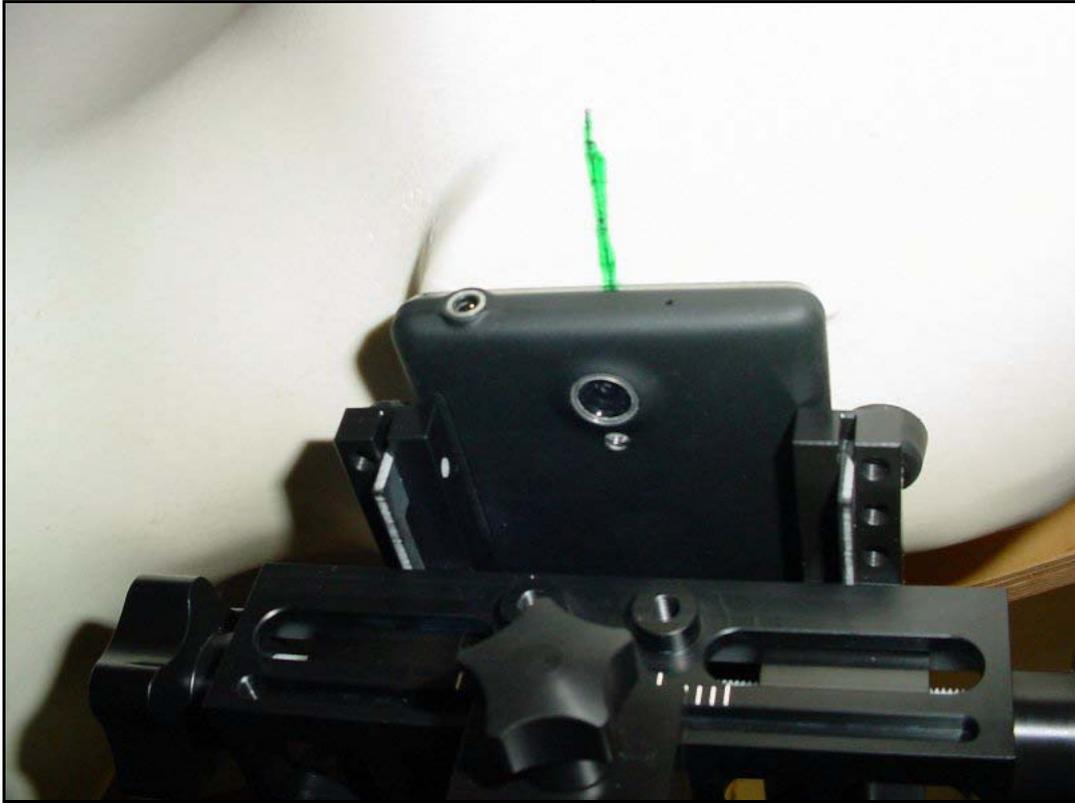
Photo 13: Test position right hand touched

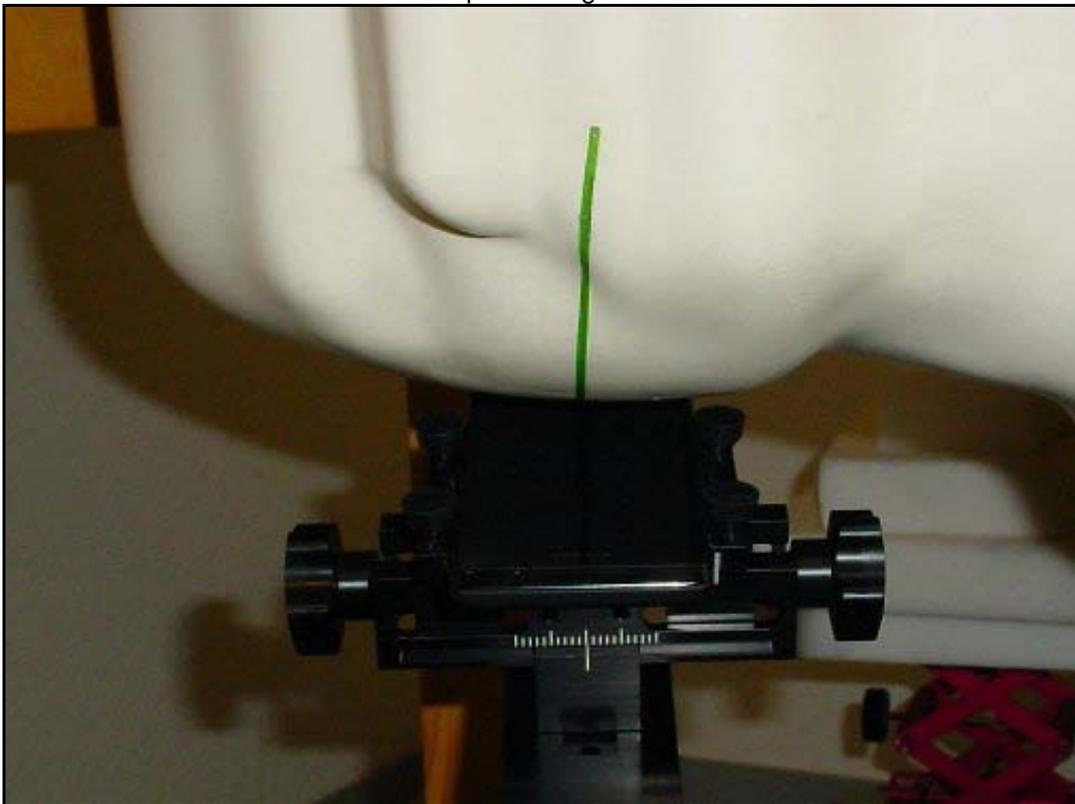
Photo 14: Test position right hand tilted 15°

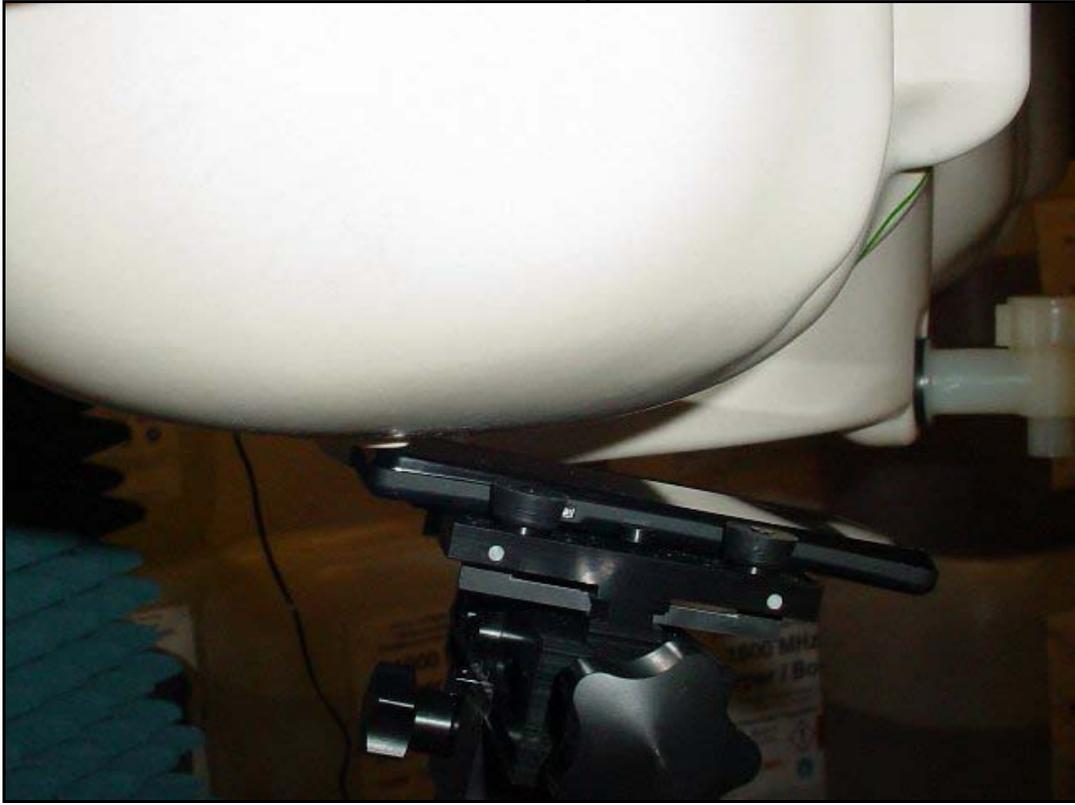
Photo 15: Test position right hand tilted 15°

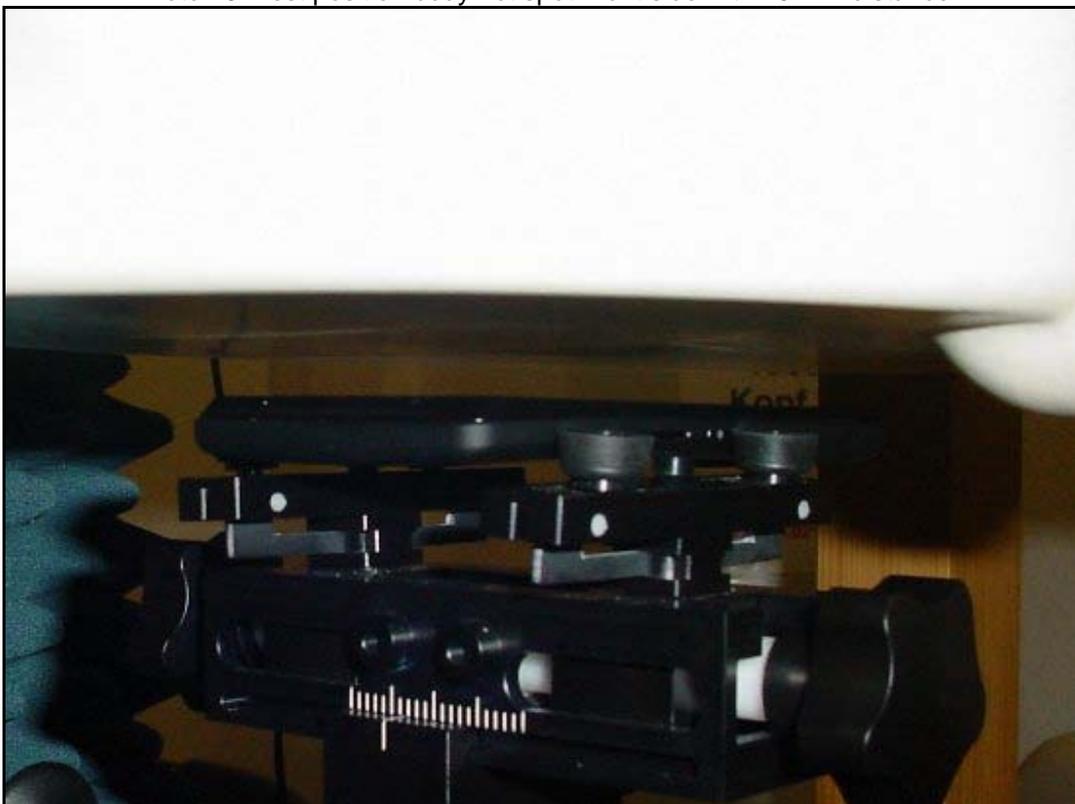
Photo 16: Test position body hot spot front side with 10 mm distance

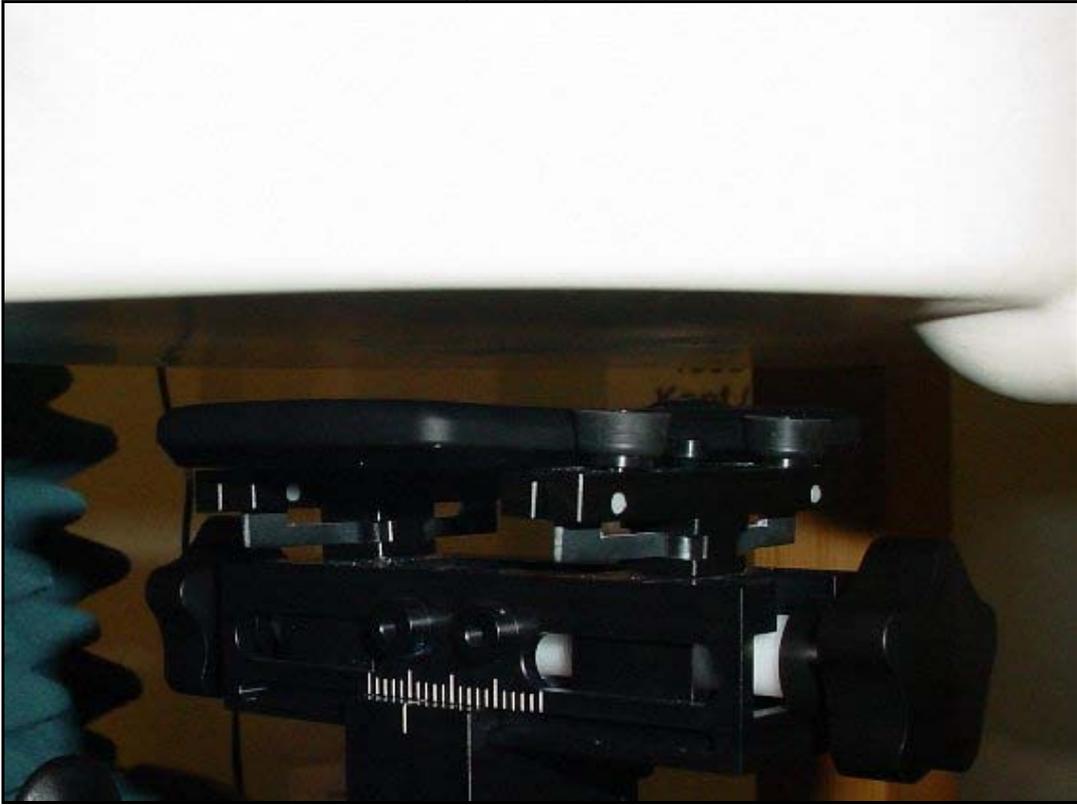
Photo 17: Test position body hot spot rear side with 10 mm distance

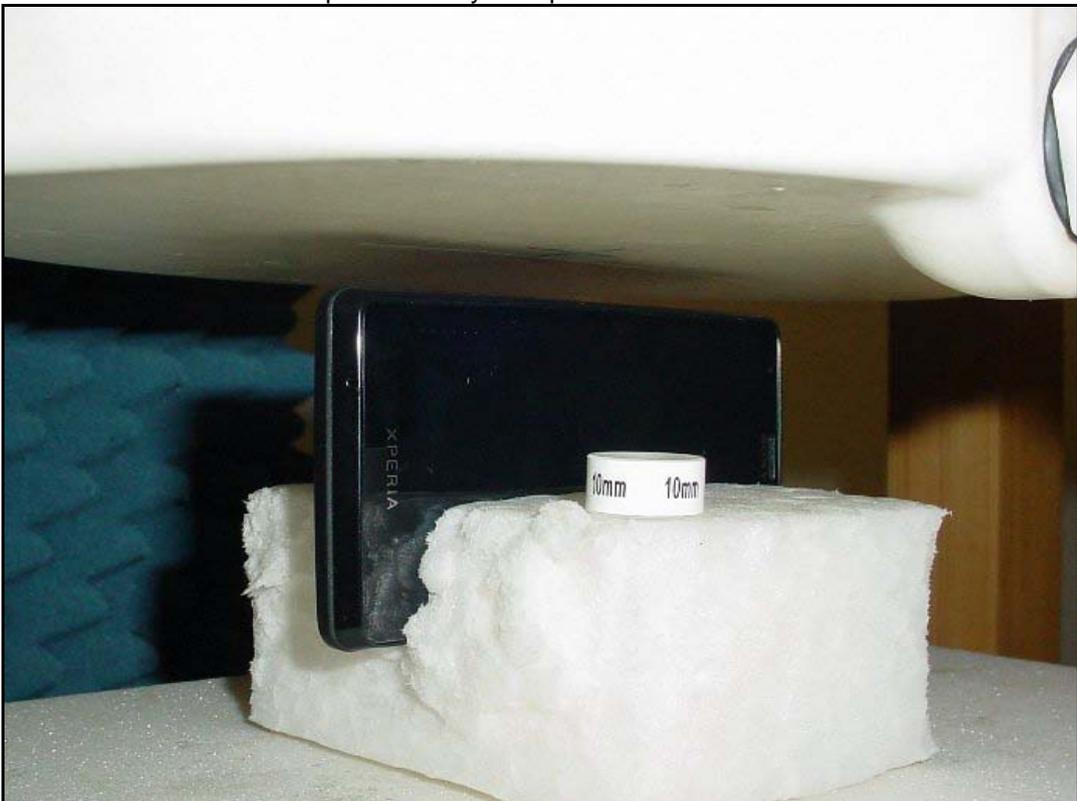
Photo 18: Test position body hot spot left side with 10 mm distance

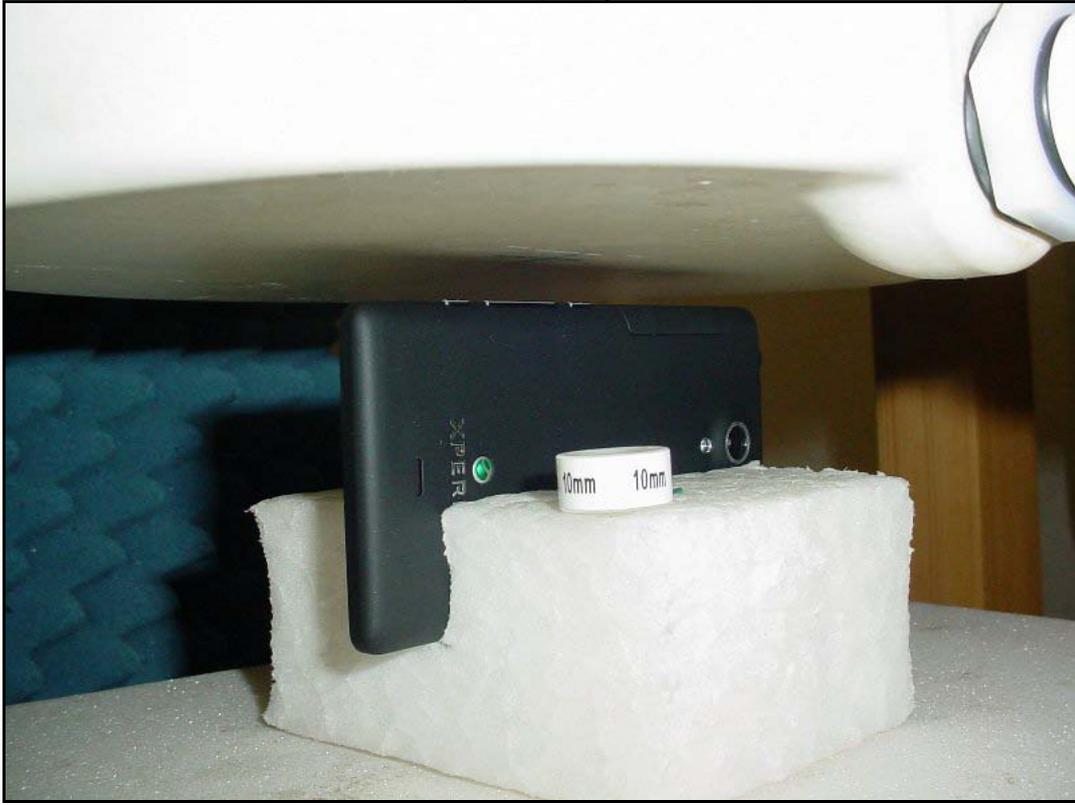
Photo 19: Test position body hot spot right side with 10 mm distance

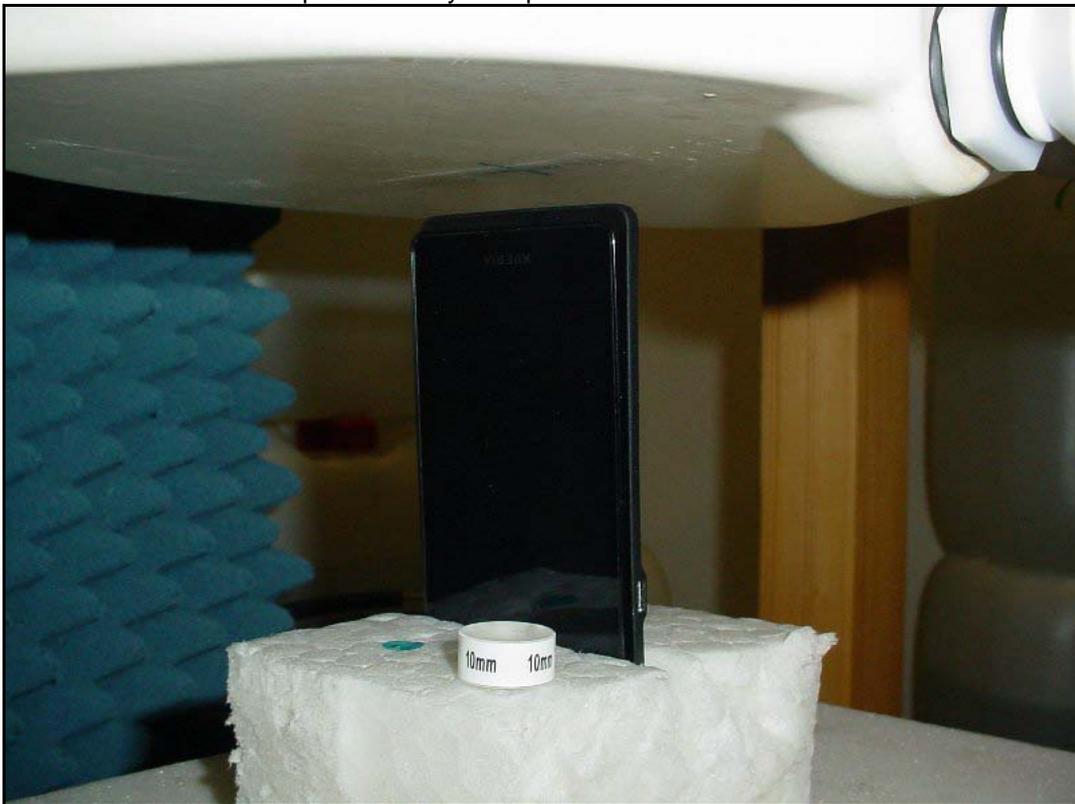
Photo 20: Test position body hot spot bottom side with 10 mm distance

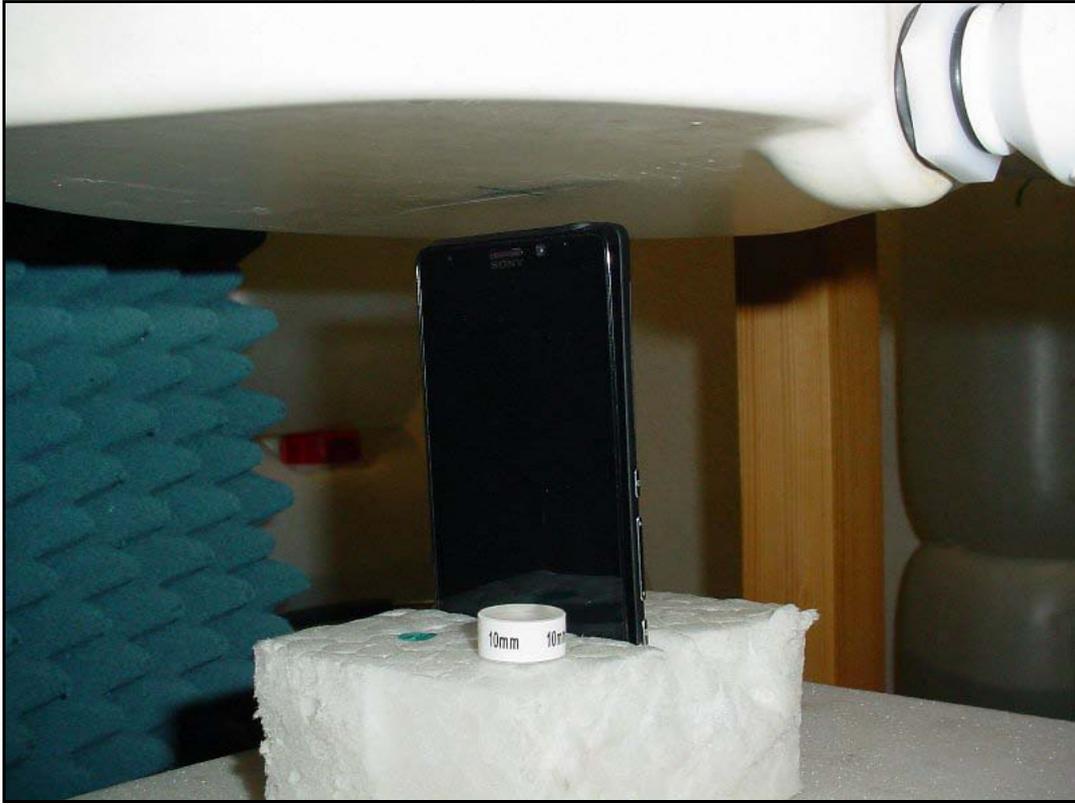
Photo 21: Test position body hot spot top side with 10 mm distance

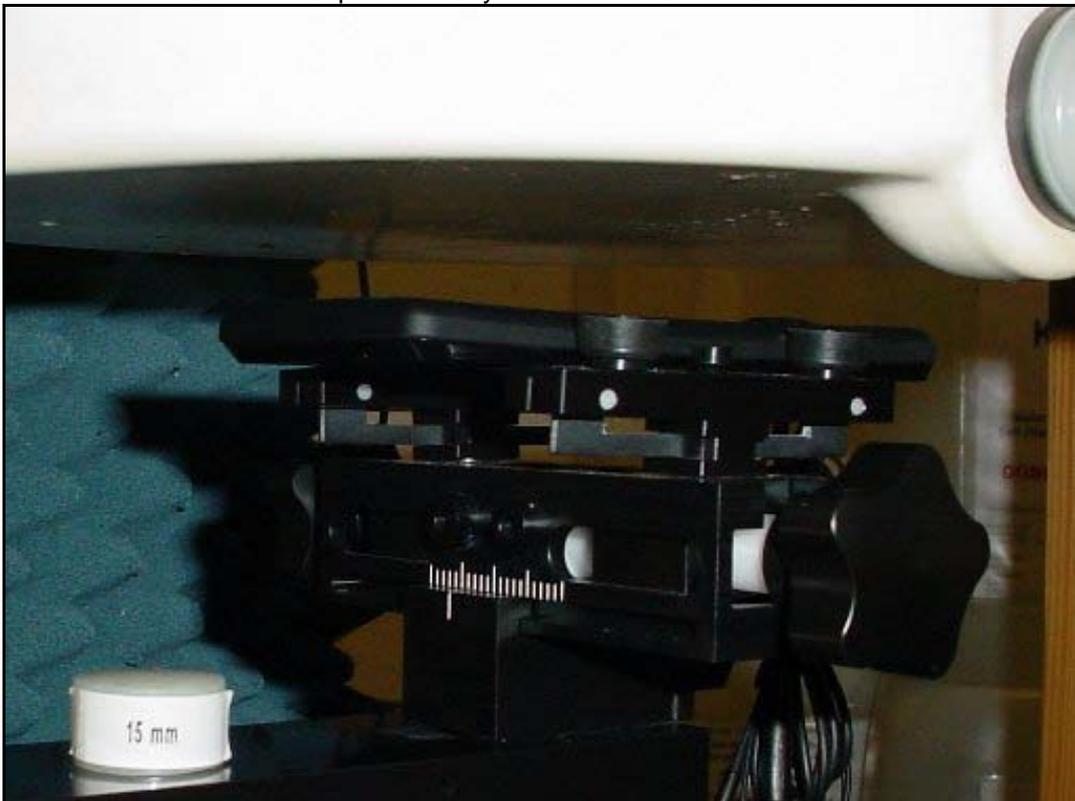
Photo 22: Test position body worn rear side with 15 mm distance
