Setup photos for HAC RF Emissions and T-Coil Test Report

| Test report no.: | HAC_Photo_RM-820_03 | | |
| Tested devices: | RM-820 | | |

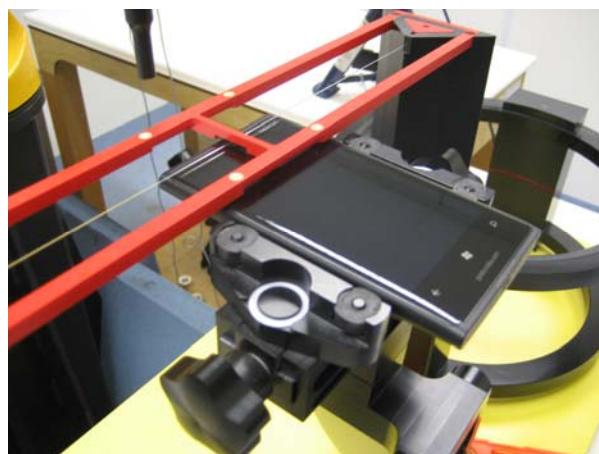
The device was positioned such that Device Reference plane was touching the bottom of the Test Arch. The scan is centered at the acoustic output by aligning the acoustic output with the intersection of the Test Arch's middle bar and dielectric wire.

Photo of the device positioned under Test Arch
