Setup photos for HAC RF Emissions and T-Coil Test Report

Test report no.:	HAC_Photo_RM-985_06		Date of report:	2014-08-28		
Template version:	3.2		Number of pages:	3		
Testing laboratory:	TCC Microsoft Salo Laboratory P.O.Box 86 Joensuunkatu 7H / Kiila 1B FIN-24101 SALO, FINLAND Tel. +358 (0) 7180 08000 Fax. +358 (0) 7180 45220		Client:	Microsoft 16620 West Bernardo Drive SAN DIEGO CA. 92127 USA Tel. +1 858 831 5000 Fax. +1 858 831 6500		
Responsible test engineer:	Janne Hirsimäki	Product contact person:		Victoria Abadilla		
Measurements made by:	Sami Savela					
Tested devices:	RM-985					
FCC ID:	QMNRM-985		IC: 661X-RM985			
Supplement reports:	RF_RM-985_04, T-Coil_RM-985_06					
Testing has been carried out in accordance with:	ANSI C63.19-2011 American National Standard for Methods of Measurement of Compatibility between Wireless Communications Devices and Hearing Aids					
Documentation:	The documentation of the testing performed on the tested devices is archived for 15 years at TCC Microsoft.

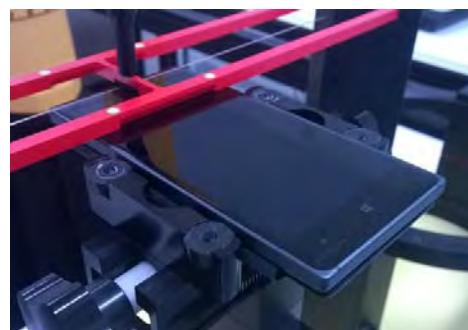
The device was positioned such that Device Reference plane was touching the bottom of the Test Arch. The scan is centered at the acoustic output by aligning the acoustic output with the intersection of the Test Arch's middle bar and dielectric wire.

Photo of the device positioned under Test Arch
