Setup photos for HAC RF Emissions and T-Coil Test Report

Test report no.:	HAC_Photo_RM-658_03		
Template version:	3.0		
Testing laboratory:	TCC Nokia Salo Laboratory P.O.Box 86 Joensuunkatu 7H / Kiila 1B FIN-24101 SALO, FINLAND Tel. +358 (0) 7180 08000 Fax. +358 (0) 7180 45220	Date of report:	2010-09-21
Responsible test engineer:	Heikki Haloila	Number of pages:	3
Measurements made by:	Heikki Haloila	Client:	Nokia Corporation Frederikskaej 1790 COPENHAGEN V DENMARK Tel. +45 33 292929 Fax. +45 33 292934
Tested devices:	RM-658	Product contact person:	Xu Shao
FCC ID:	QTKRM-658	IC:	661AD-RM658
Supplement reports:	RF_RM-658_01, T-Coil_RM-658_02		
Testing has been carried out in accordance with:	<p>ANSI C63.19-2007 American National Standard for Methods of Measurement of Compatibility between Wireless Communications Devices and Hearing Aids</p>		
Documentation:	The documentation of the testing performed on the tested devices is archived for 15 years at TCC Nokia.

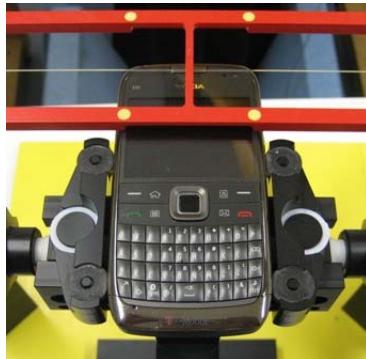
The device was positioned such that Device Reference plane was touching the bottom of the Test Arch. The scan is centered at the acoustic output by aligning the acoustic output with the intersection of the Test Arch's middle bar and dielectric wire.

Photo of the device positioned under Test Arch
