APPENDIX 3: Photographs of test setup

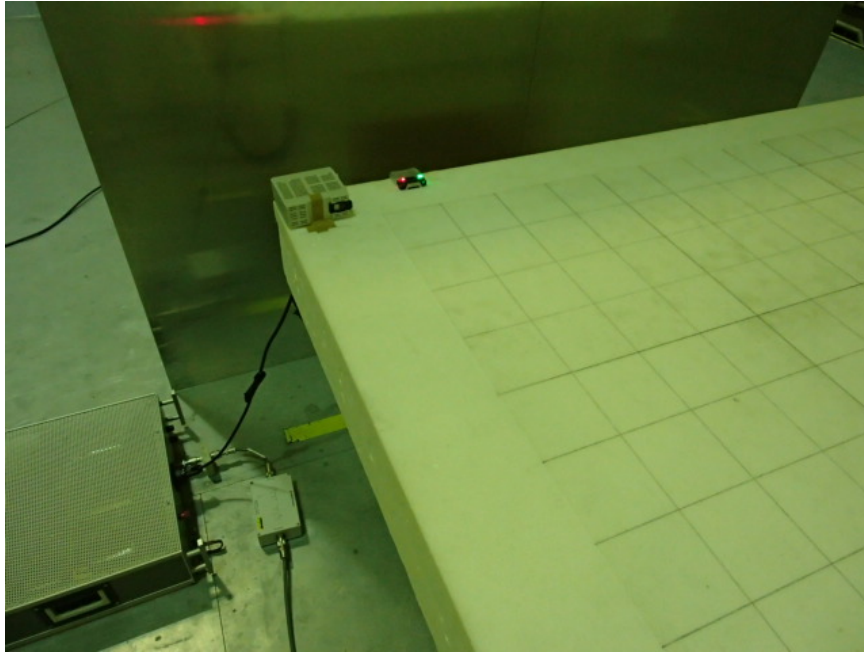
Photo 1

Conducted Emission

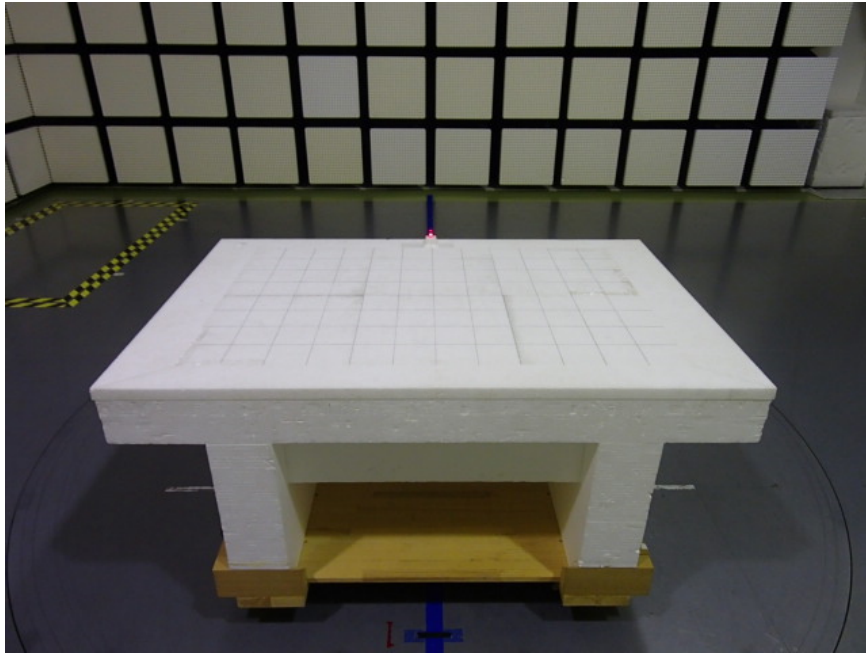
Photo 1

Radiated Emission

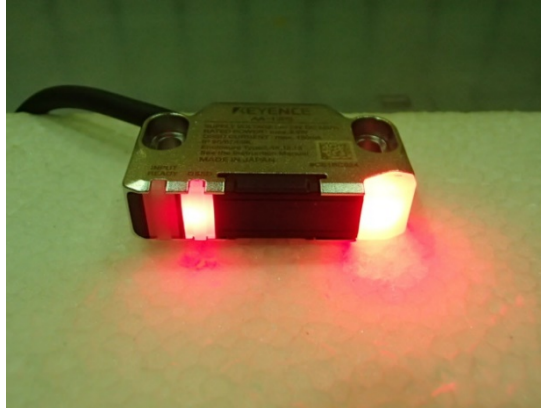
X-axis

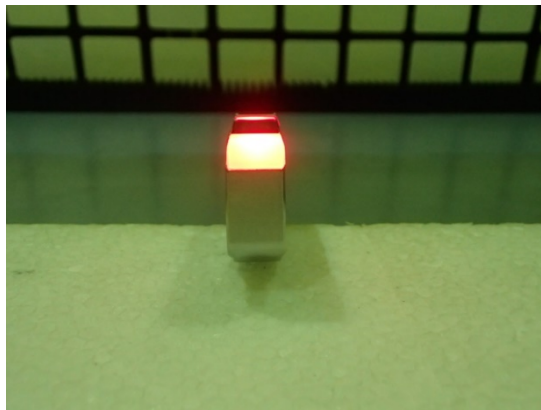
Below 30 MHz

Y-axis

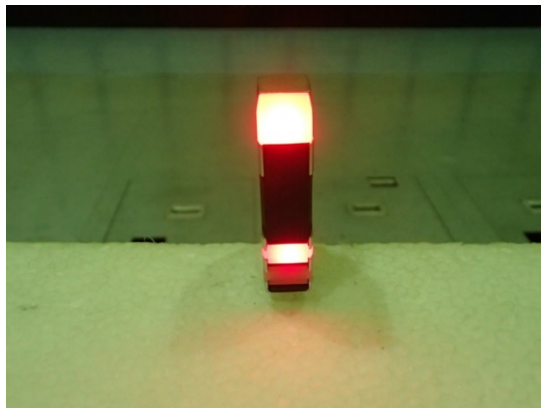
Z-axis

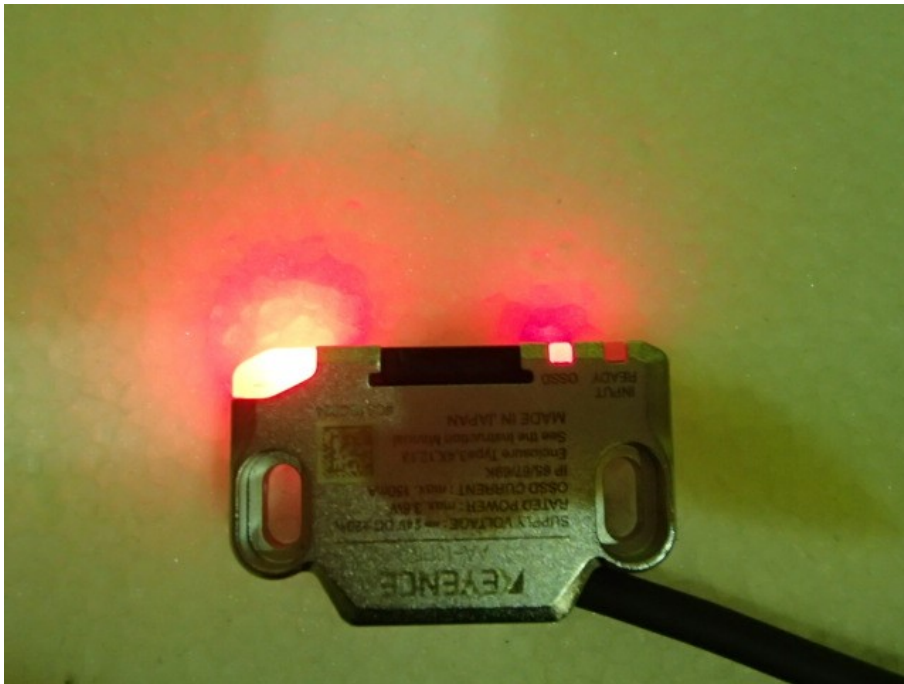
Without Actuator (Worst)

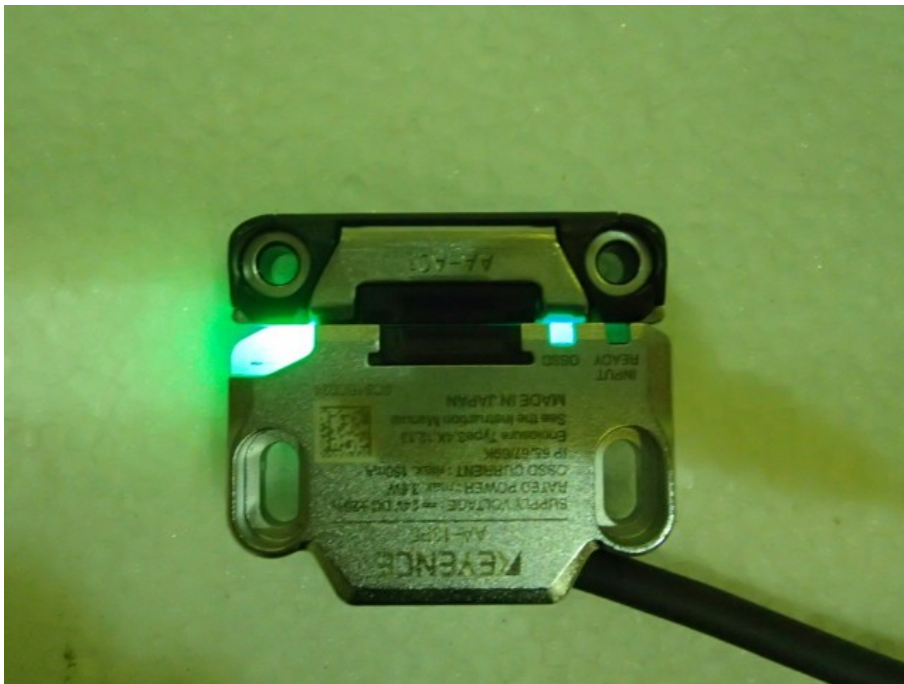
With Actuator
