Test# 186-05 Opticon Radiated Test Setup Front

Test# 186-05 Opticon Radiated Test Setup Rear

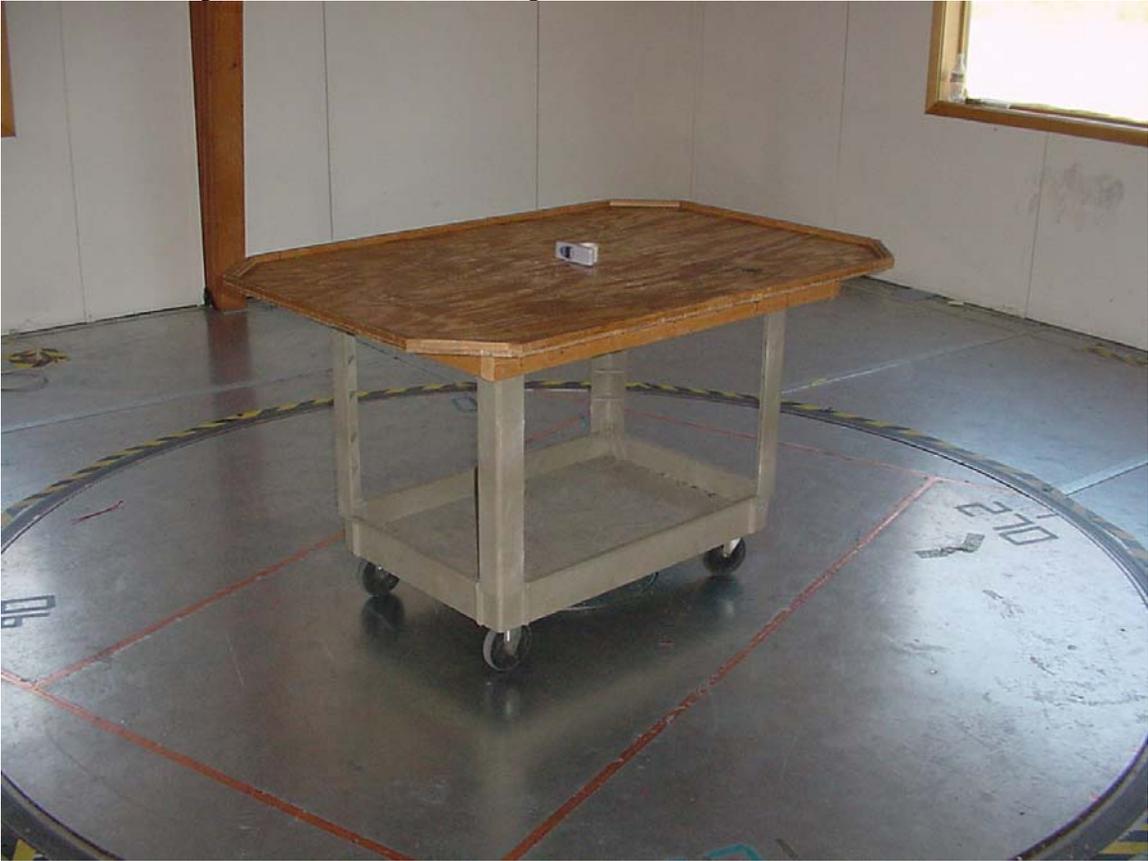
A small PVC pipe cut off was used to hold the EUT in position for testing.

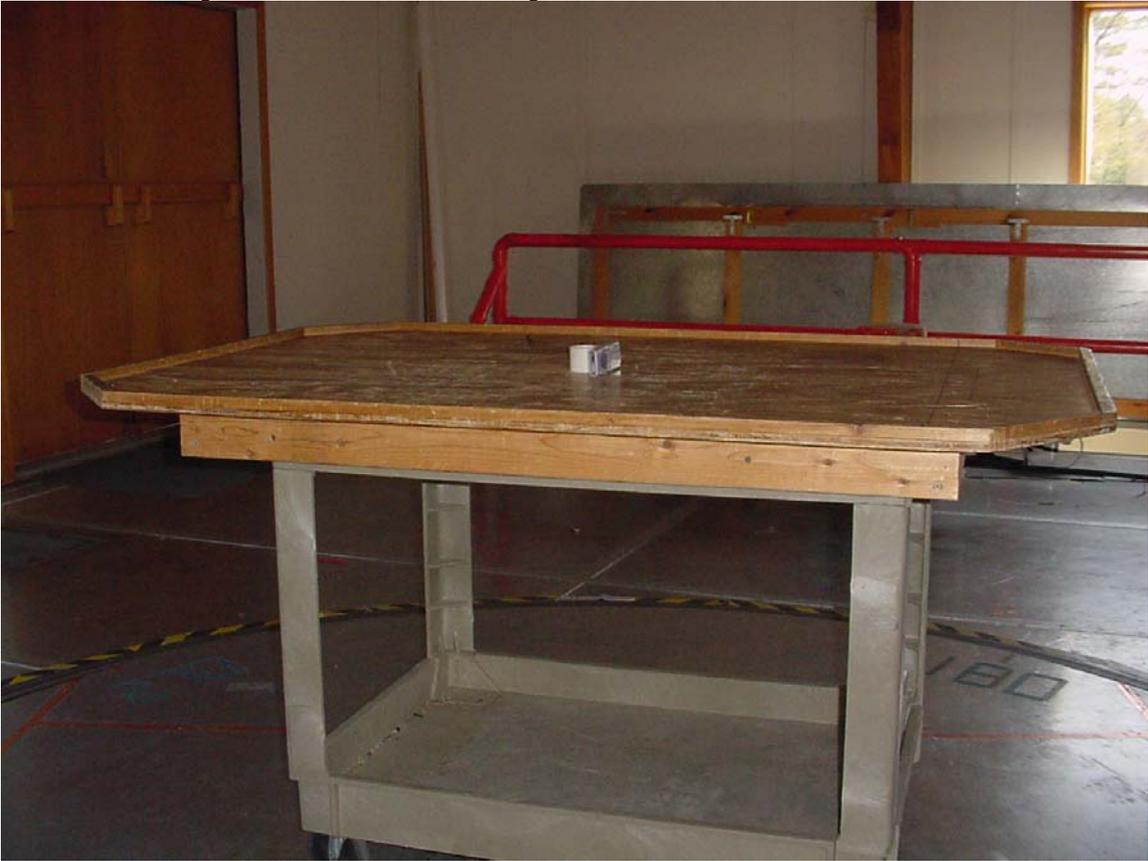
The metal sheet in the background is the door to the OATS, it was closed during testing.
