# Test Setup Photos: DLO TransDock 30760114

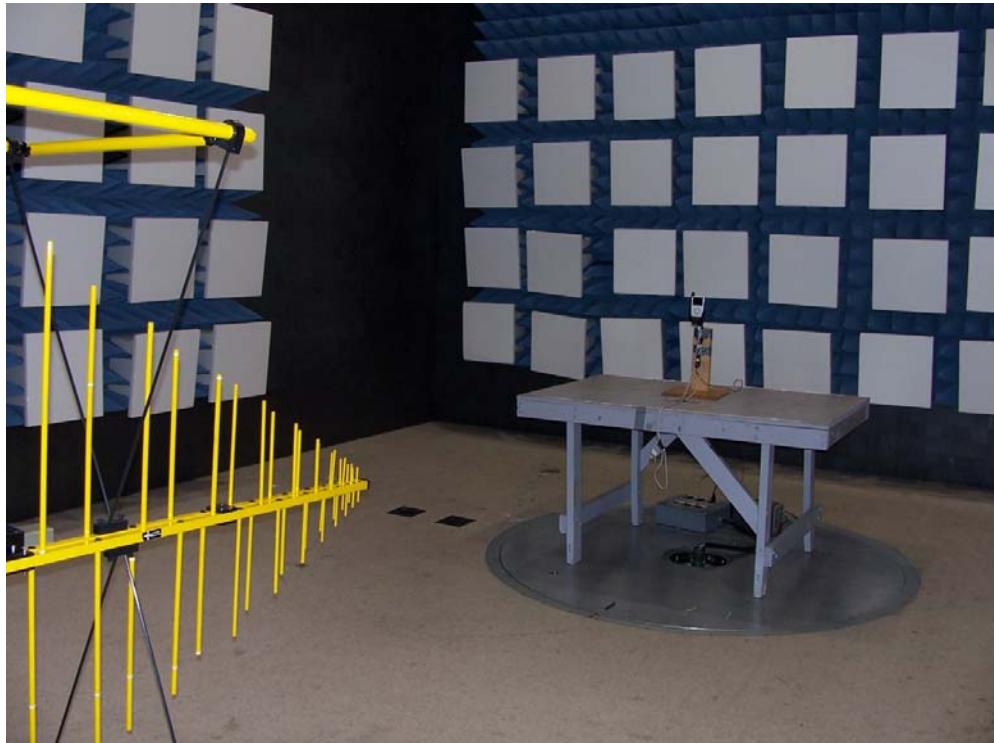
Figure 1- Photo of Part 15.209 testing set up (Front)

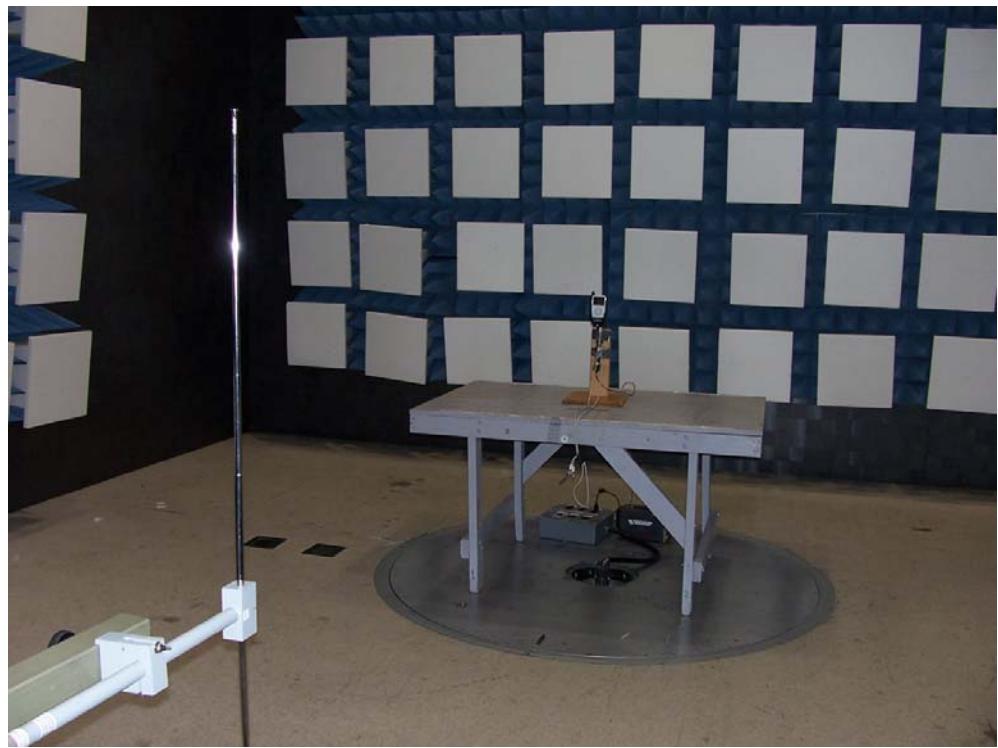
Figure 3 - Photo of Part 15.239 testing set up (Front)

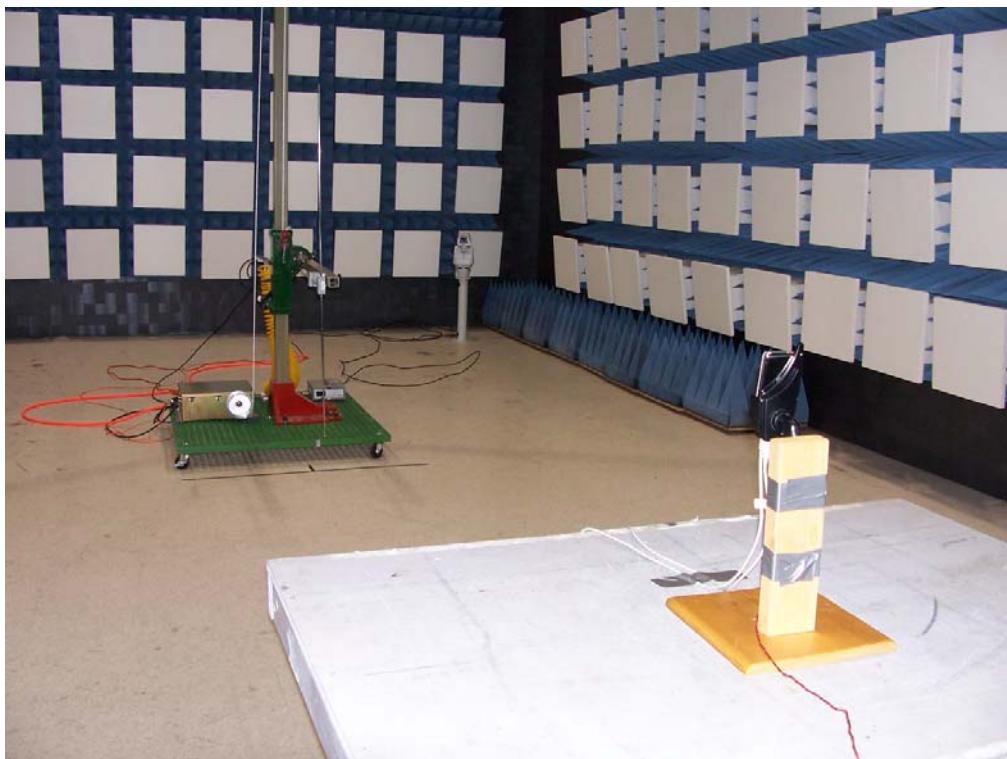
Figure 4 - Photo of Part 15.209 testing set up (Back)

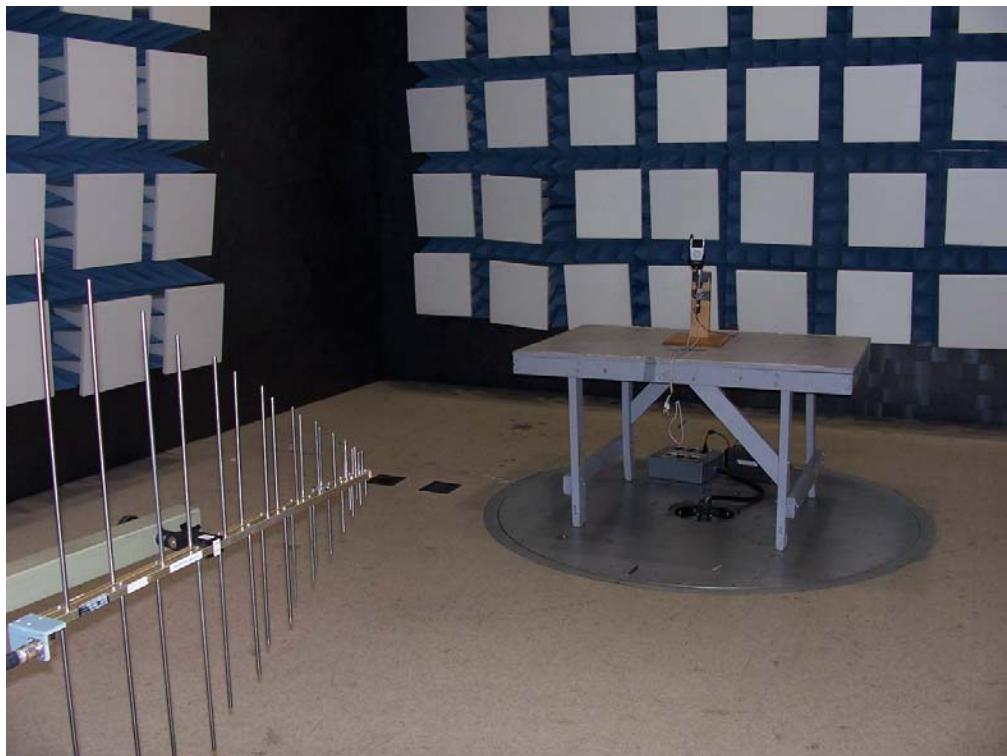
Figure 7 - Photo of Part 15.239 testing set up (Front)

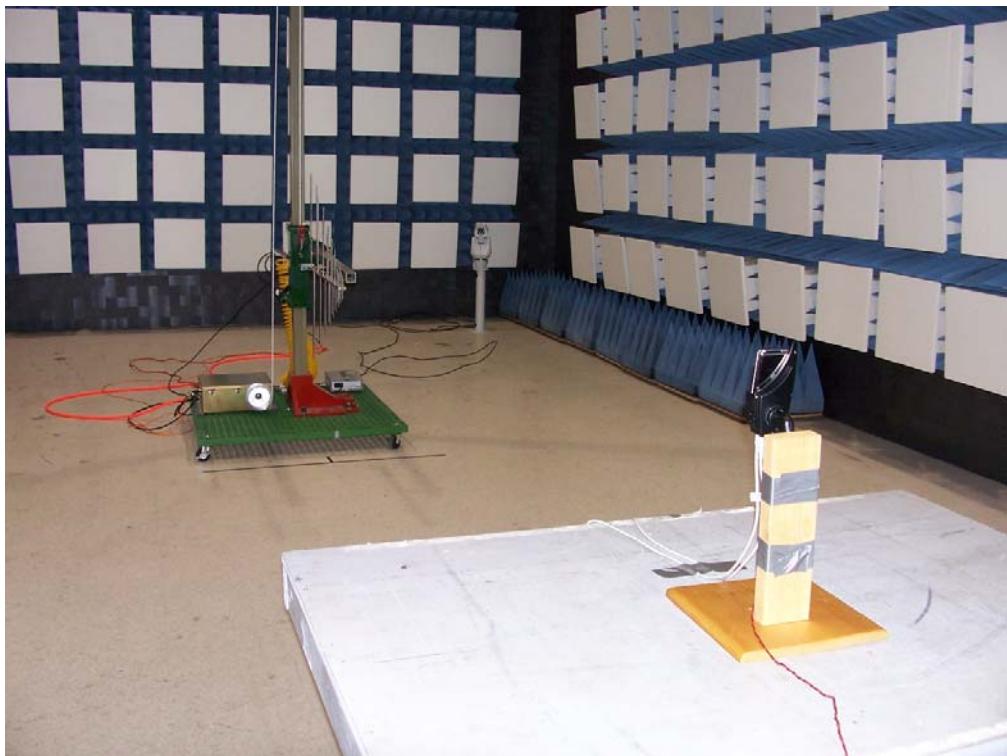
Figure 8 - Photo of Part 15.209 testing set up (Back)

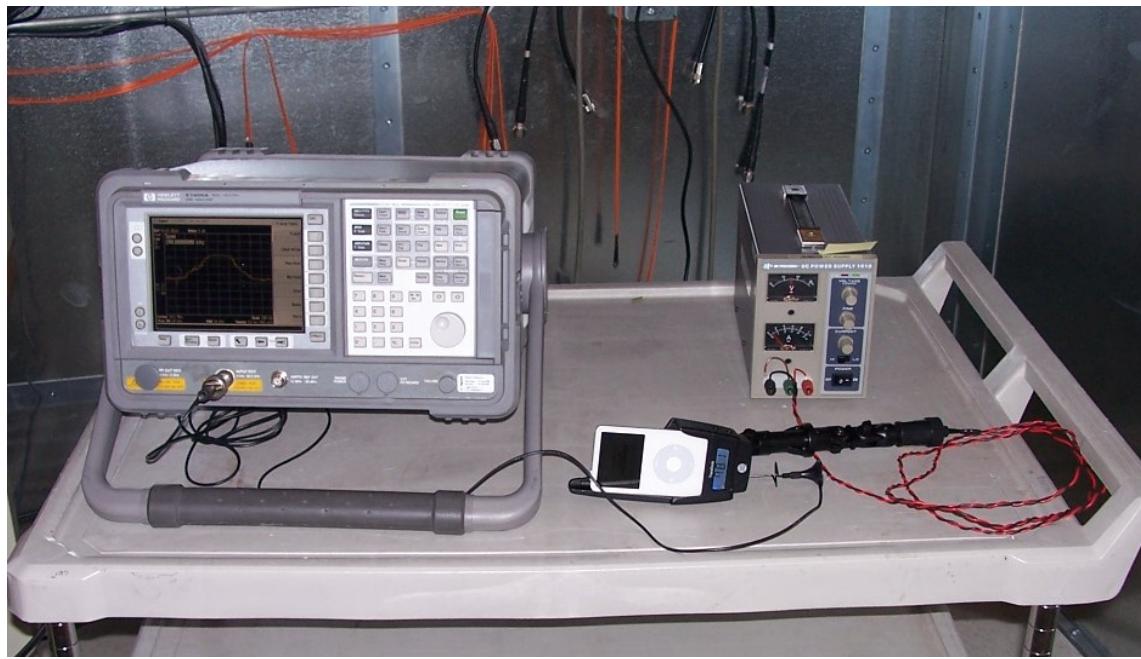
Figure 9- Setup for Bandwidth testing and Frequency Stability over Voltage Variations.

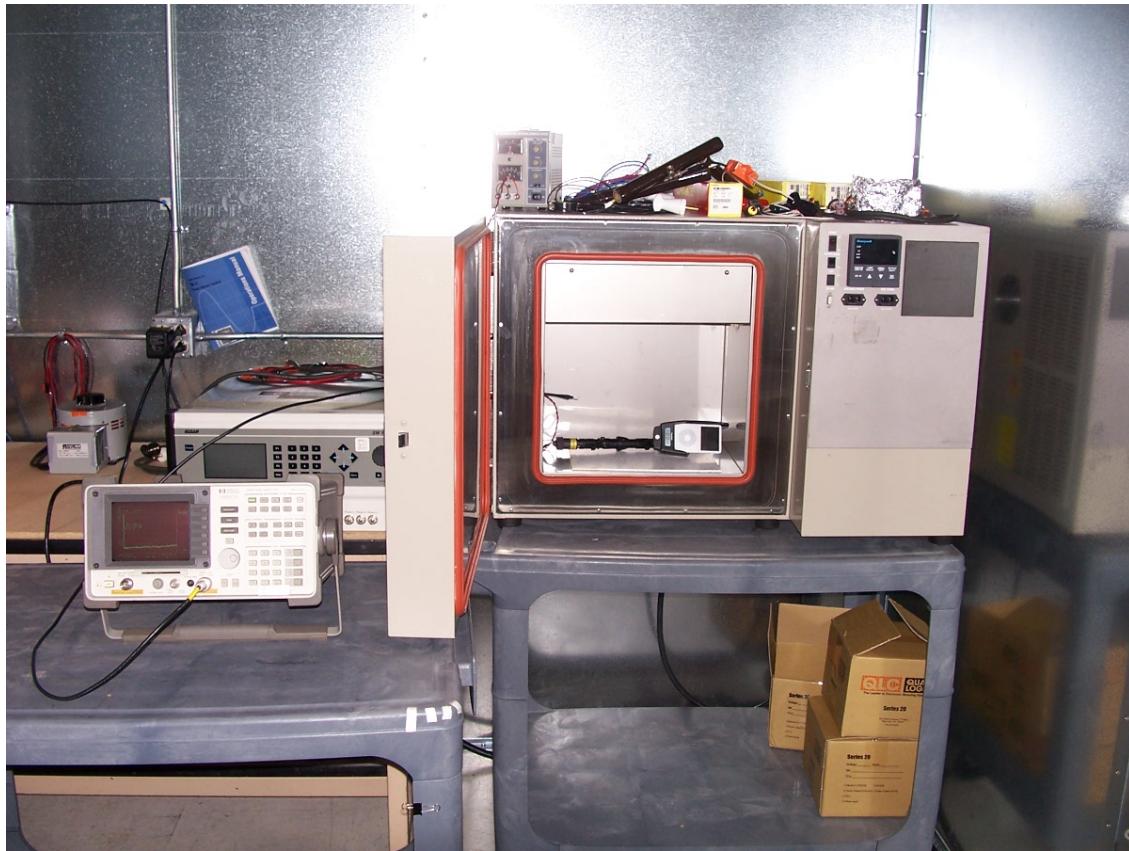
Figure 10 – Setup for Frequency Stability over Temperature Variation Measurements.

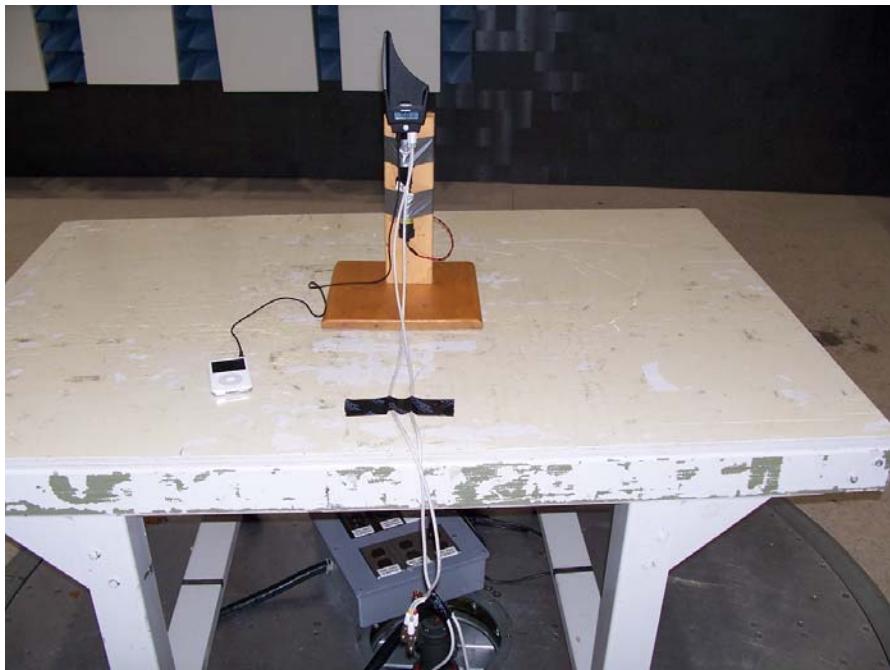
Figure 11 – Shows ipod tethered through audio cable.

**The Following Photos show the test setups that determined “worst case” testing.**

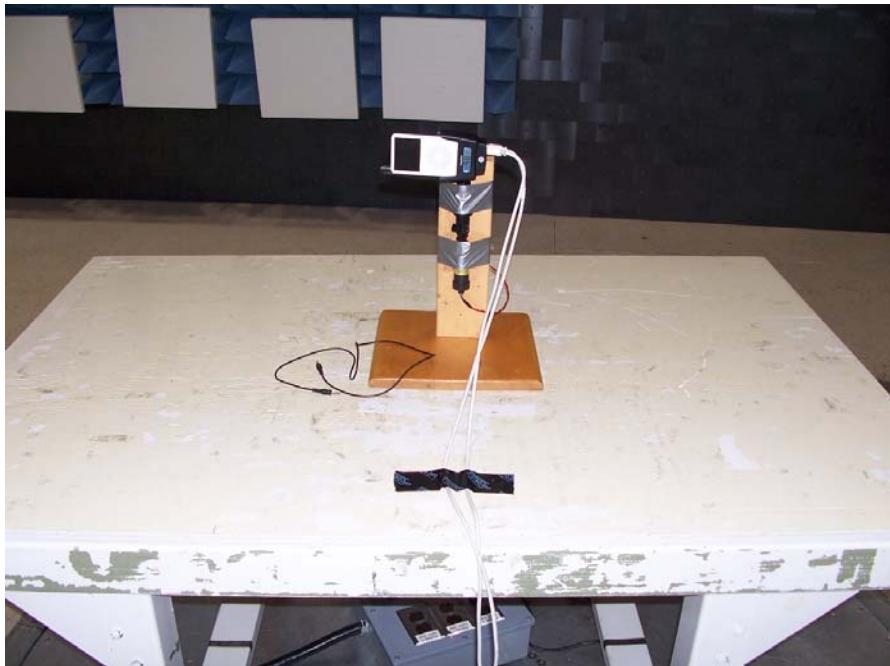
Figure 12 – Shows one of the 3 orthogonal positions used for testing.

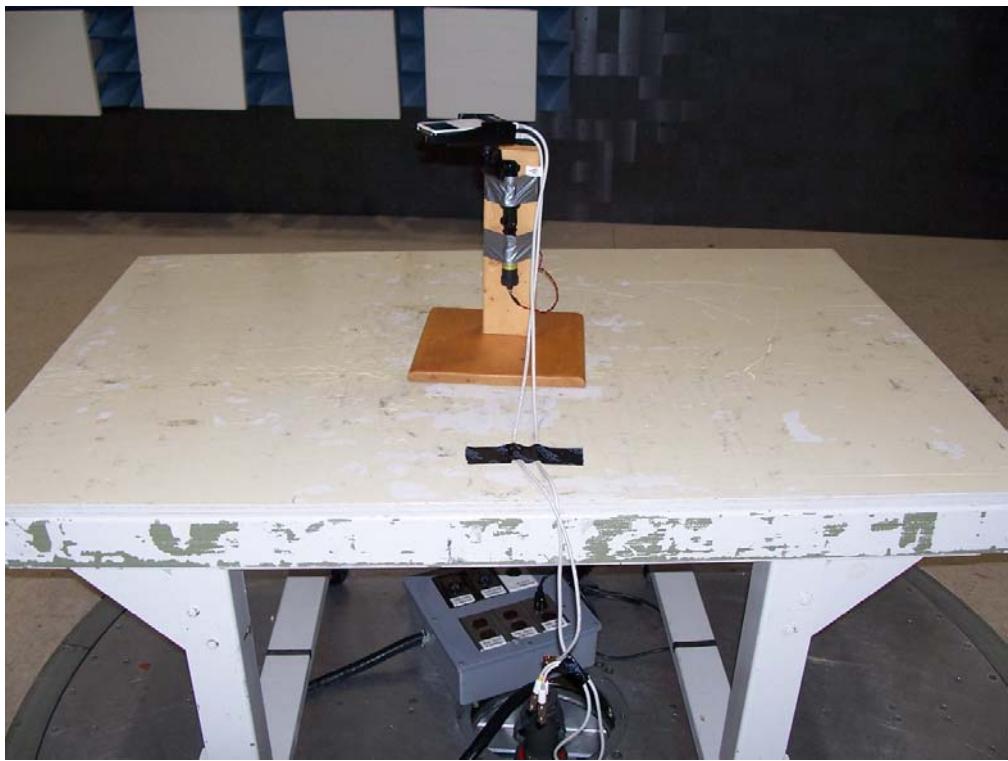
Figure 13 – shows another one of the 3 orthogonal positions used in testing.

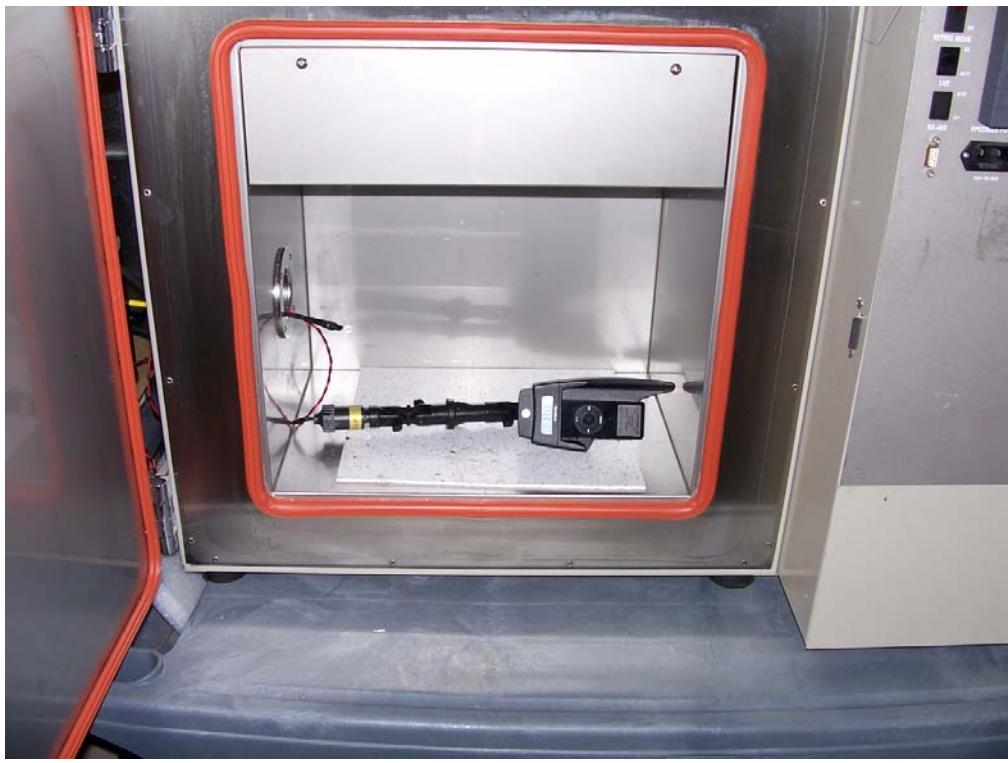
Figure 14 – Shows the use of the ipod nano for Frequency stability over temperature variations.
