## A.4 POWER SPECTRAL DENSITY

### Test Result

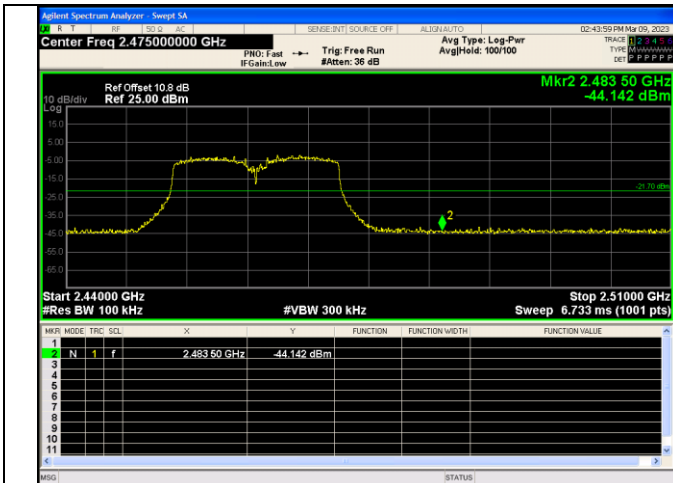
**Out Of Band Emission**  
IEEE 802.11ax\_Channel 11\_20MHz\_Antenna 1\_RU&Index  
106RU54

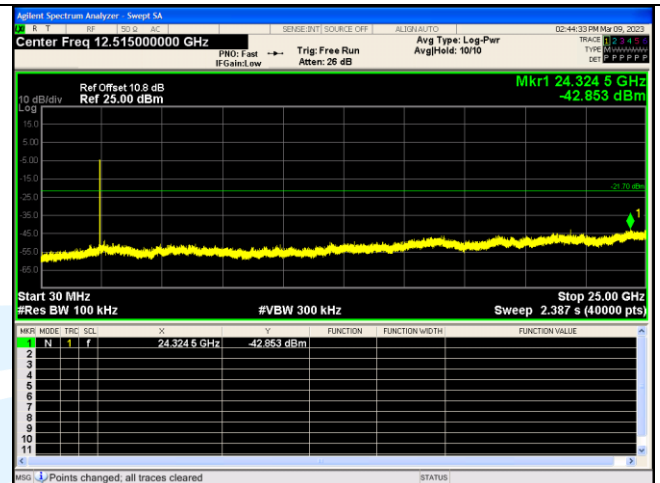
**Spurious Emission**  
IEEE 802.11ax\_Channel 11\_20MHz\_Antenna 1\_RU&Index  
106RU54

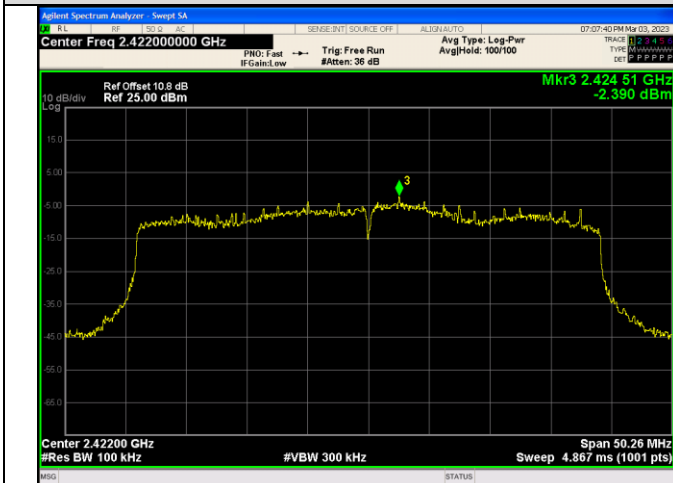
**In-Band Reference Level**  
IEEE 802.11ax\_Channel 3\_40MHz\_Antenna 0\_RU&Index SU

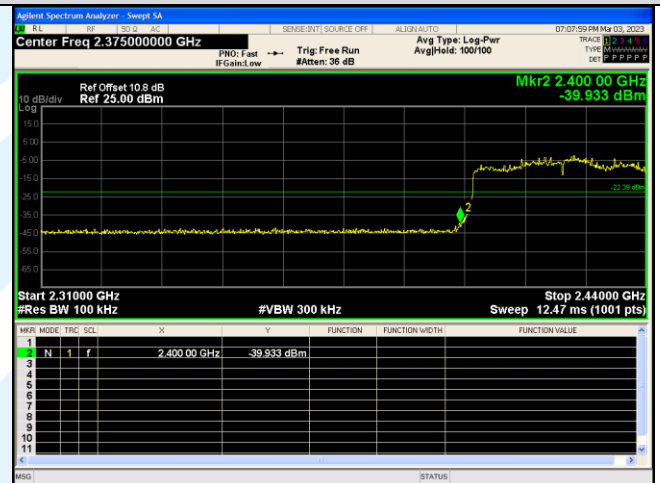
**Out Of Band Emission**  
IEEE 802.11ax\_Channel 3\_40MHz\_Antenna 0\_RU&Index SU

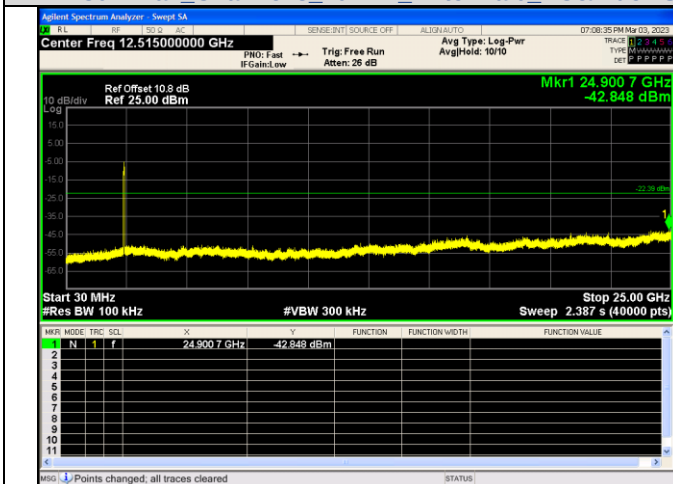
**Spurious Emission**  
IEEE 802.11ax\_Channel 3\_40MHz\_Antenna 0\_RU&Index SU

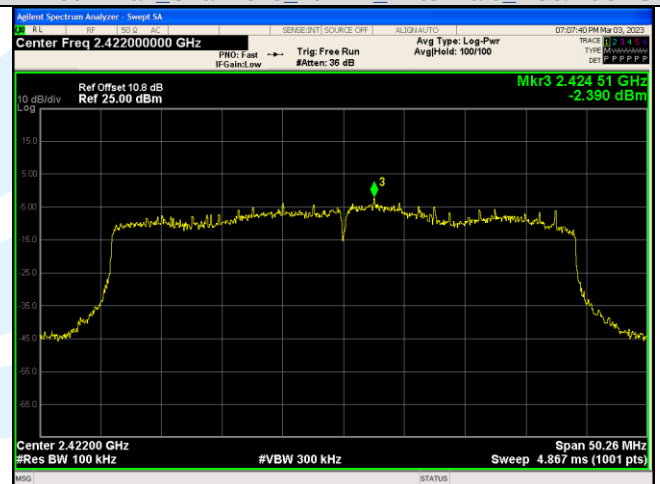
**In-Band Reference Level**  
IEEE 802.11ax\_Channel 3\_40MHz\_Antenna 1\_RU&Index SU

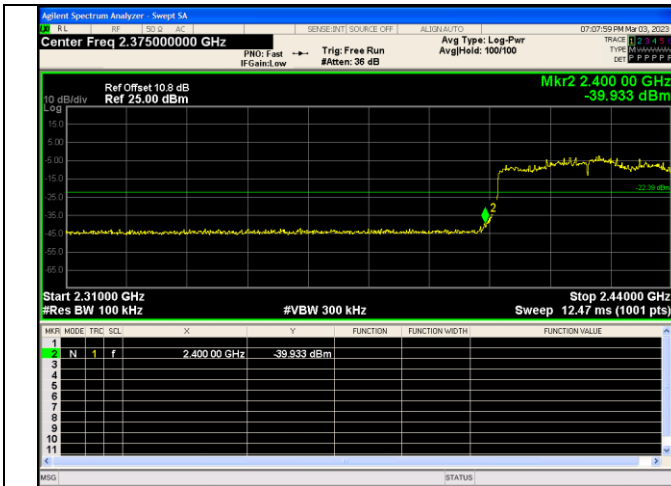
Out Of Band Emission

IEEE 802.11ax Channel 3 40MHz Antenna 1 RU&amp;Index SU

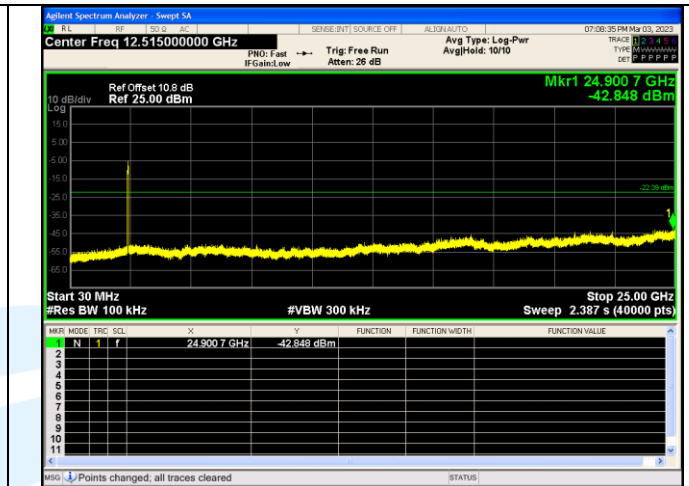
Spurious Emission

IEEE 802.11ax Channel 3 40MHz Antenna 1 RU&amp;Index SU

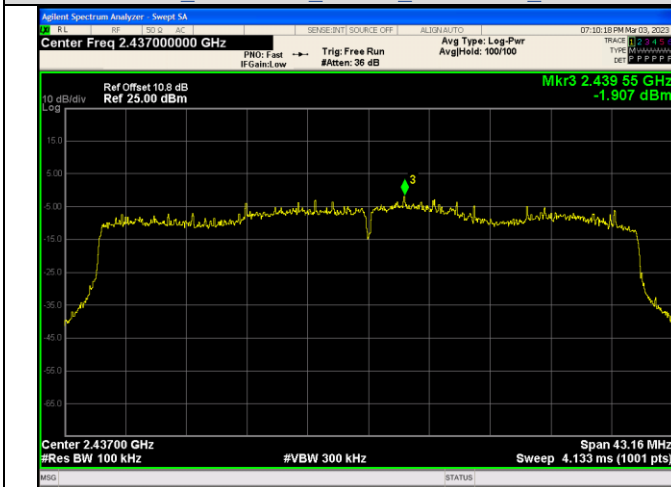
In-Band Reference Level

IEEE 802.11ax Channel 6 40MHz Antenna 0 RU&amp;Index SU

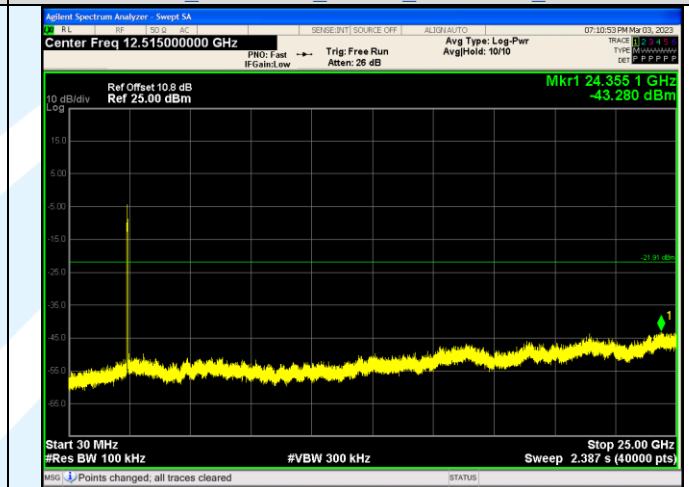
Spurious Emissions

IEEE 802.11ax Channel 6 40MHz Antenna 0 RU&amp;Index SU

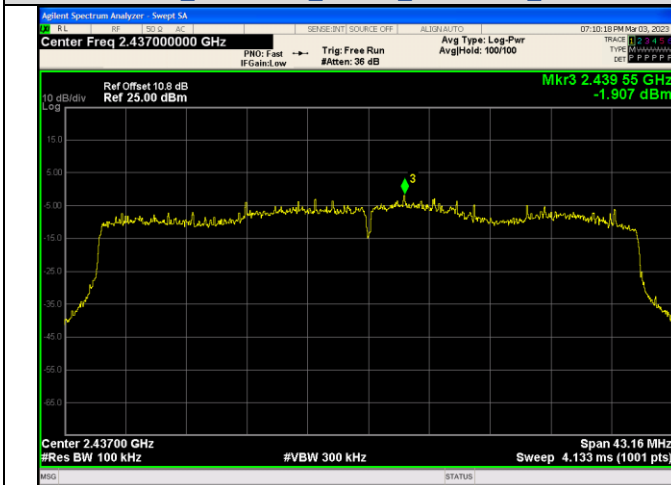
In-Band Reference Level

IEEE 802.11ax Channel 6 40MHz Antenna 1 RU&amp;Index SU

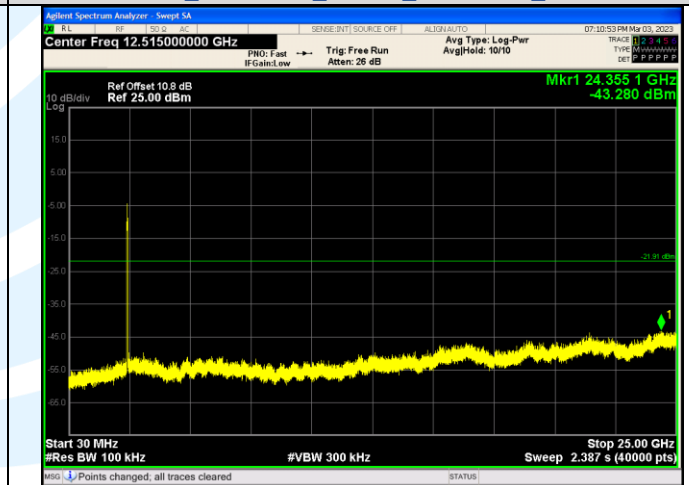
Spurious Emissions

IEEE 802.11ax Channel 6 40MHz Antenna 1 RU&amp;Index SU

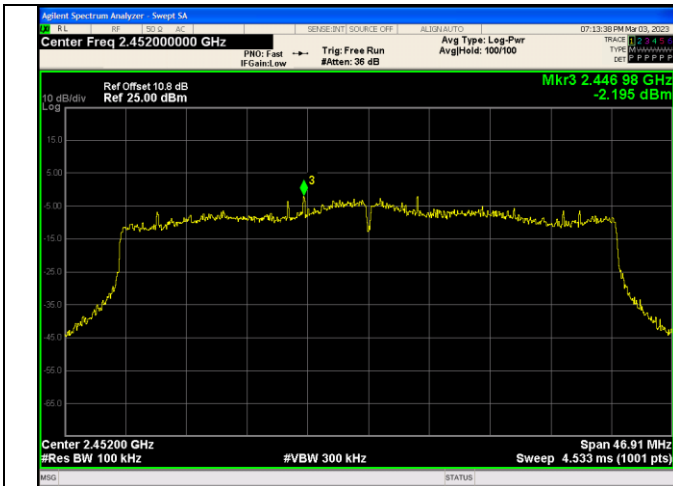
**In-Band Reference Level**  
IEEE 802.11ax Channel 9 40MHz Antenna 0 RU&Index SU

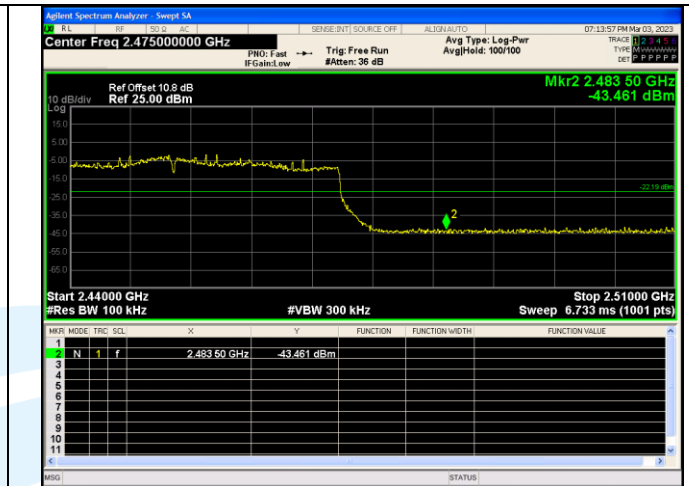
**Out Of Band Emission**  
IEEE 802.11ax Channel 9 40MHz Antenna 0 RU&Index SU

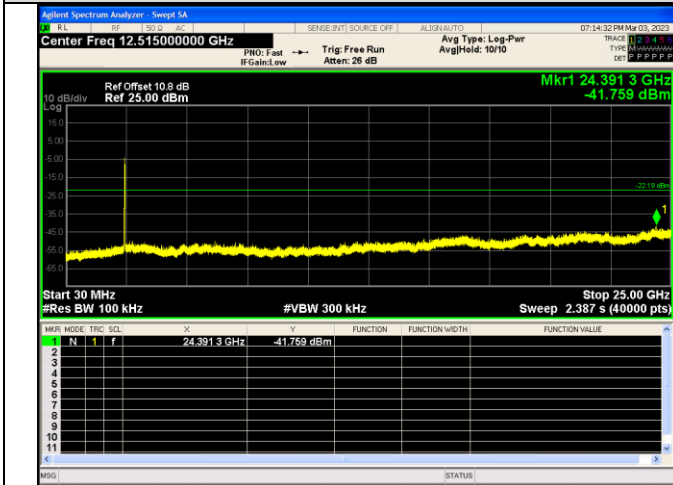
**Spurious Emission**  
IEEE 802.11ax Channel 9 40MHz Antenna 0 RU&Index SU

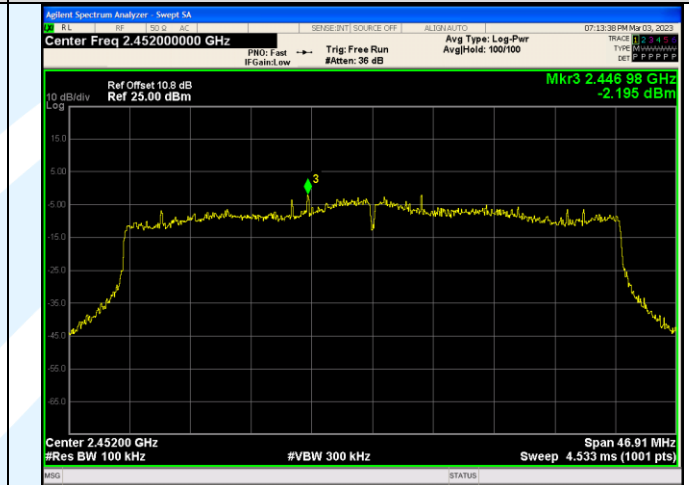
**In-Band Reference Level**  
IEEE 802.11ax Channel 9 40MHz Antenna 1 RU&Index SU

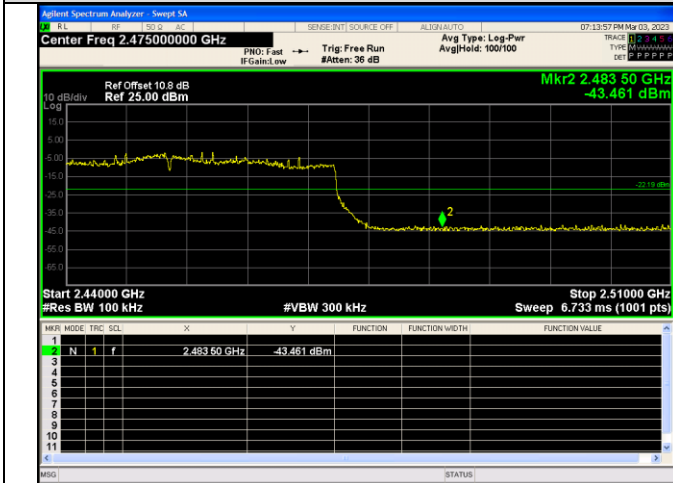
**Out Of Band Emission**  
IEEE 802.11ax Channel 9 40MHz Antenna 1 RU&Index SU

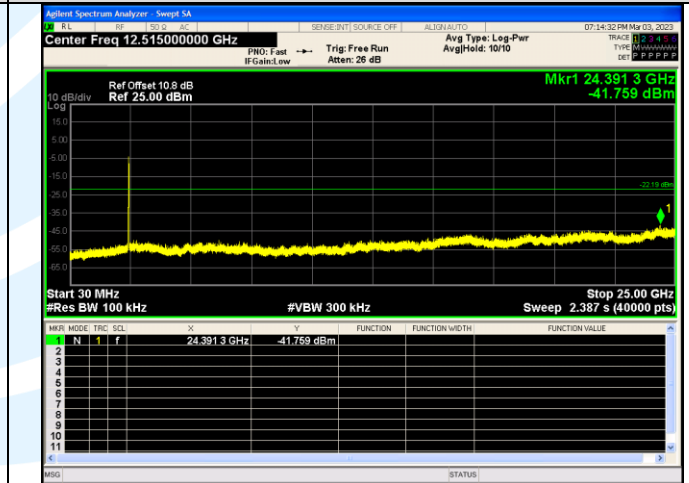
**Spurious Emission**  
IEEE 802.11ax Channel 9 40MHz Antenna 1 RU&Index SU
