Annex B.iii. Photograph: Test Setup Photo

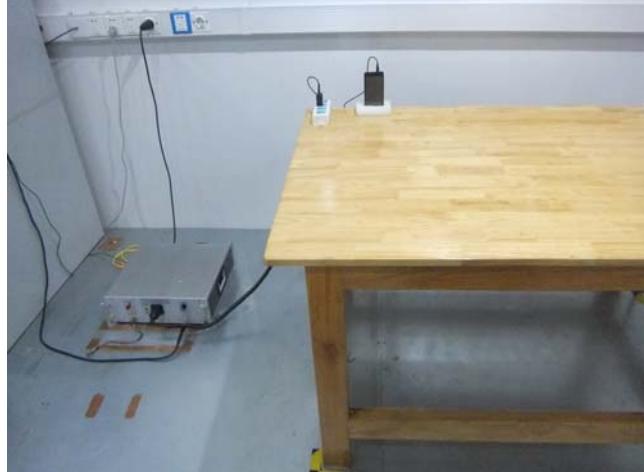
A photograph showing a wooden table in a test chamber. On the table, there is a power strip with several cables connected to it. The background shows the interior of the test chamber with a metal mesh screen.

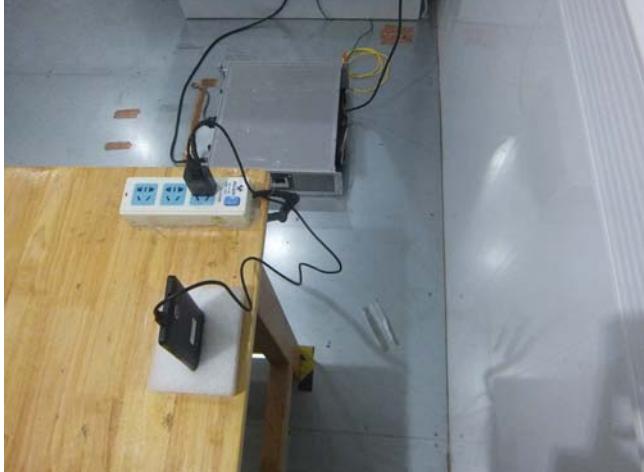
A photograph showing a side view of the test setup. It features a wooden table with a power strip and various cables. The background shows the test chamber's interior and a power distribution unit on the wall.
Conducted Emissions Test Setup Front View	Conducted Emissions Test Setup Side View

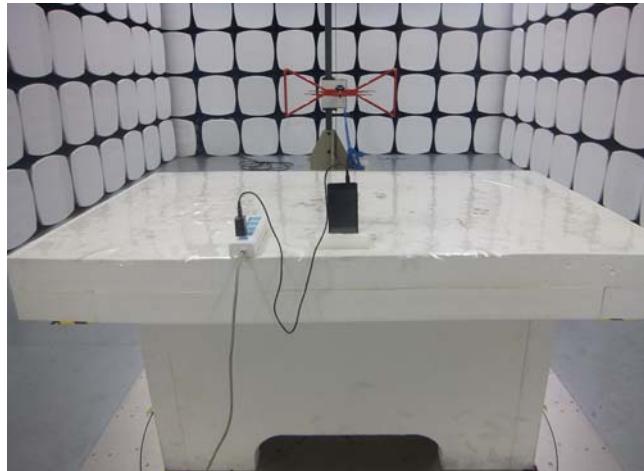
A photograph showing the test setup for radiated spurious emissions below 1GHz. A device is mounted on a vertical test horn, which is positioned above a large, white, rectangular test object. The background is a test chamber with a metal mesh screen.

Radiated Spurious Emissions Test Setup Below 1GHz	Radiated Spurious Emissions Test Setup Above 1GHz

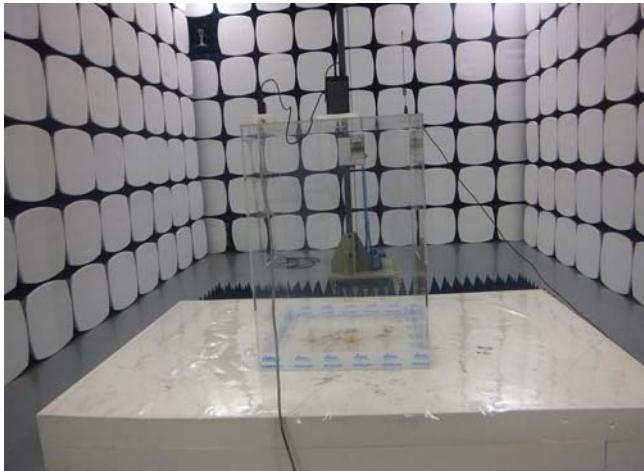
A photograph showing the test setup for radiated spurious emissions above 1GHz. A device is mounted on a vertical test horn, which is positioned above a large, white, rectangular test object. The background is a test chamber with a metal mesh screen.
