Radiated Emission Measurement

Condition : FCC\_part 15 RE-Class C\_Above 1GHz\_PK

EUT : W6M21903-18922

Test Mode : TX 802.11g CH1

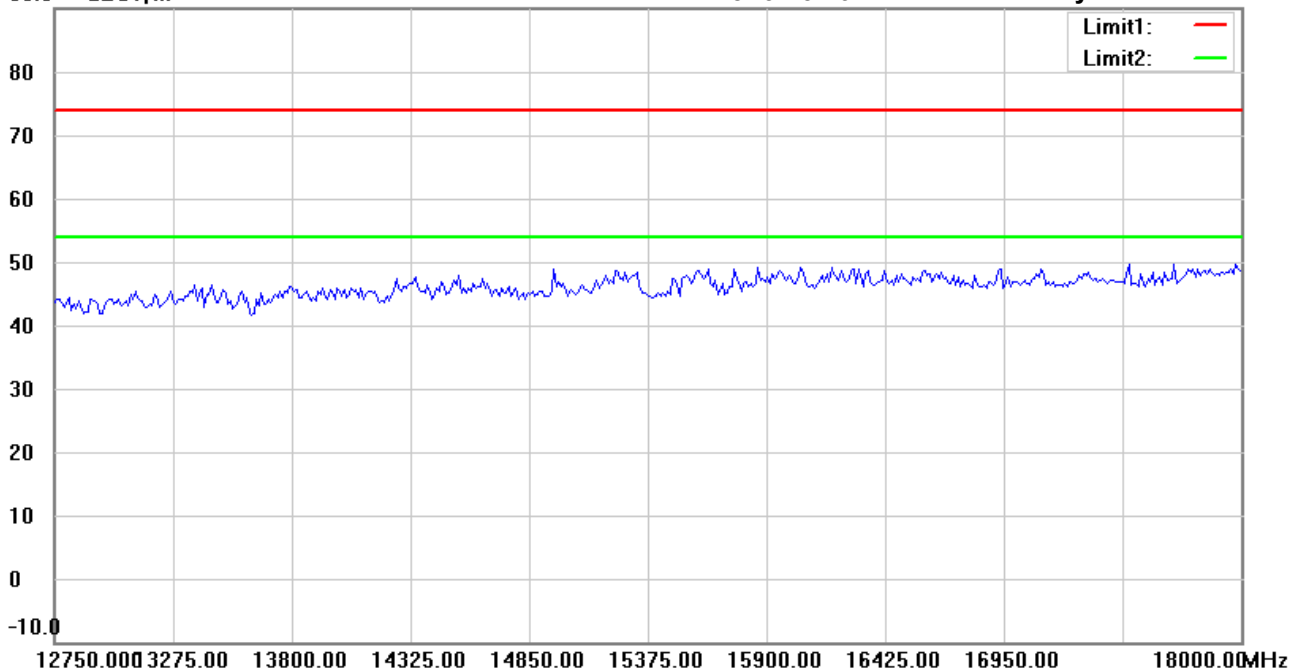
Condition : FCC\_part 15 RE-Class C\_Above 1GHz\_PK

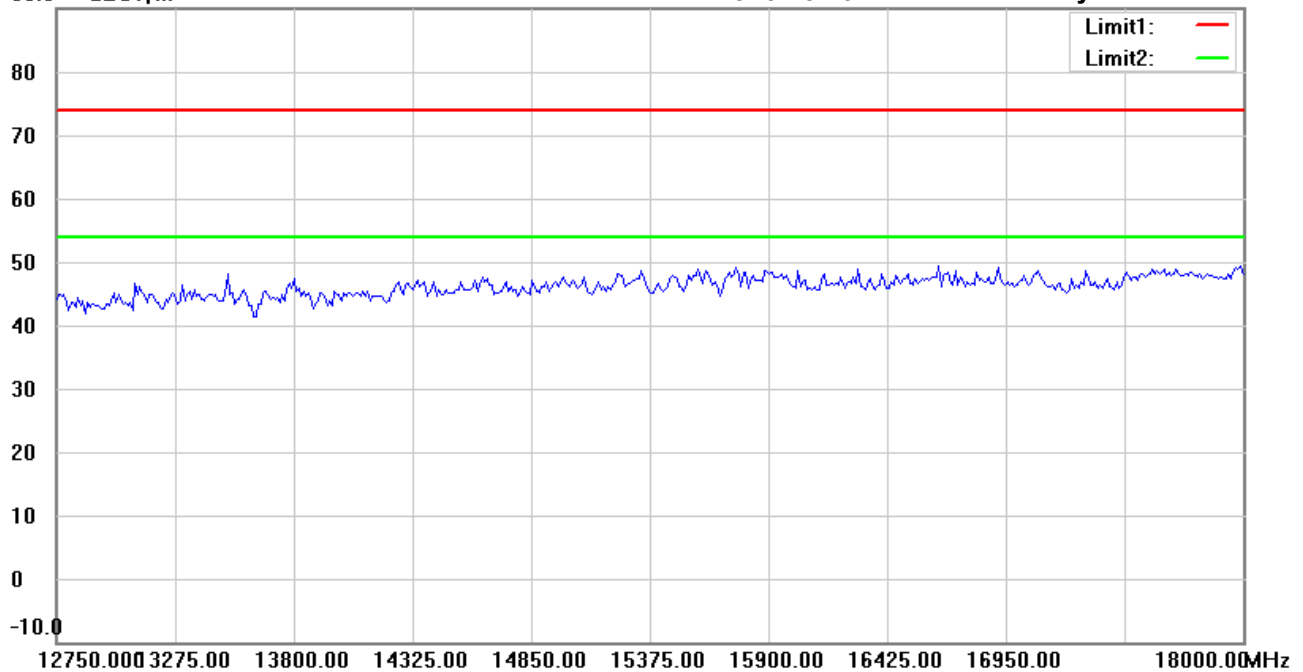
Condition : FCC\_part 15 RE-Class C\_Above 1GHz\_PK

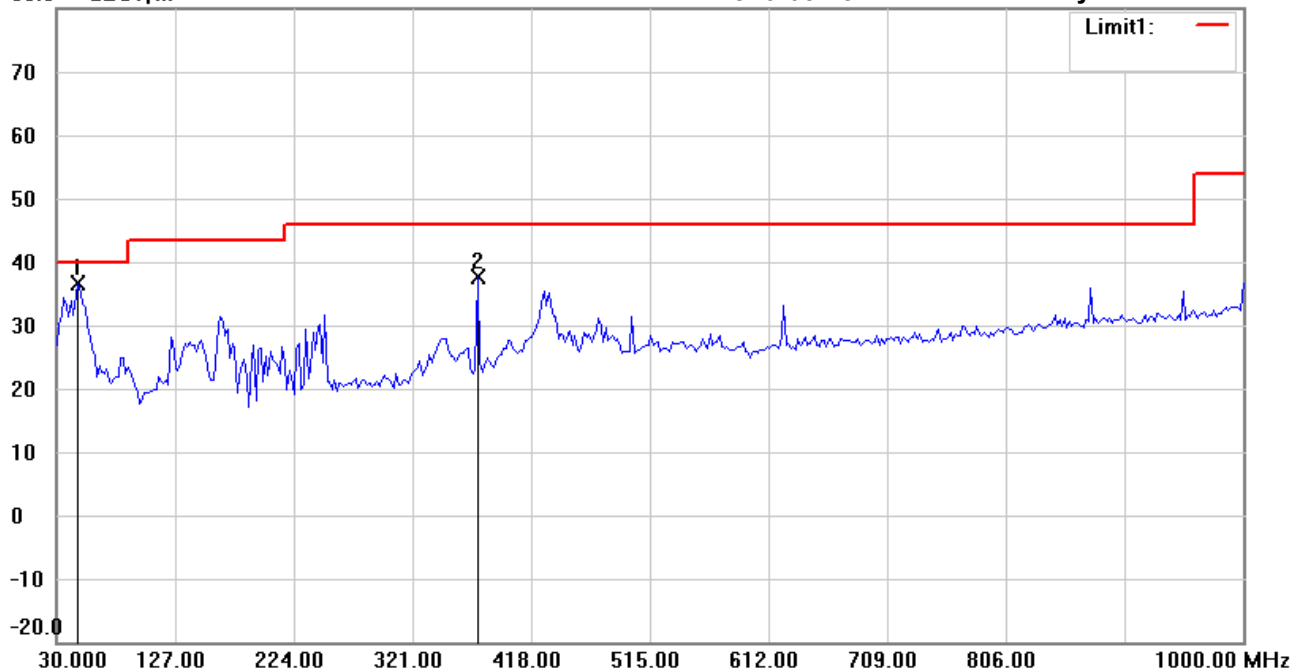
Condition : FCC\_part 15 RE-Class C\_30-1000MHz

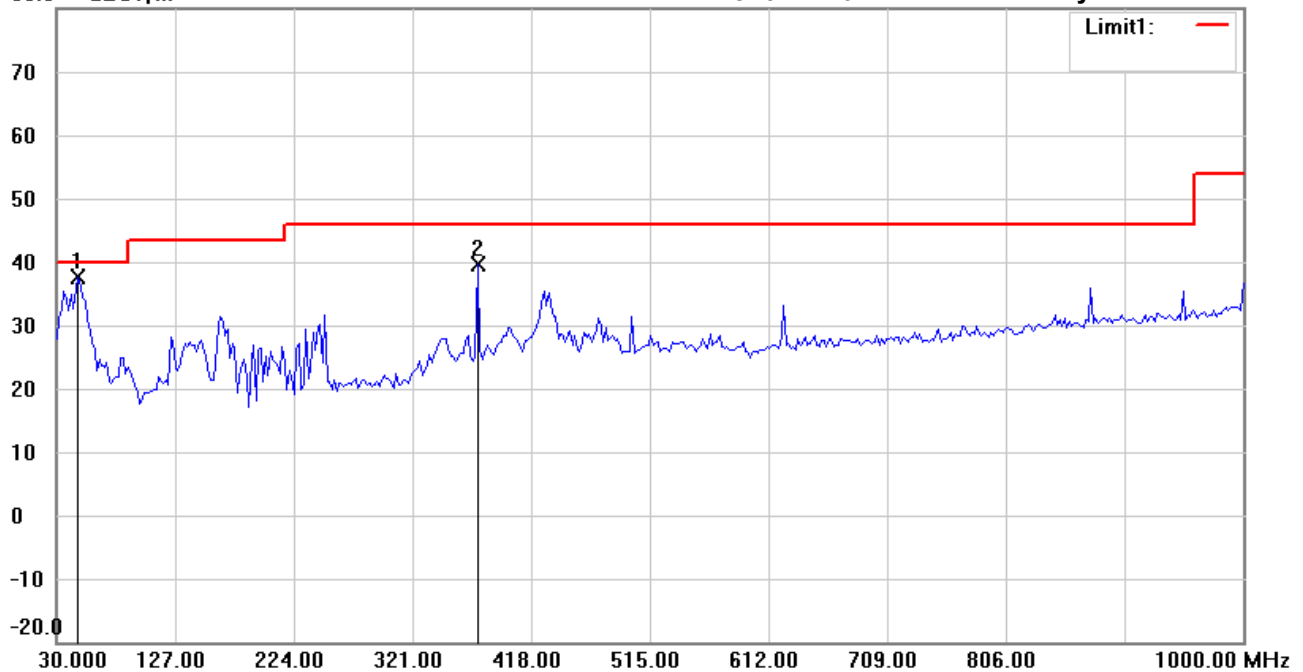
Condition : FCC\_part 15 RE-Class C\_30-1000MHz

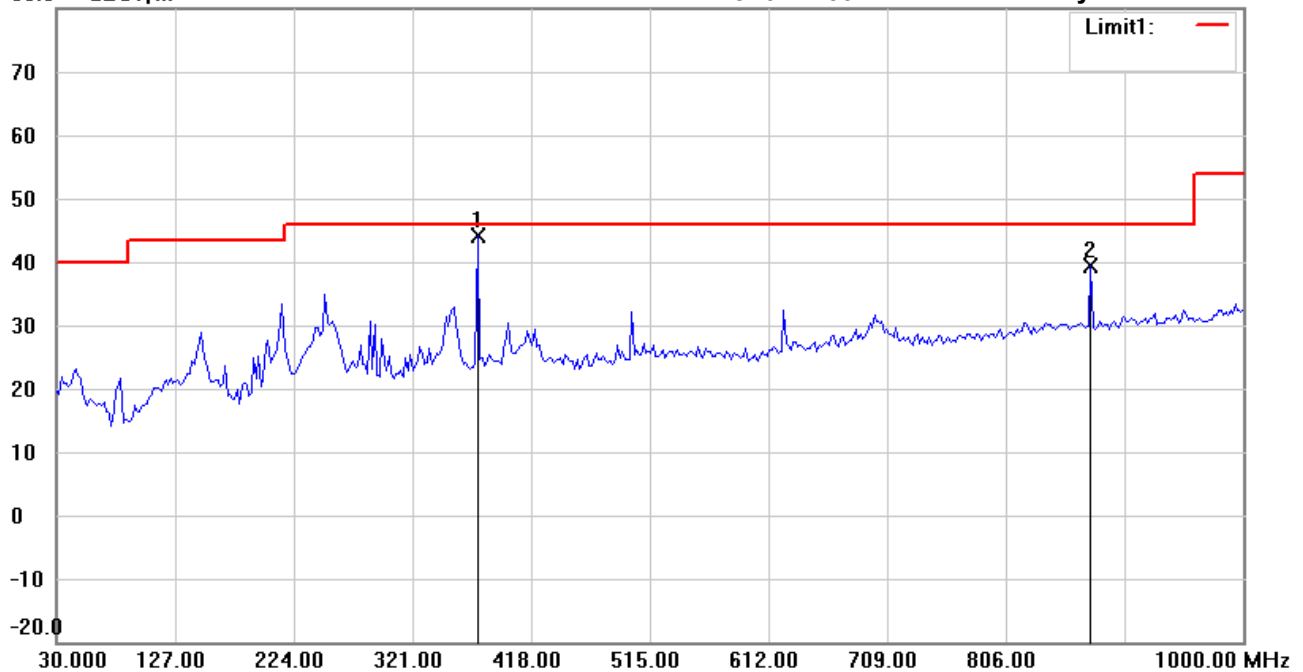
Condition : FCC\_part 15 RE-Class C\_30-1000MHz
