## **Exhibit: Test Setup Photos**

Report File #: 7169006883R-000

| Client | <b>Flosonic Medical</b> | |
| Product | <b>FloPatch FP120</b> | |

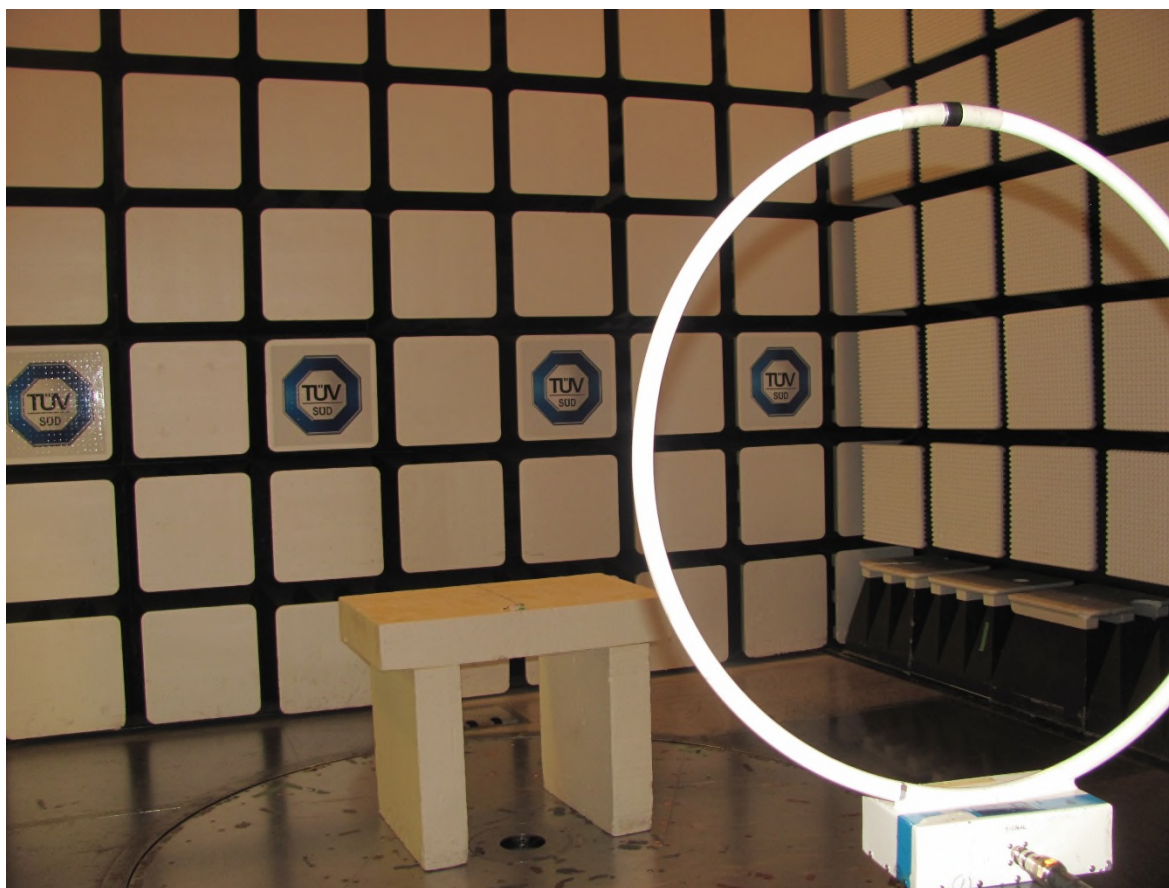
Figure 2 – Radiated Emissions Setup – Photo 1

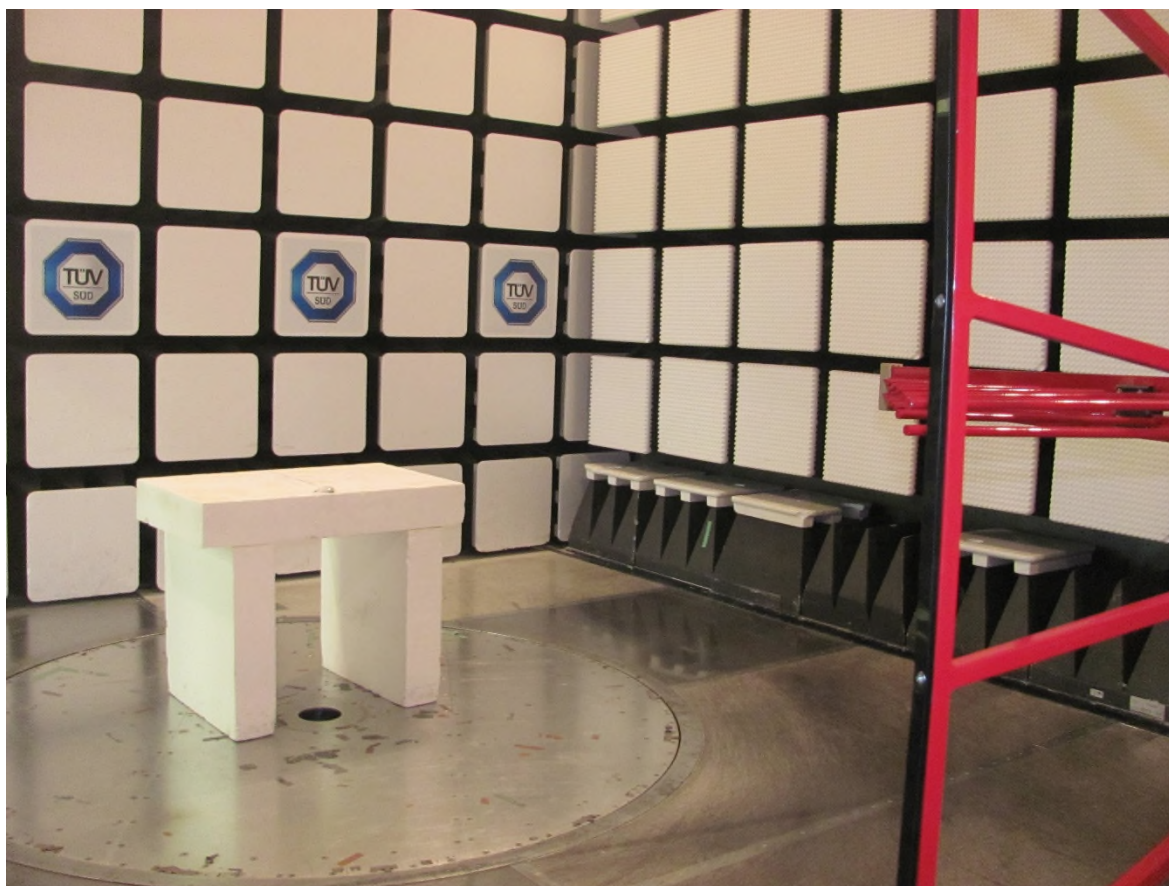
Figure 3 – Radiated Emissions Setup – Photo 2

Note: As per ANSI C63.10-2013 Clause 6.3.1, below 1GHz, the height of the EUT was set to 80cm. Above 1GHz, the height was raised to 1.5m.
