Appendix G: Band edge measurements
 Test Result

Appendix H: Conducted Spurious Emission Test Result

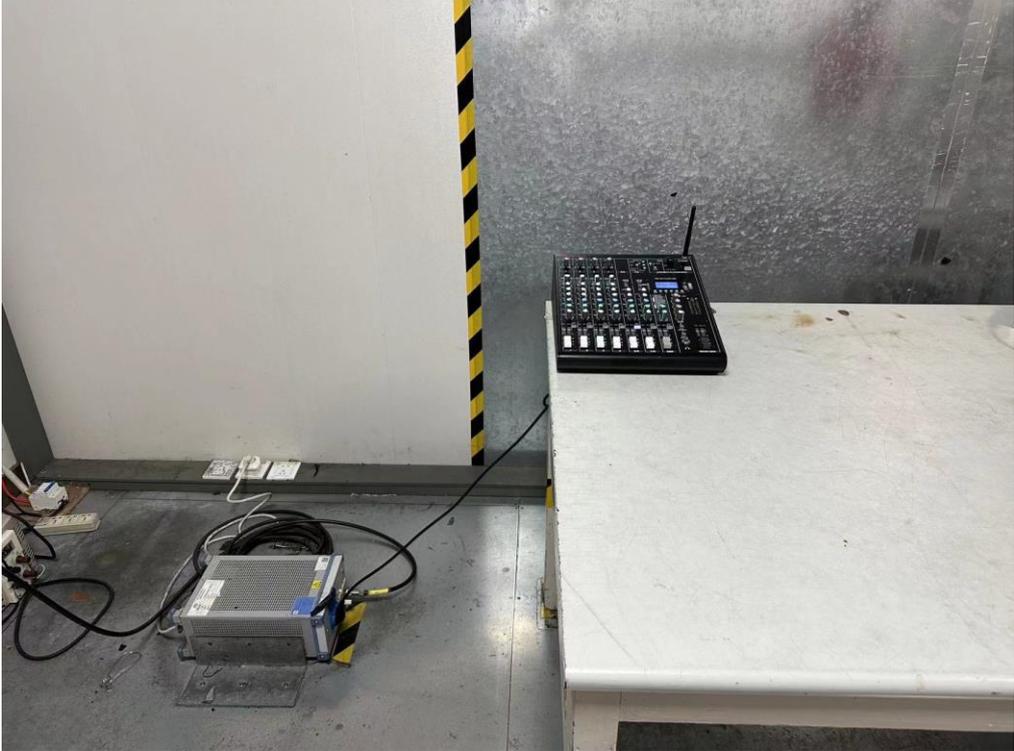
Conducted Test

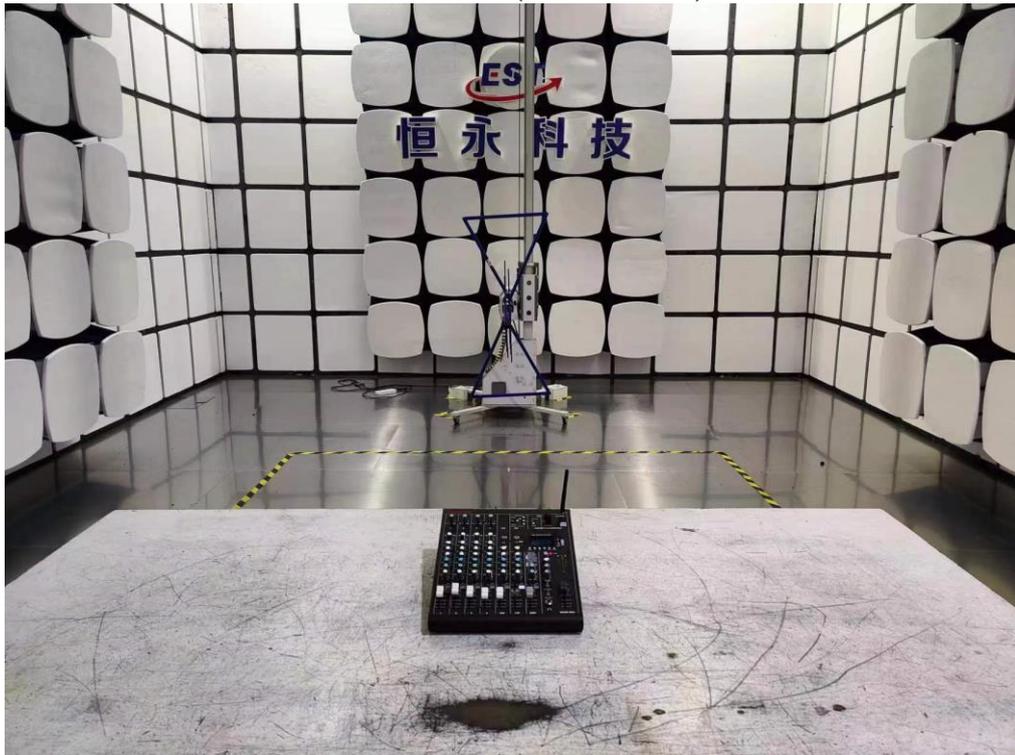
Radiated Test (Below 1GHz)

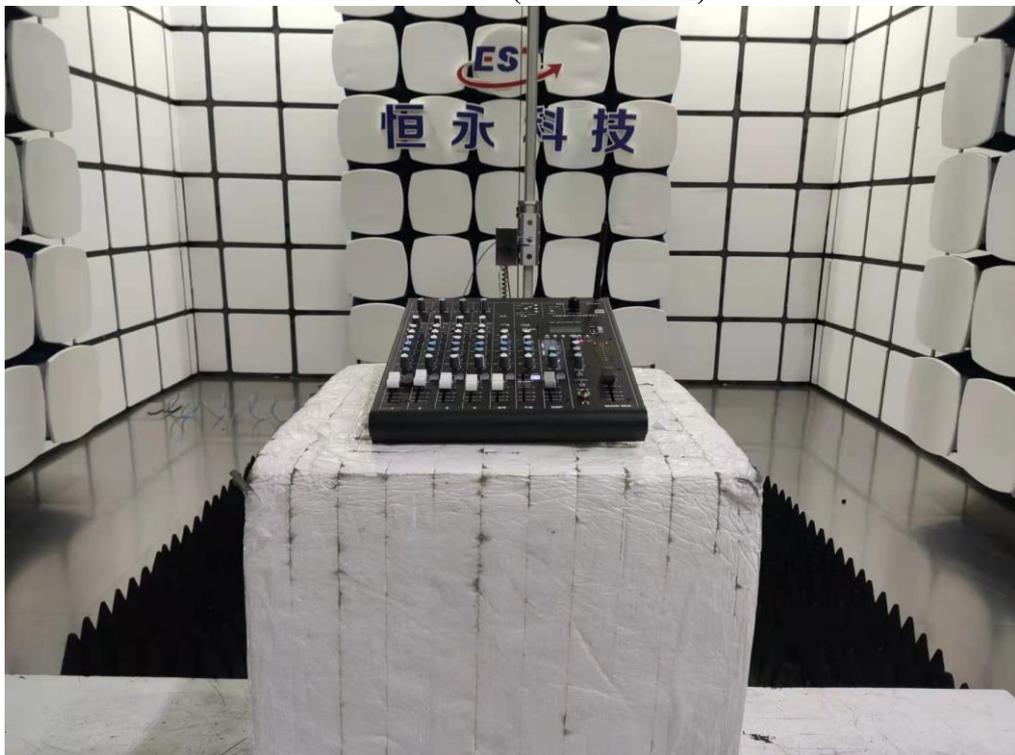
Radiated Test (Above 1GHz)

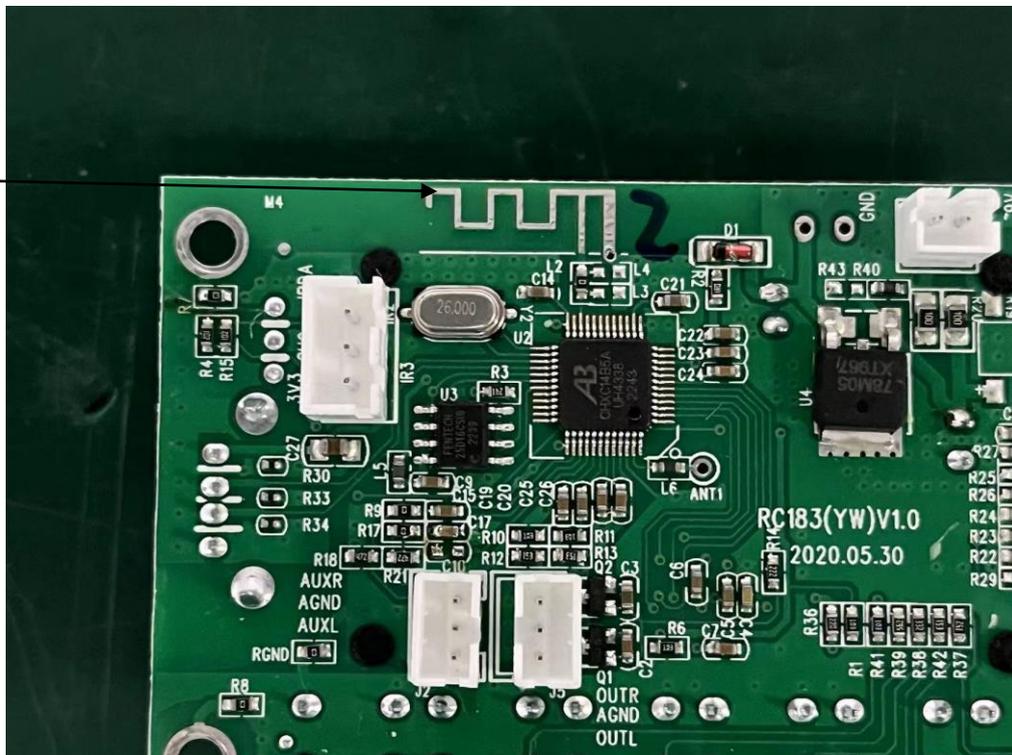
Bluetooth
Antenna
