## Appendix F: Band edge measurements

## Appendix G: Conducted Spurious Emission

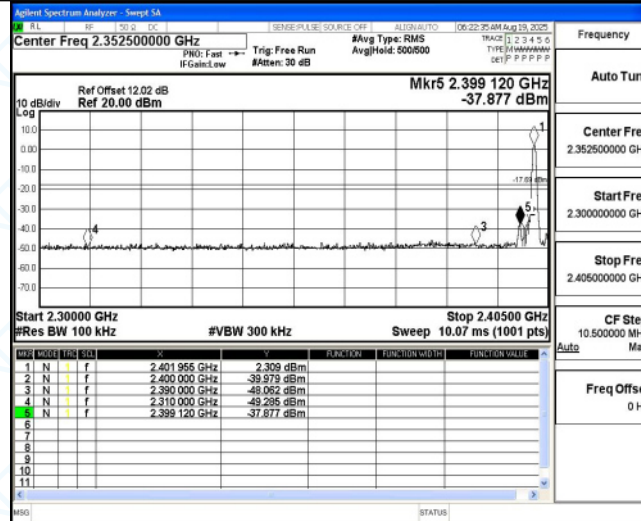
DH5\_Ant1\_Low\_2402

| TestMode | Antenna | ChName | Freq(MHz) | RefLevel [dBm] | Result [dBm] | Limit [dBm] | Verdict |
|---|---|---|---|---|---|---|---|
| DH5 | Ant1 | Low | 2402 | 2.31 | -37.88 | $\leq -17.69$ | PASS |

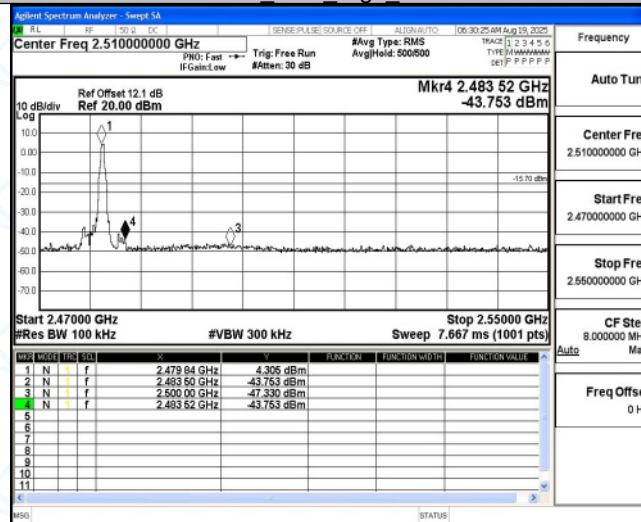
DH5\_Ant1\_High\_2480

| TestMode | Antenna | ChName | Freq(MHz) | RefLevel [dBm] | Result [dBm] | Limit [dBm] | Verdict |
|---|---|---|---|---|---|---|---|
| | | High | 2480 | 4.31 | -43.75 | $\leq -15.7$ | PASS |

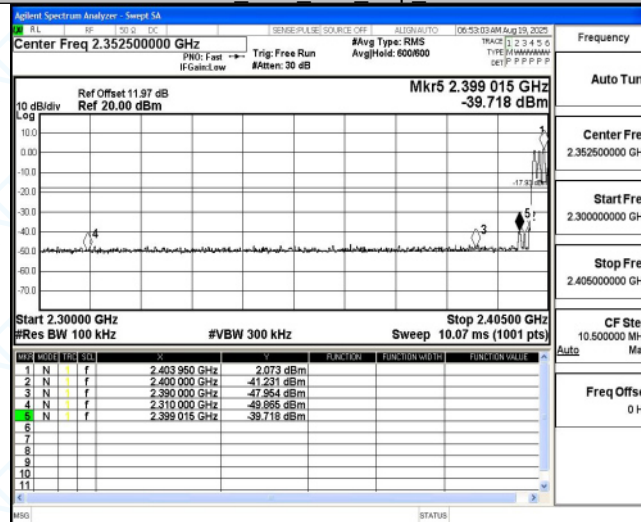
DH5\_Ant1\_Low\_Hop\_2402

| TestMode | Antenna | ChName | Freq(MHz) | RefLevel [dBm] | Result [dBm] | Limit [dBm] | Verdict |
|---|---|---|---|---|---|---|---|
| | | Low | Hop_2402 | 2.07 | -39.72 | $\leq -17.93$ | PASS |

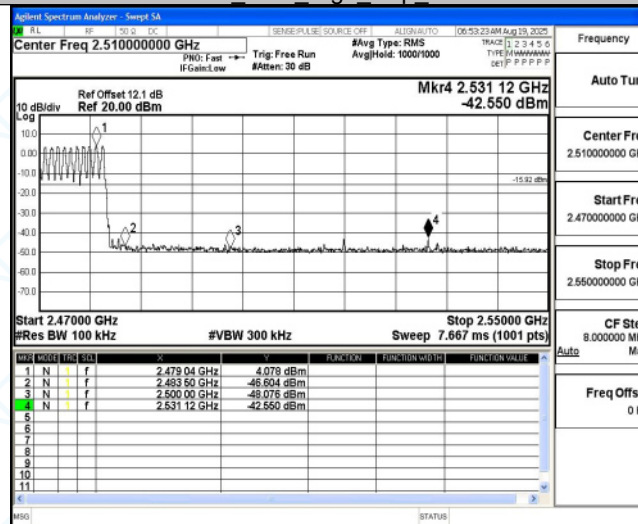
## DH5 Ant1\_High\_Hop 2480

| TestMode | Antenna | ChName | Freq(MHz) | RefLevel [dBm] | Result [dBm] | Limit [dBm] | Verdict |
|---|---|---|---|---|---|---|---|
| | | High | Hop_2480 | 4.08 | -42.55 | $\leq -15.92$ | PASS |

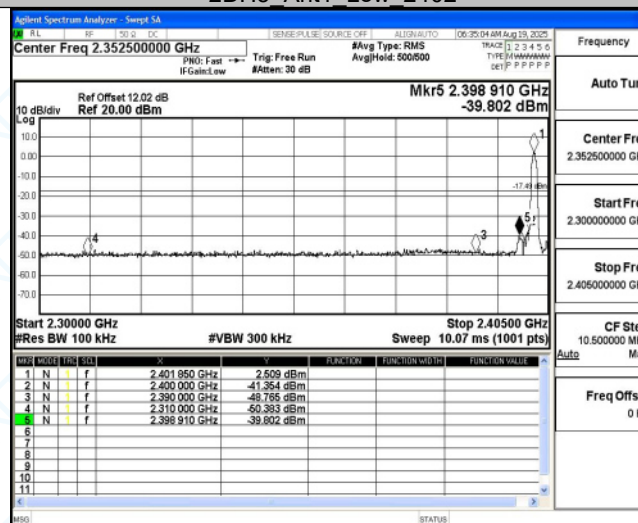
## 2DH5 Ant1\_Low\_2402

| TestMode | Antenna | ChName | Freq(MHz) | RefLevel [dBm] | Result [dBm] | Limit [dBm] | Verdict |
|---|---|---|---|---|---|---|---|
| 2DH5 | Ant1 | Low | 2402 | 2.51 | -39.8 | $\leq -17.49$ | PASS |

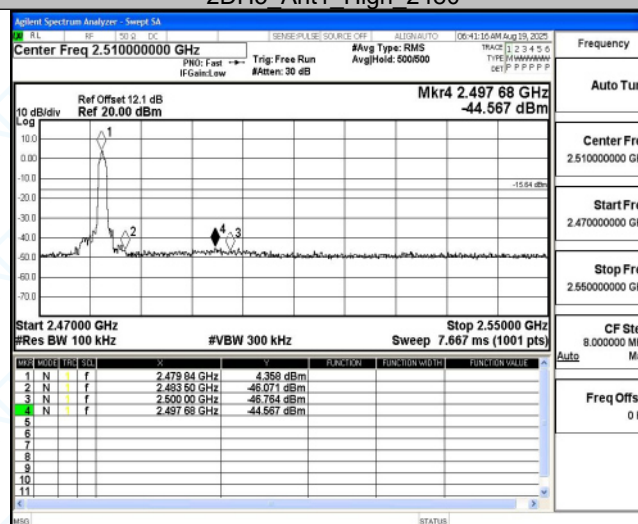
## 2DH5 Ant1\_High\_2480

| TestMode | Antenna | ChName | Freq(MHz) | RefLevel [dBm] | Result [dBm] | Limit [dBm] | Verdict |
|---|---|---|---|---|---|---|---|
| | | High | 2480 | 4.36 | -44.57 | $\leq -15.64$ | PASS |

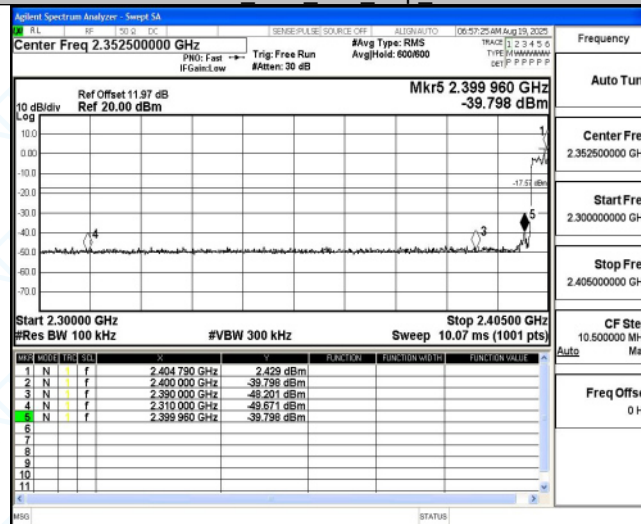
## 2DH5 Ant1 Low Hop 2402

| TestMode | Antenna | ChName | Freq(MHz) | RefLevel [dBm] | Result [dBm] | Limit [dBm] | Verdict |
|---|---|---|---|---|---|---|---|
| | | Low | Hop_2402 | 2.43 | -39.8 | $\leq -17.57$ | PASS |

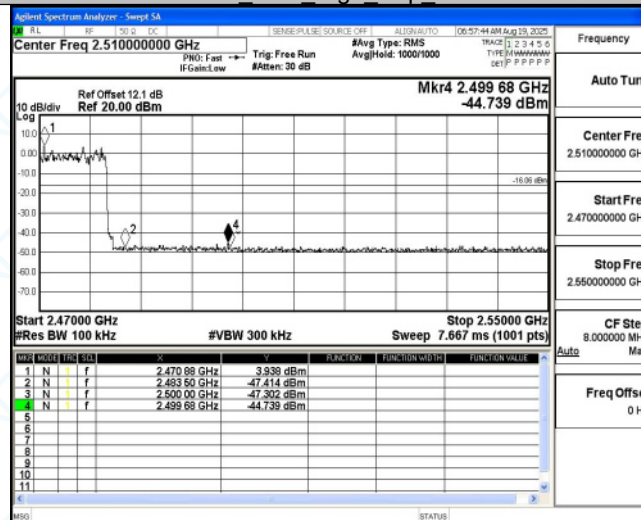
## 2DH5 Ant1 High Hop 2480

| TestMode | Antenna | ChName | Freq(MHz) | RefLevel [dBm] | Result [dBm] | Limit [dBm] | Verdict |
|---|---|---|---|---|---|---|---|
| | | High | Hop_2480 | 3.94 | -44.74 | $\leq -16.06$ | PASS |

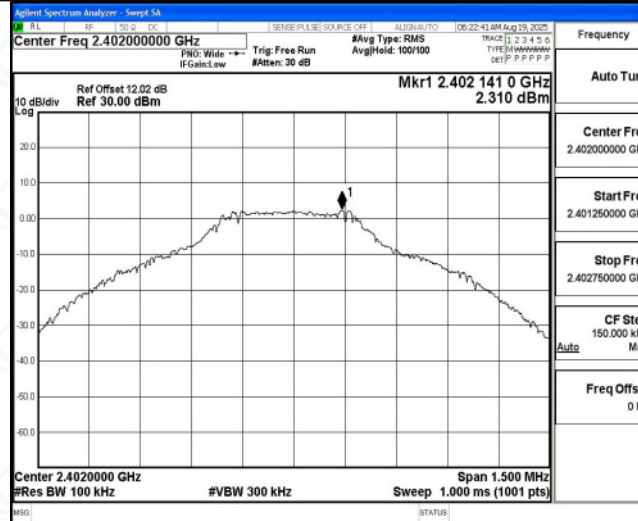
DH5\_Ant1\_2402\_0~Reference

| TestMode | Antenna | Freq(MHz) | FreqRange [MHz] | RefLevel [dBm] | Result [dBm] | Limit [dBm] | Verdict |
|---|---|---|---|---|---|---|---|
| DH5 | Ant1 | 2402 | Reference | 2.31 | 2.31 | --- | PASS |

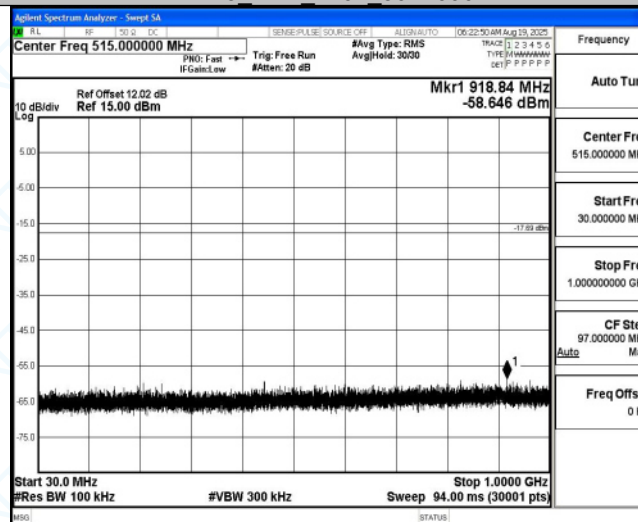
DH5\_Ant1\_2402\_30~1000

| TestMode | Antenna | Freq(MHz) | FreqRange [MHz] | RefLevel [dBm] | Result [dBm] | Limit [dBm] | Verdict |
|---|---|---|---|---|---|---|---|
| | | | 30~1000 | 2.31 | -58.65 | $\leq -17.69$ | PASS |

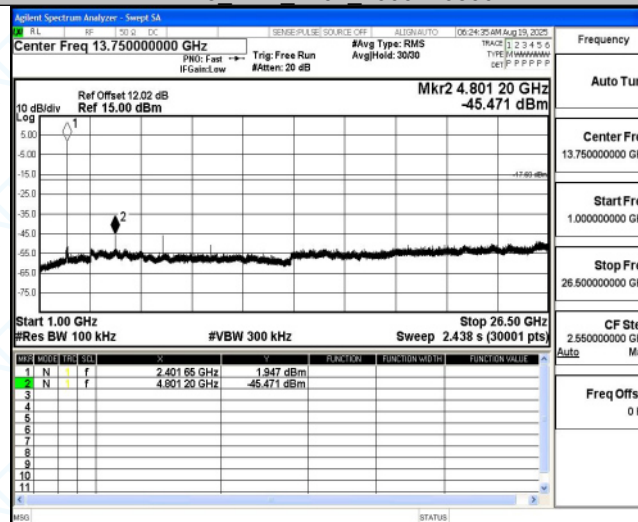
DH5\_Ant1\_2402\_1000~26500

| TestMode | Antenna | Freq(MHz) | FreqRange [MHz] | RefLevel [dBm] | Result [dBm] | Limit [dBm] | Verdict |
|---|---|---|---|---|---|---|---|
| | | | 1000~26500 | 2.31 | -45.47 | $\leq -17.69$ | PASS |

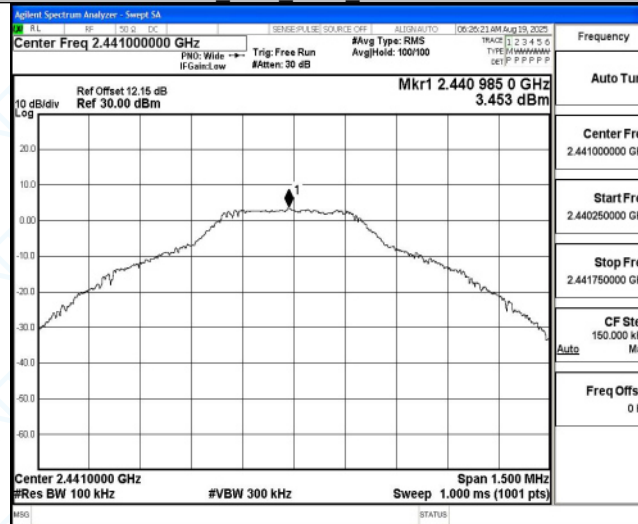
## DH5\_Ant1\_2441\_0~Reference

| TestMode | Antenna | Freq(MHz) | FreqRange [MHz] | RefLevel [dBm] | Result [dBm] | Limit [dBm] | Verdict |
|---|---|---|---|---|---|---|---|
| | | 2441 | Reference | 3.45 | 3.45 | --- | PASS |

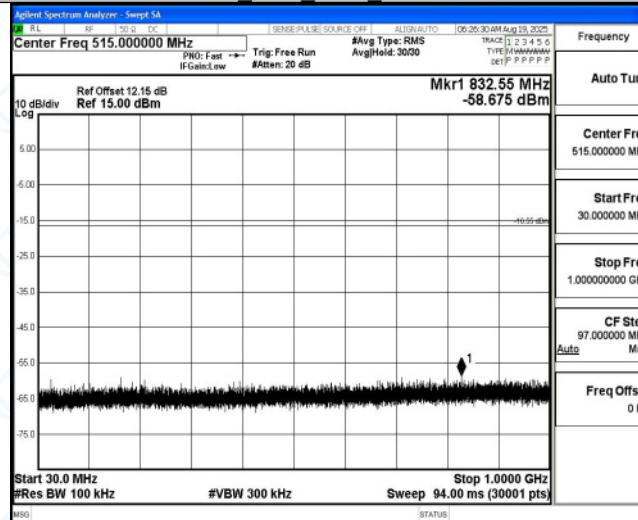
## DH5\_Ant1\_2441\_30~1000

| TestMode | Antenna | Freq(MHz) | FreqRange [MHz] | RefLevel [dBm] | Result [dBm] | Limit [dBm] | Verdict |
|---|---|---|---|---|---|---|---|
| | | | 30~1000 | 3.45 | -58.68 | $\leq -16.55$ | PASS |

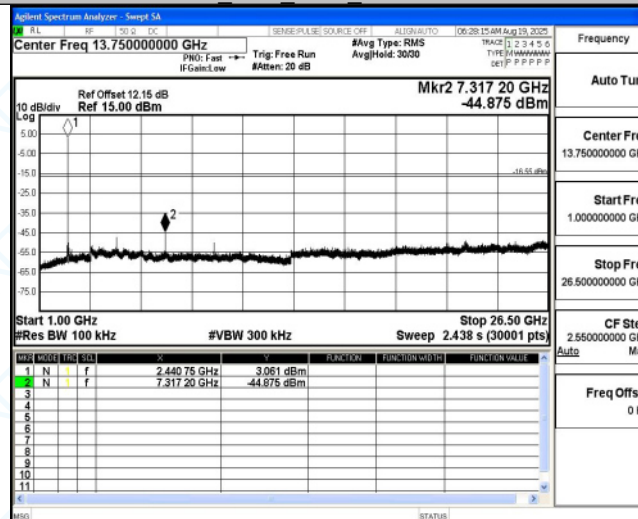
## DH5\_Ant1\_2441\_1000~26500

| TestMode | Antenna | Freq(MHz) | FreqRange [MHz] | RefLevel [dBm] | Result [dBm] | Limit [dBm] | Verdict |
|---|---|---|---|---|---|---|---|
| | | | 1000~26500 | 3.45 | -44.88 | $\leq -16.55$ | PASS |

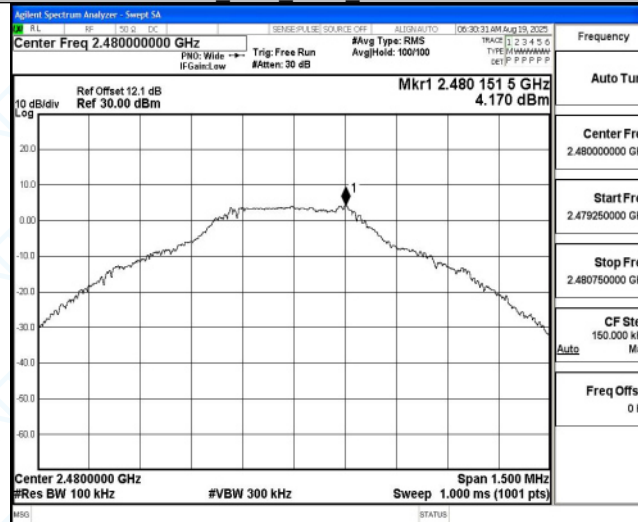
## DH5\_Ant1\_2480\_0~Reference

| TestMode | Antenna | Freq(MHz) | FreqRange [MHz] | RefLevel [dBm] | Result [dBm] | Limit [dBm] | Verdict |
|---|---|---|---|---|---|---|---|
| | | 2480 | Reference | 4.17 | 4.17 | --- | PASS |

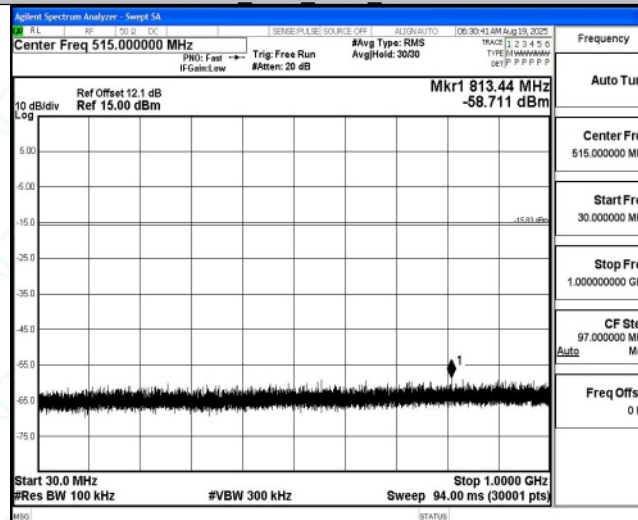
## DH5\_Ant1\_2480\_30~1000

| TestMode | Antenna | Freq(MHz) | FreqRange [MHz] | RefLevel [dBm] | Result [dBm] | Limit [dBm] | Verdict |
|---|---|---|---|---|---|---|---|
| | | | 30~1000 | 4.17 | -58.71 | $\leq -15.83$ | PASS |

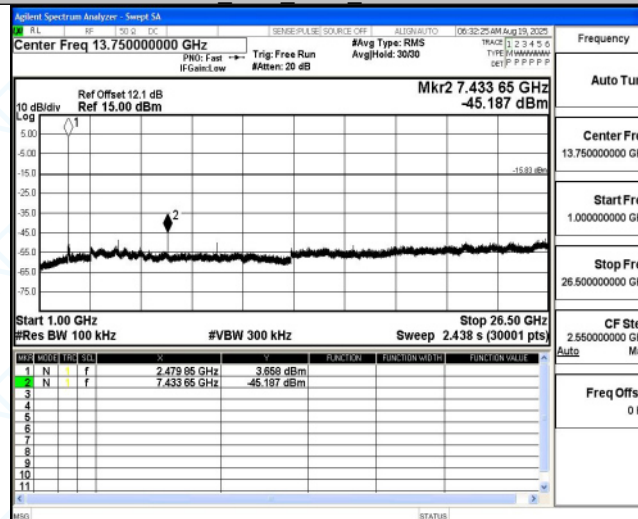
## DH5\_Ant1\_2480\_1000~26500

| TestMode | Antenna | Freq(MHz) | FreqRange [MHz] | RefLevel [dBm] | Result [dBm] | Limit [dBm] | Verdict |
|---|---|---|---|---|---|---|---|
| | | | 1000~26500 | 4.17 | -45.19 | $\leq -15.83$ | PASS |

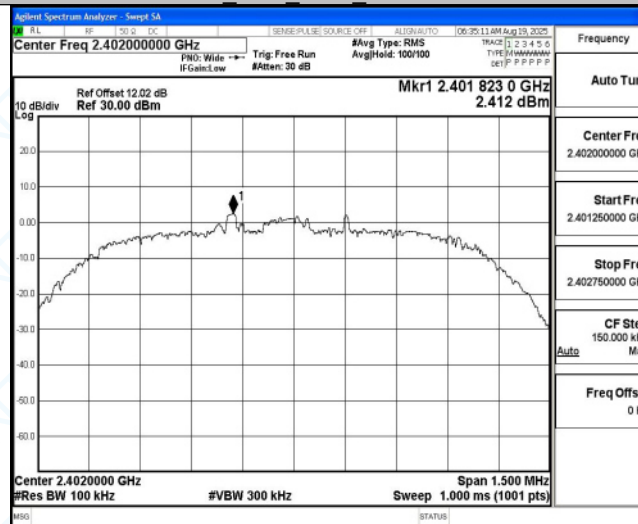
## 2DH5\_Ant1\_2402\_0~Reference

| TestMode | Antenna | Freq(MHz) | FreqRange [MHz] | RefLevel [dBm] | Result [dBm] | Limit [dBm] | Verdict |
|---|---|---|---|---|---|---|---|
| 2DH5 | Ant1 | 2402 | Reference | 2.41 | 2.41 | --- | PASS |

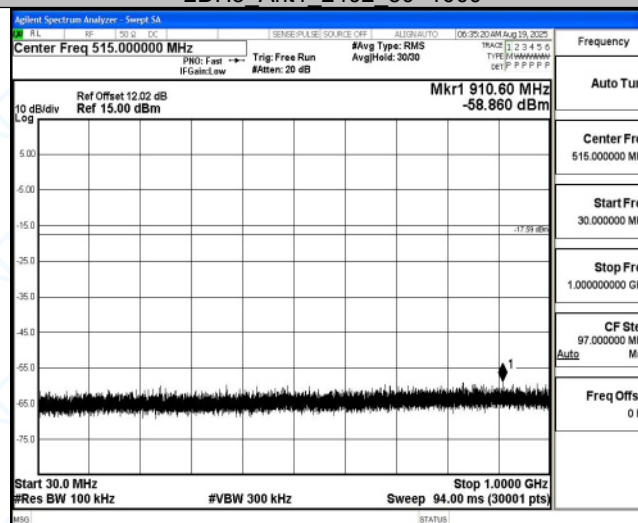
## 2DH5\_Ant1\_2402\_30~1000

| TestMode | Antenna | Freq(MHz) | FreqRange [MHz] | RefLevel [dBm] | Result [dBm] | Limit [dBm] | Verdict |
|---|---|---|---|---|---|---|---|
| | | | 30~1000 | 2.41 | -58.86 | $\leq -17.59$ | PASS |

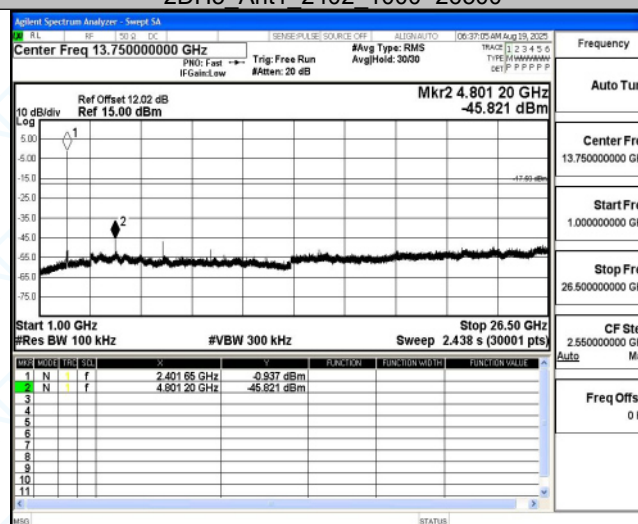
## 2DH5\_Ant1\_2402\_1000~26500

| TestMode | Antenna | Freq(MHz) | FreqRange [MHz] | RefLevel [dBm] | Result [dBm] | Limit [dBm] | Verdict |
|---|---|---|---|---|---|---|---|
| | | | 1000~26500 | 2.41 | -45.82 | $\leq -17.59$ | PASS |

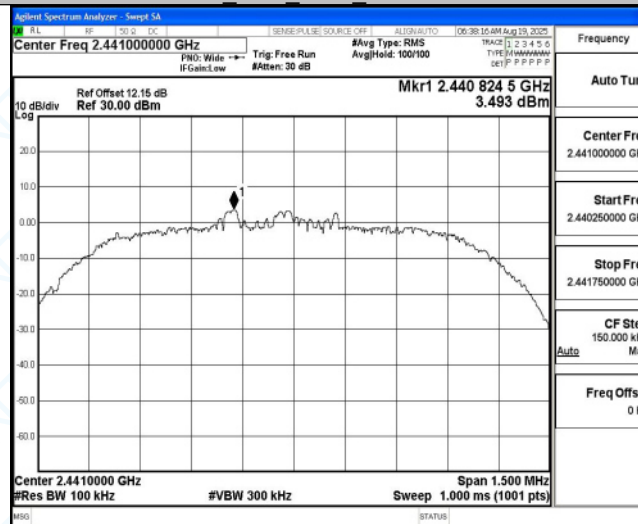
## 2DH5 Ant1 2441 0~Reference

| TestMode | Antenna | Freq(MHz) | FreqRange [MHz] | RefLevel [dBm] | Result [dBm] | Limit [dBm] | Verdict |
|---|---|---|---|---|---|---|---|
| | | 2441 | Reference | 3.49 | 3.49 | --- | PASS |

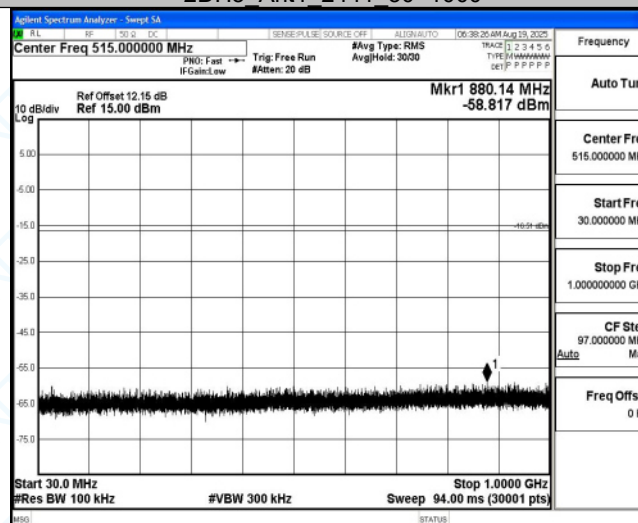
## 2DH5 Ant1 2441 30~1000

| TestMode | Antenna | Freq(MHz) | FreqRange [MHz] | RefLevel [dBm] | Result [dBm] | Limit [dBm] | Verdict |
|---|---|---|---|---|---|---|---|
| | | | 30~1000 | 3.49 | -58.82 | $\leq -16.51$ | PASS |

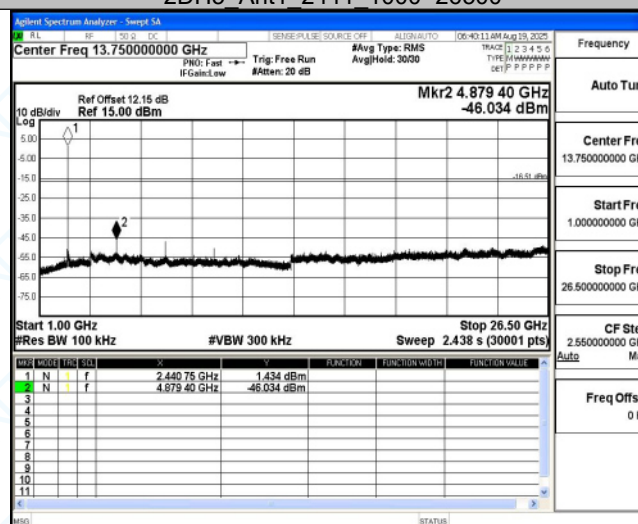
## 2DH5 Ant1 2441 1000~26500

| TestMode | Antenna | Freq(MHz) | FreqRange [MHz] | RefLevel [dBm] | Result [dBm] | Limit [dBm] | Verdict |
|---|---|---|---|---|---|---|---|
| | | | 1000~26500 | 3.49 | -46.03 | $\leq -16.51$ | PASS |

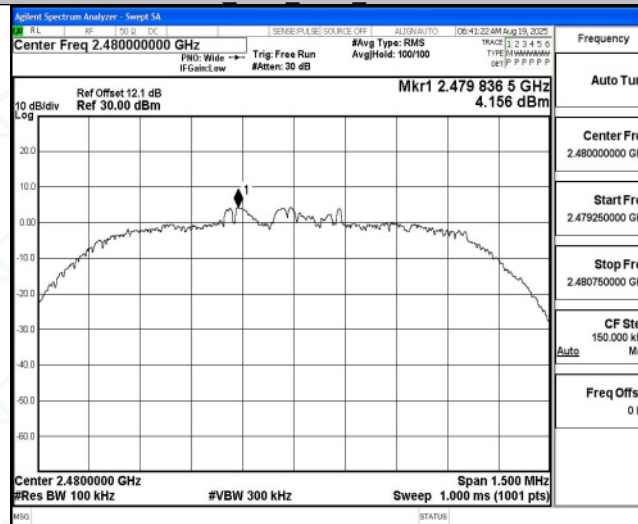
## 2DH5 Ant1 2480 0~Reference

| TestMode | Antenna | Freq(MHz) | FreqRange [MHz] | RefLevel [dBm] | Result [dBm] | Limit [dBm] | Verdict |
|---|---|---|---|---|---|---|---|
| | | 2480 | Reference | 4.16 | 4.16 | --- | PASS |

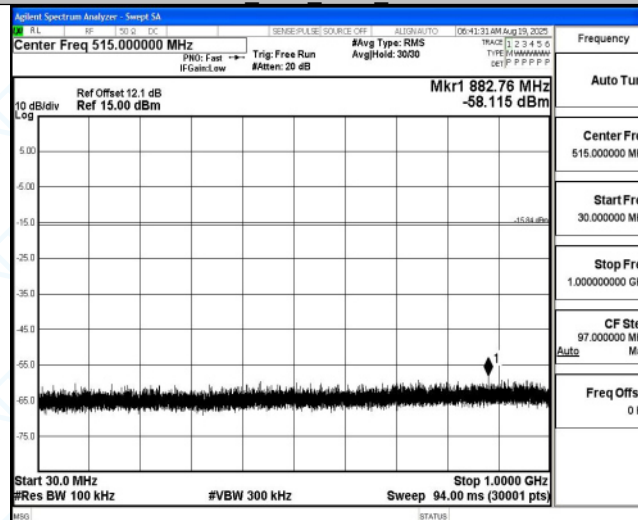
## 2DH5 Ant1 2480 30~1000

| TestMode | Antenna | Freq(MHz) | FreqRange [MHz] | RefLevel [dBm] | Result [dBm] | Limit [dBm] | Verdict |
|---|---|---|---|---|---|---|---|
| | | | 30~1000 | 4.16 | -58.12 | $\leq -15.84$ | PASS |

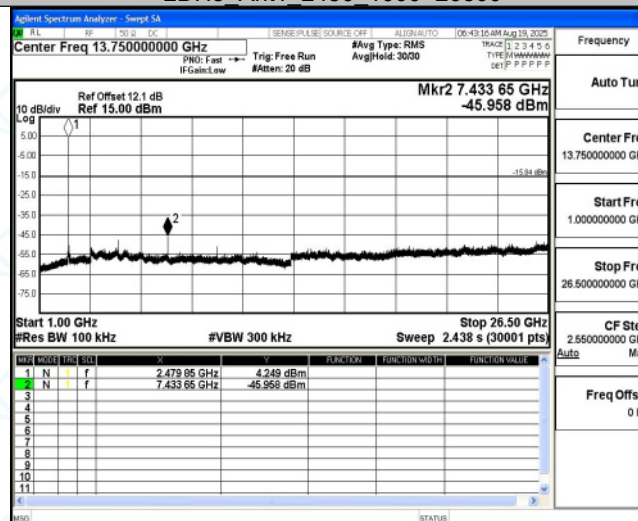
## 2DH5 Ant1 2480 1000~26500

| TestMode | Antenna | Freq(MHz) | FreqRange [MHz] | RefLevel [dBm] | Result [dBm] | Limit [dBm] | Verdict |
|---|---|---|---|---|---|---|---|
| | | | 1000~26500 | 4.16 | -45.96 | $\leq -15.84$ | PASS |
