APPENDIX 3: Photographs of test setup

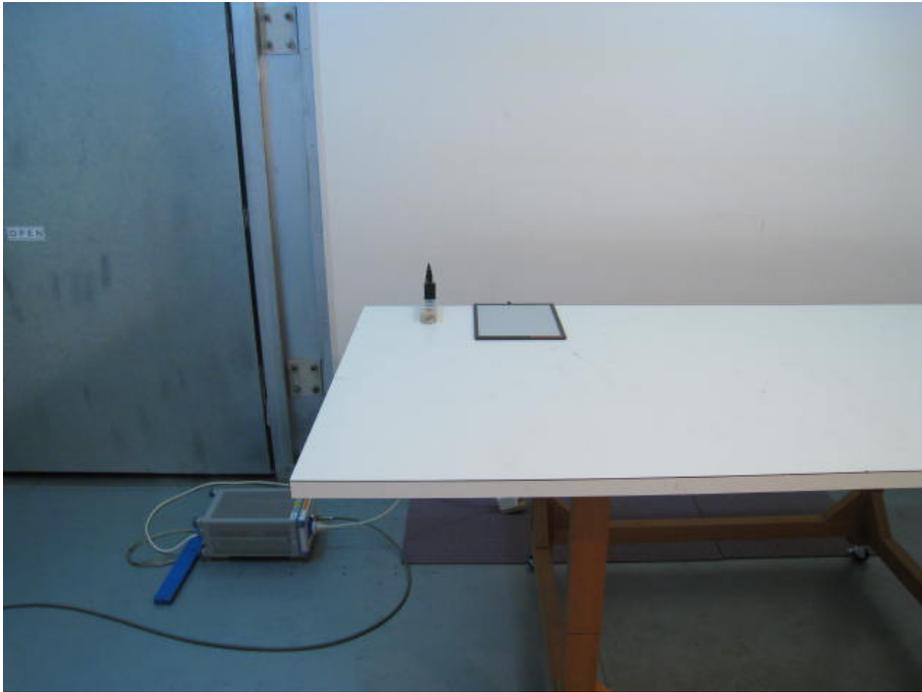
Photo 1

Conducted Emission

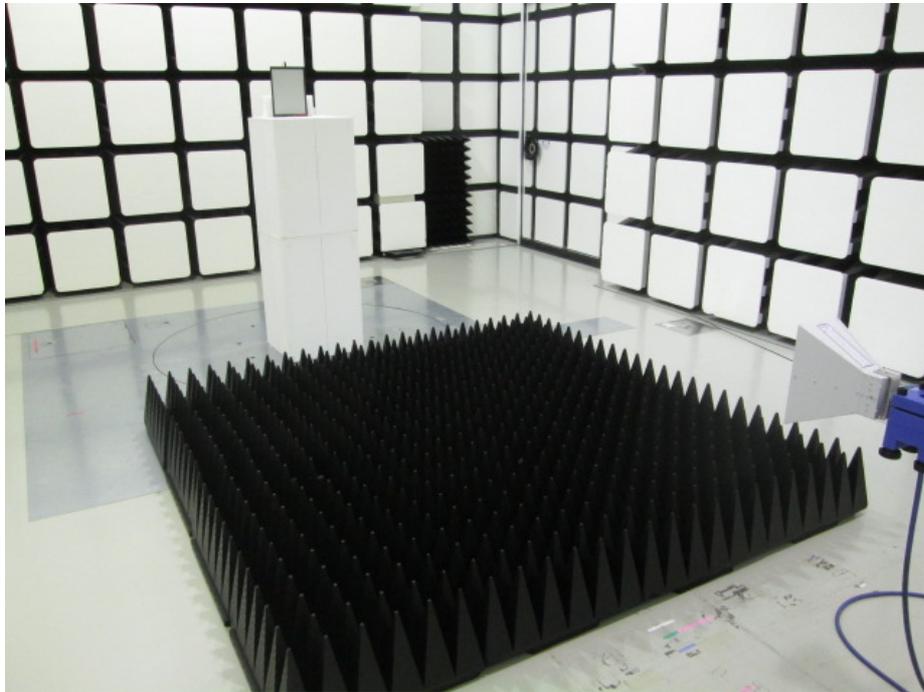
Photo 1

Radiated Spurious Emission

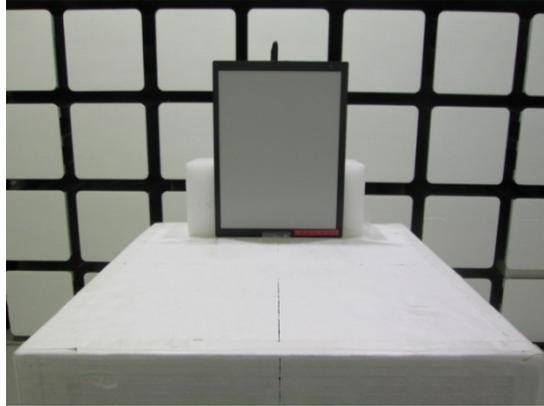
X-axis

Worst Case Position

(Horizontal: X-axis/ Vertical:Y-axis)
