APPENDIX 3: Photographs of test setup

Conducted Emission

Radiated Emission

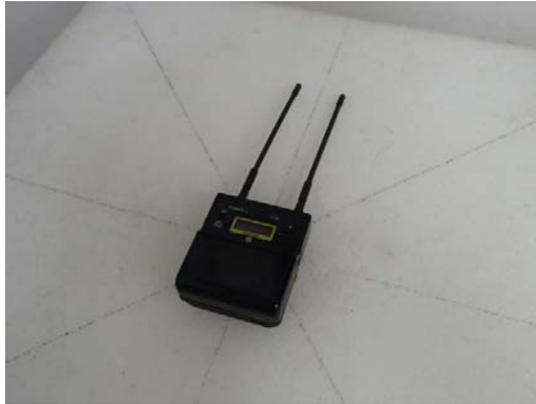
X-axis

Worst Case Position

Receiver

**Below 30 MHz (Receiver: Z-Axis / MODE: USB)
Above 30 MHz (Receiver: (Horizontal: Y-Axis / Vertical: Y-Axis) /
MODE: MI-Shoe power Supply)**

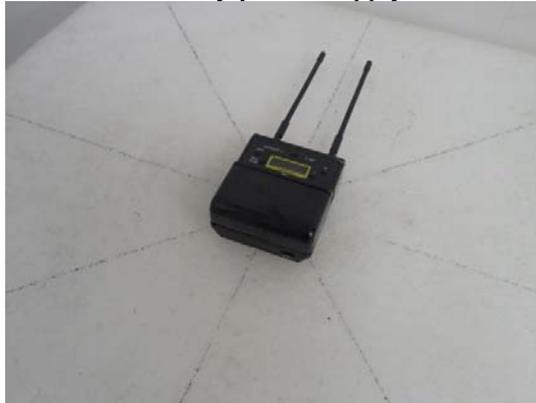
Battery power Supply

MODE

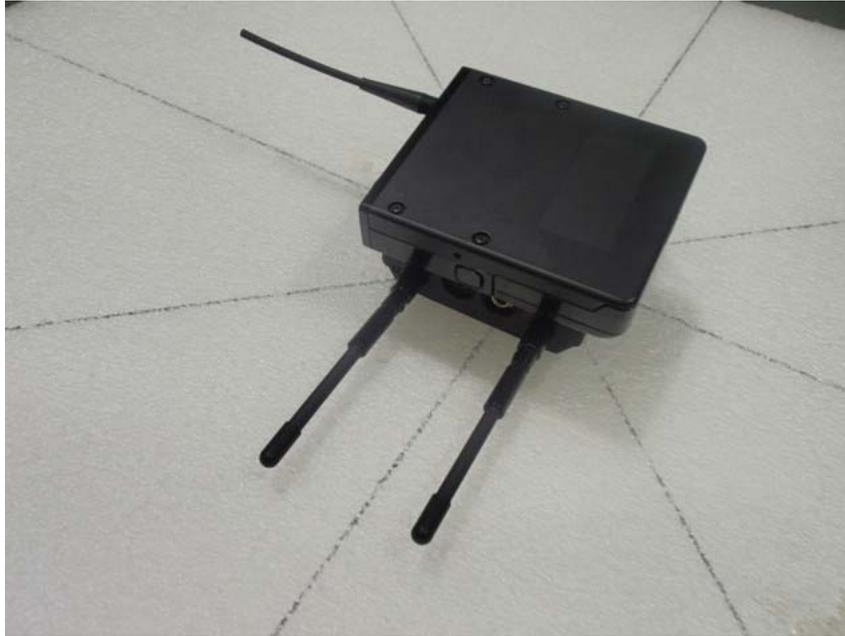
With Tag

Worst Case Position
