APPENDIX 3: Photographs of test setup

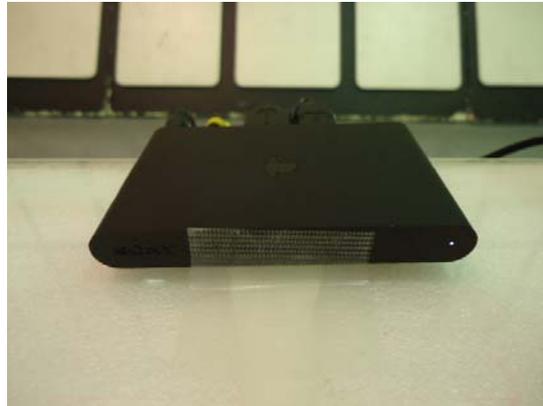
X-axis

Worst Case Position
Above 1GHz(Horizontal: Z-axis/ Vertical:Y-axis)
Below 1GHz(Horizontal: Y-axis/ Vertical:Y-axis)
