APPENDIX 3: Photographs of test setup

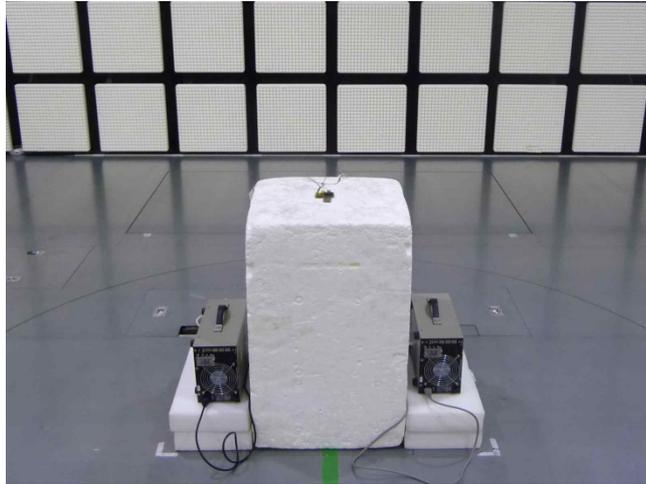
Front

Radiated Spurious Emission

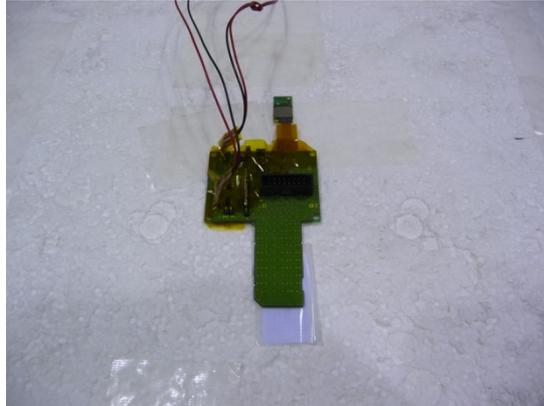
X-axis

Worst Case Position (Horizontal: X-axis/ Vertical:X-axis)
