A.4 DWELL TIME

UTTR-RF-FCCPART15.247-V1.1

A.5 NUMBER OF HOPPING CHANNEL

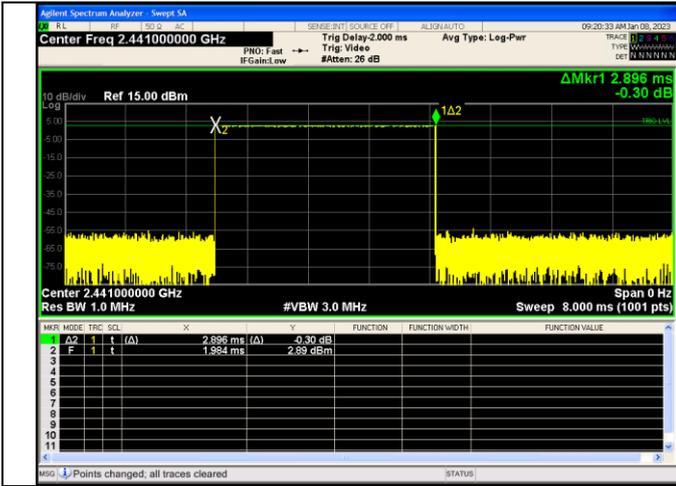
**Pulse Width
GFSK_DH5**

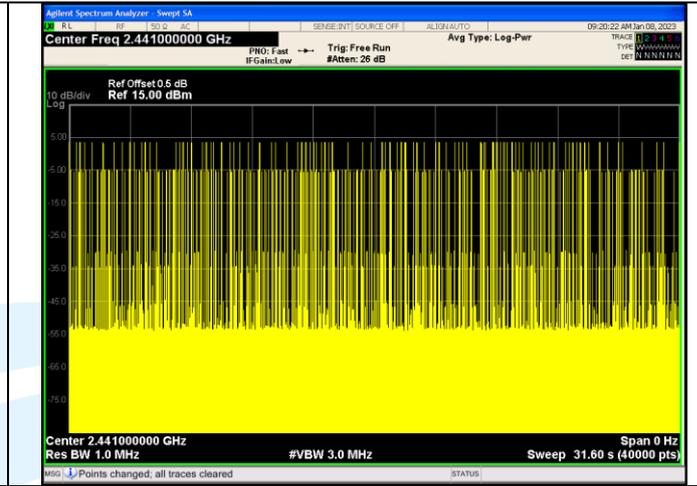
**Number of Pulses in 31.6 seconds
GFSK_DH5**

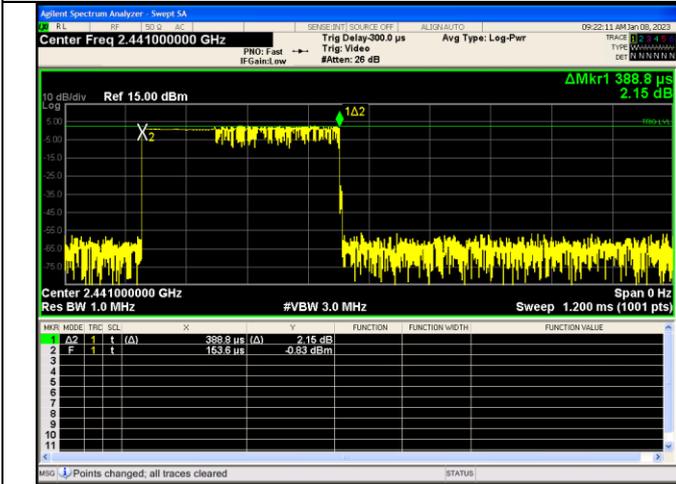
**Pulse Width
π/4DQPSK_2-DH1**

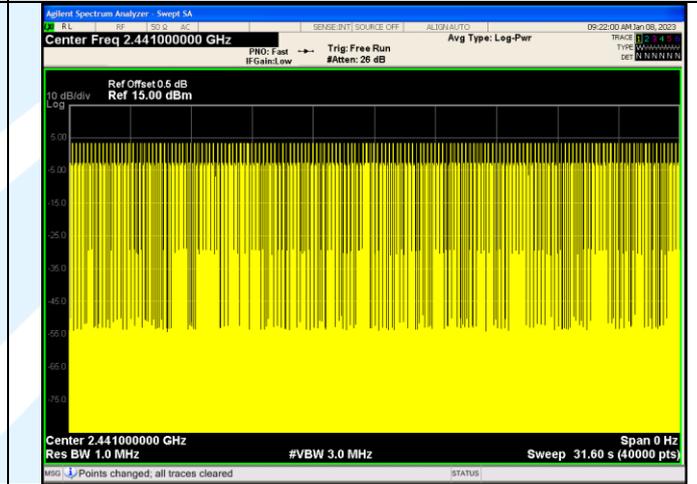
**Number of Pulses in 31.6 seconds
π/4DQPSK_2-DH1**

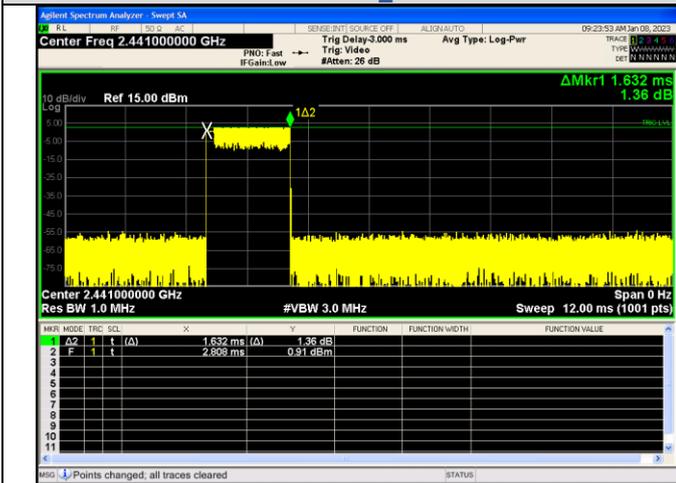
**Pulse Width
π/4DQPSK_2-DH3**

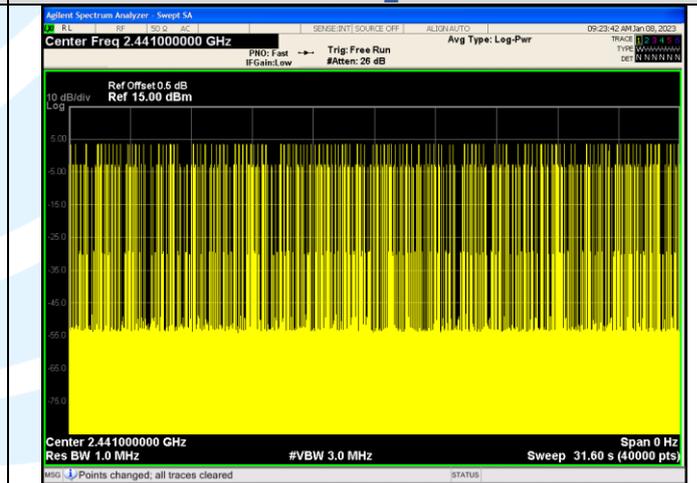
**Number of Pulses in 31.6 seconds
π/4DQPSK_2-DH3**

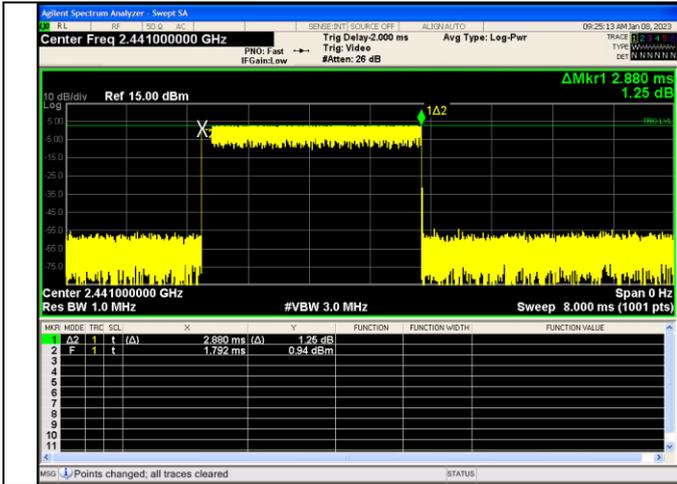
Pulse Width
 $\pi/4$ DQPSK 2-DH5

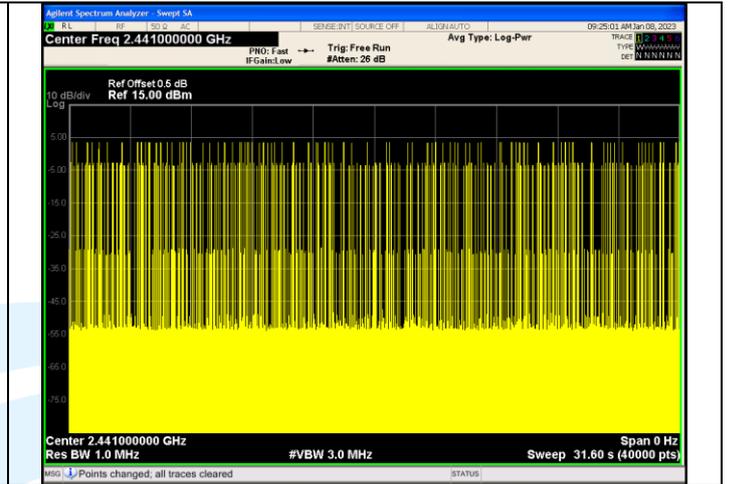
Number of Pulses in 31.6 seconds
 $\pi/4$ DQPSK 2-DH5

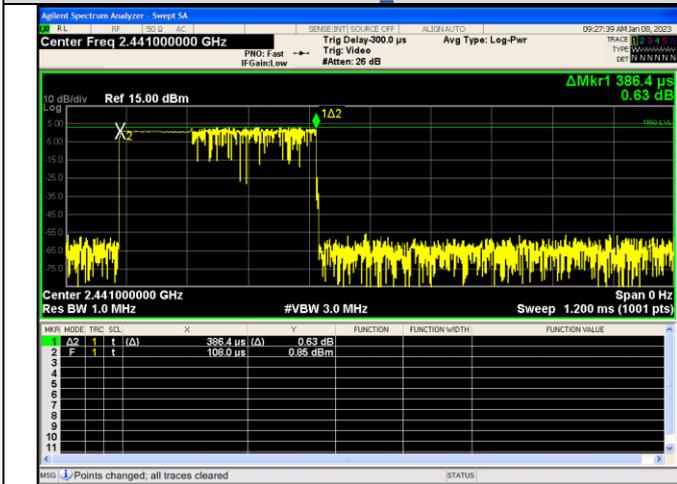
Pulse Width
8DPSK 3-DH1

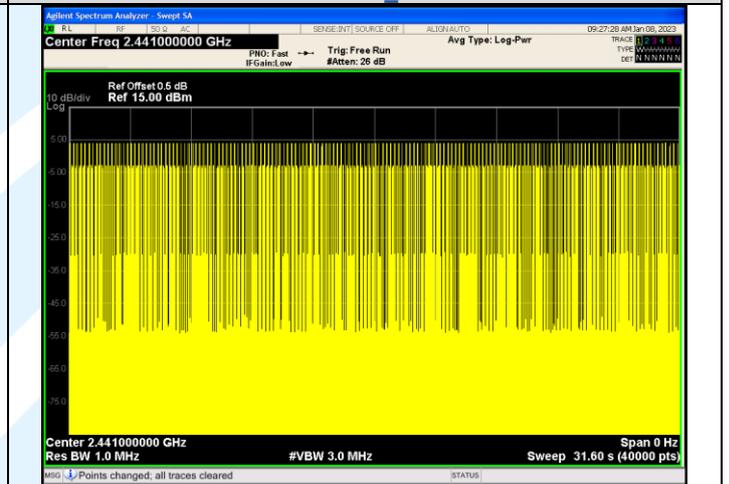
Number of Pulses in 31.6 seconds
8DPSK 3-DH1

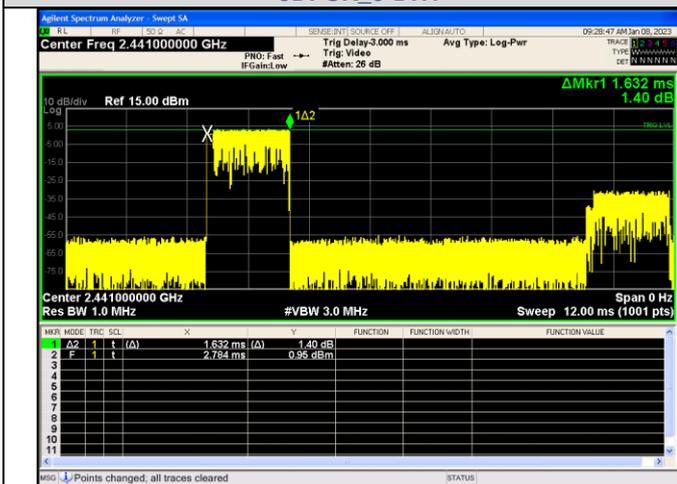
Pulse Width
8DPSK 3-DH3

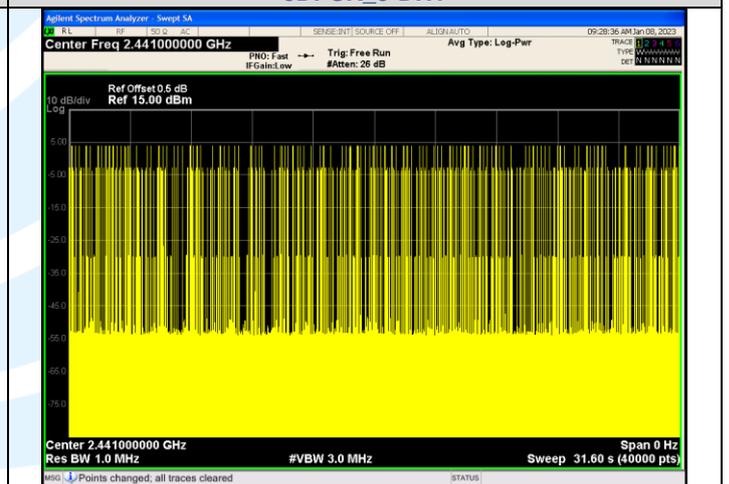
Number of Pulses in 31.6 seconds
8DPSK 3-DH3

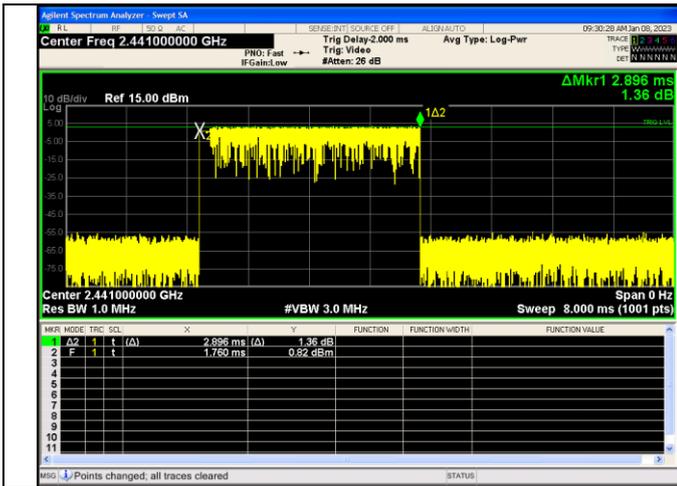
Pulse Width
8DPSK_3-DH5

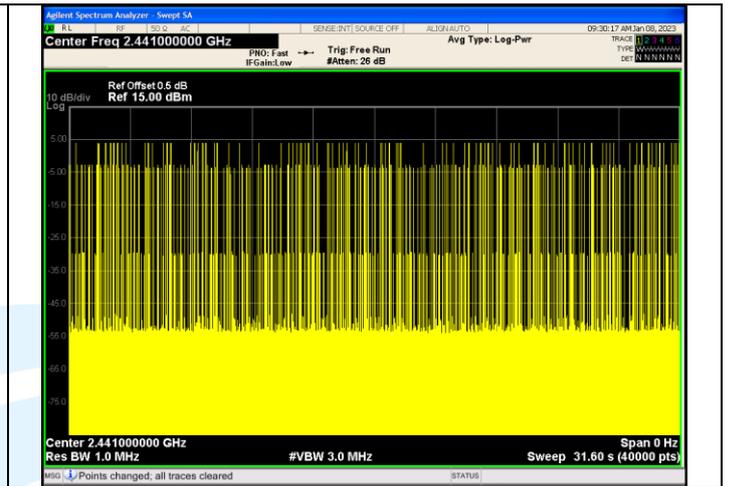
Number of Pulses in 31.6 seconds
8DPSK_3-DH5

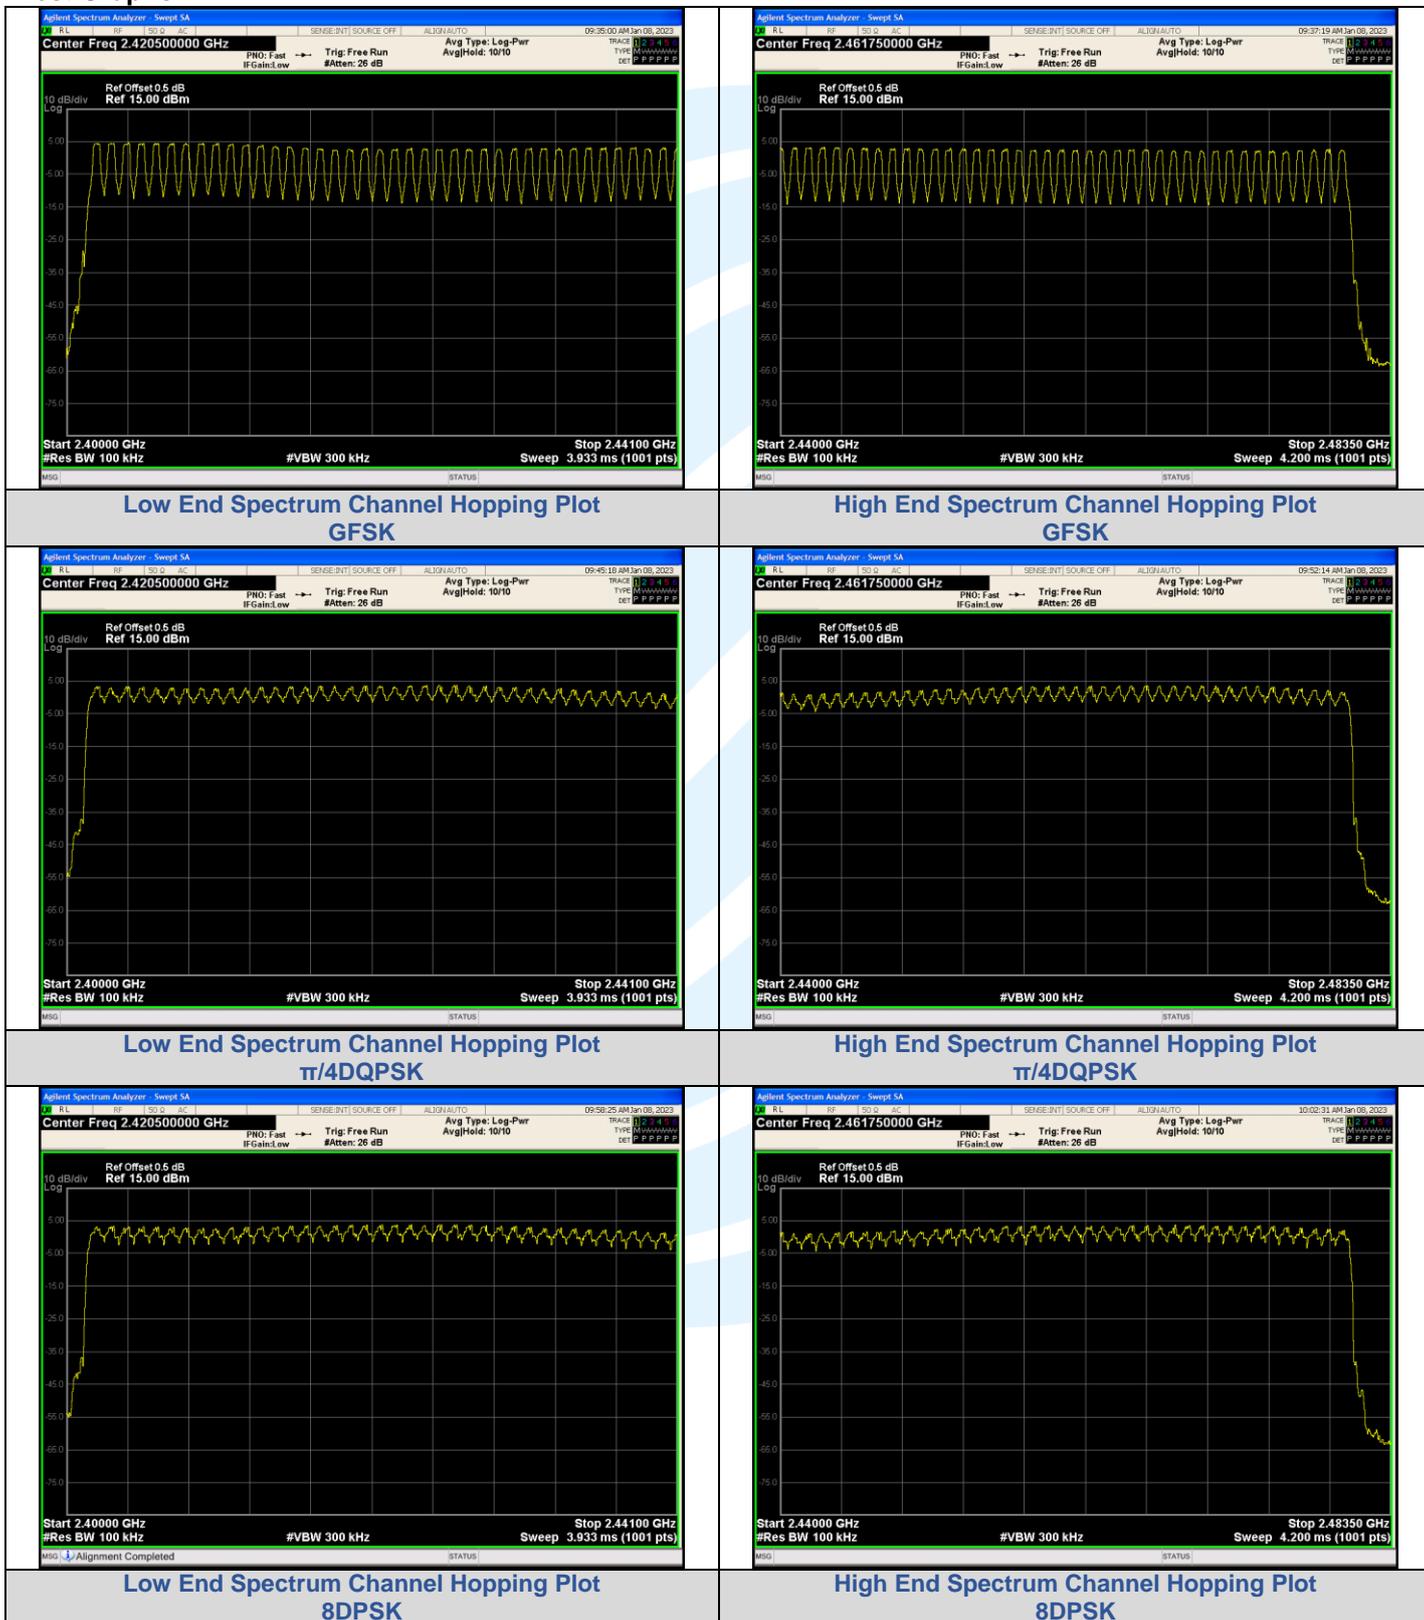
Modulation	Packet	Number of Hopping Channel	Result
GFSK	DH5	79	PASS
$\pi/4$ DQPSK	2-DH5	79	PASS
8DPSK	3-DH5	79	PASS
