### **APPENDIX 3: Photographs of test setup**

#### **Radiated emission**

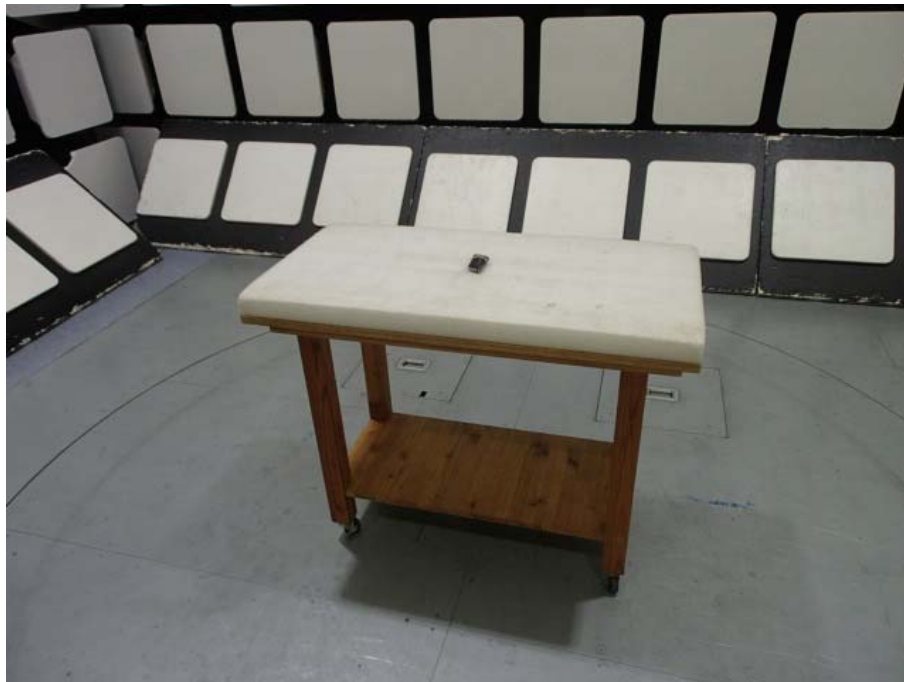
**Photo 1**

Below 1GHz

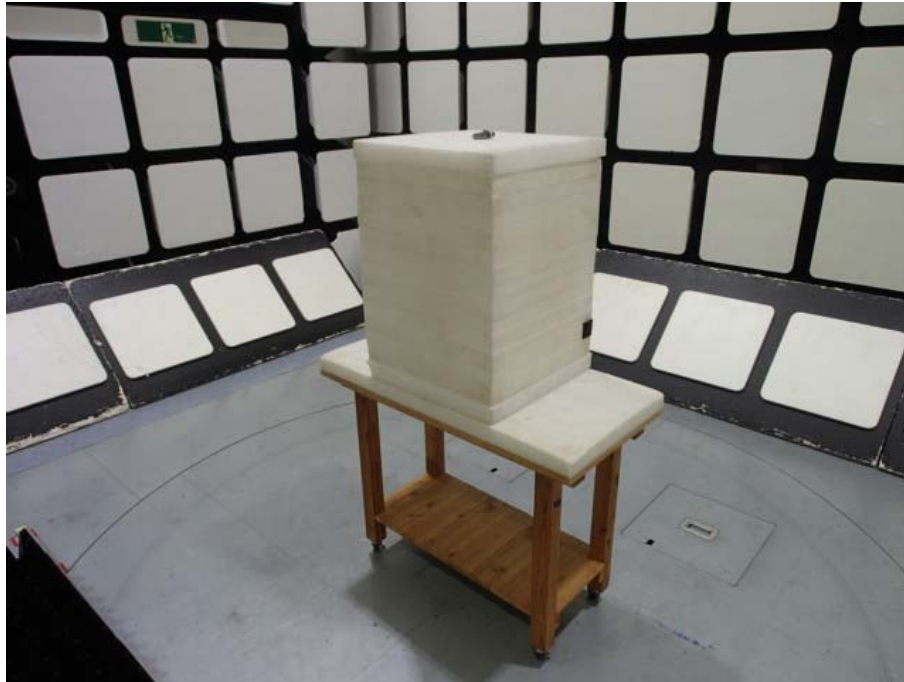
**Photo 1**

**Radiated emission**  
Above 1GHz

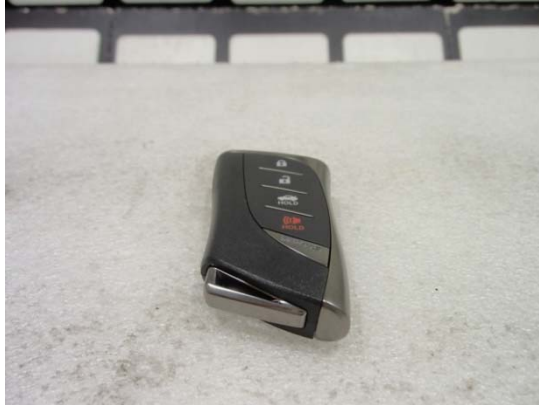
**X-axis**

Below 1GHz Horizontal: X-axis / Vertical: Y-axis  
Above 1GHz Horizontal: X-axis / Vertical: X-axis

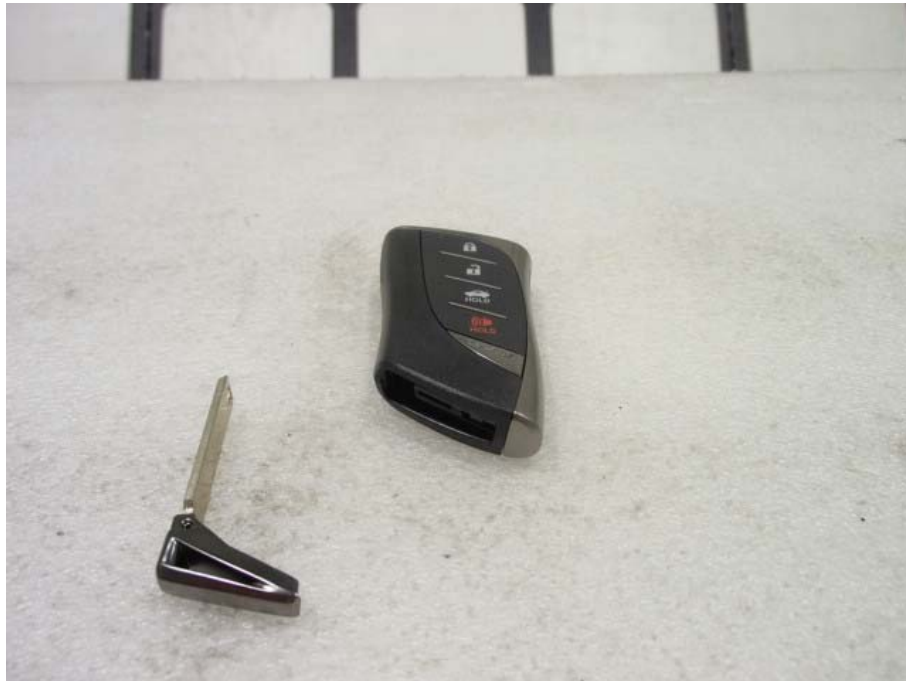
**Mechanical Key (Not Inserted)**

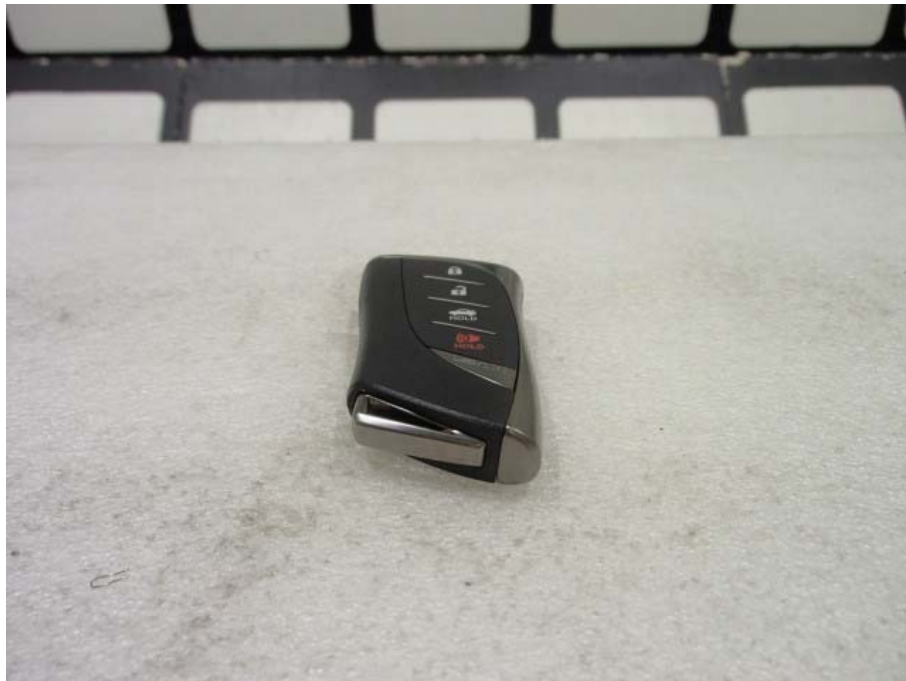
**Mechanical Key (Inserted) Worst**
