**Application for Certification  
For an RF amplifier**

**RF amplifier**

**FCC ID: RFK-LMSWDJHNEX**

**REPORT # RV58031A-001**

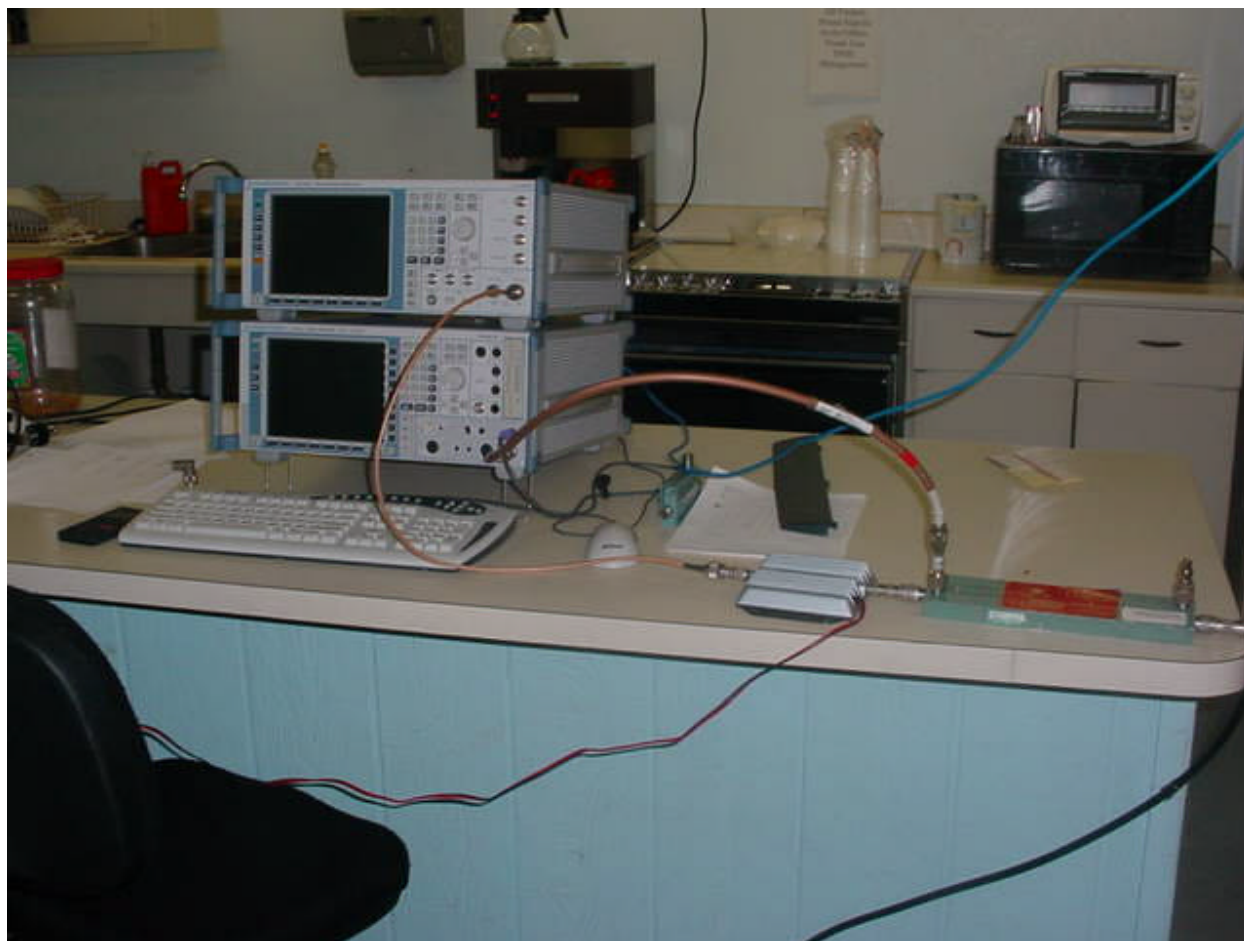
FIGURE 3: TEST SET UP BLOCK DIAGRAM FOR RF POWER OUTPUT, EMISSIONS LIMITATIONS GSM/TDMA, OCCUPIED BANDWIDTH GSM/TDMA, CONDUCTED SPURIOUS EMISSIONS AT ANTENNA TERMINALS.

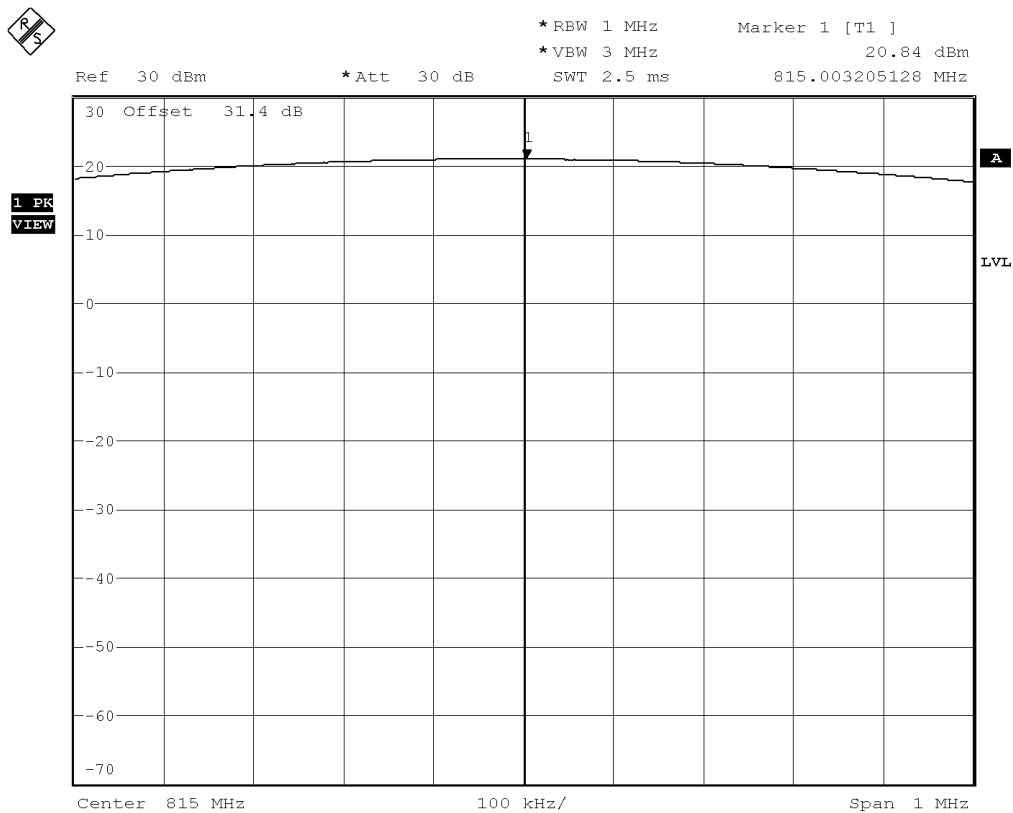
FIGURE 5: OUTPUT POWER PLOTS, UPLINK.

5969 Robinson Avenue Riverside, CA 92503 (951) 637-2630 FAX (951) 637-2704	<b>Output Power</b>	
DNB Job Number:	RV58031A	Date: 11 Sep 2004	<b>Conformance Standards</b> [X] FCC Part 24 [X] FCC Part 90 [X] IC RSS-131 Cl 4.3
Customer:	Janizary Holdings Inc		
Model Number:	LMSWDJHNEX	Serial Number:	
Description:	RF amplifier		
	Uplink 815MHz

Output Power is measured across a precision 50 ohm load with a Spectrum Analyzer. For the power measurement, CW (no modulation) is used. CW signal provided maximum emissions signature for all modulation types.

Frequency in MHz	Power (dBm)	Power (W)
806-824	20.84	0.121
851-869	0.25	0.00106
1860-1910	24.16	0.261
1930-1980	0.22	0.00105

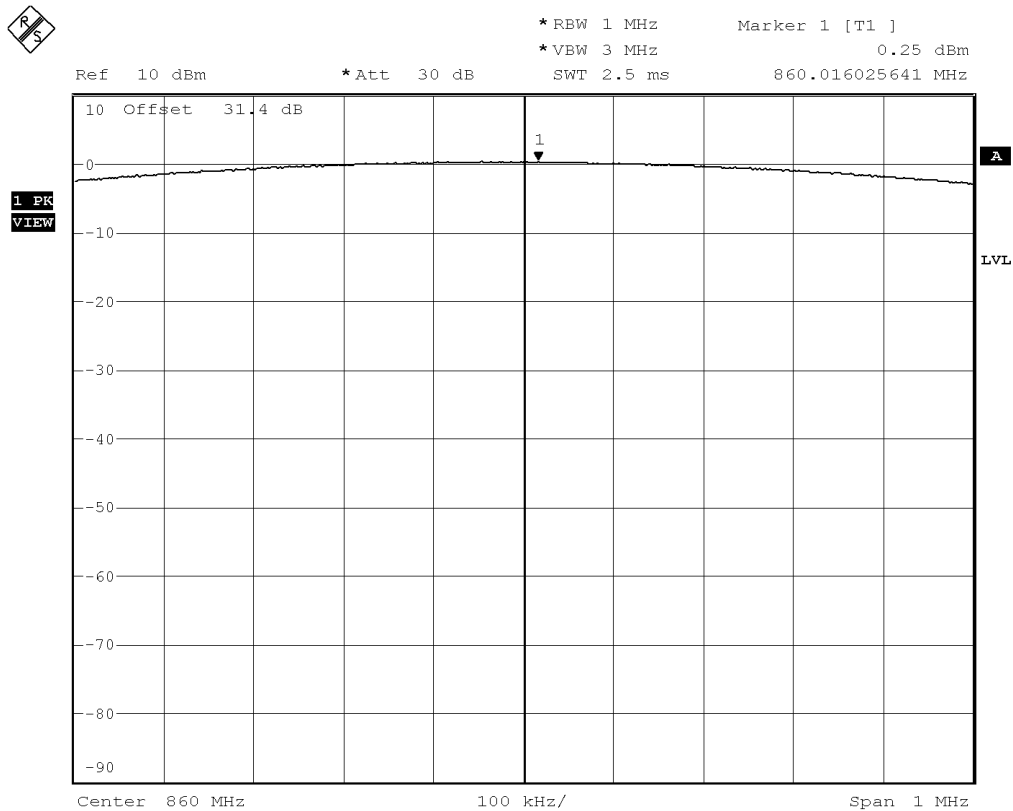
FIGURE 5: OUTPUT POWER PLOTS, UPLINK.

5969 Robinson Avenue Riverside, CA 92503 (951) 637-2630 FAX (951) 637-2704	<b>Output Power</b>	
DNB Job Number:	RV58031A	Date: 11 Sep 2004	<b>Conformance Standards</b>  [X] FCC Part 24 [X] FCC Part 90 [X] IC RSS-131 Cl 4.3
Customer:	Janizary Holdings Inc		
Model Number:	LMSWDJHNEX	Serial Number:	
Description:	RF amplifier		
	Downlink 860MHz

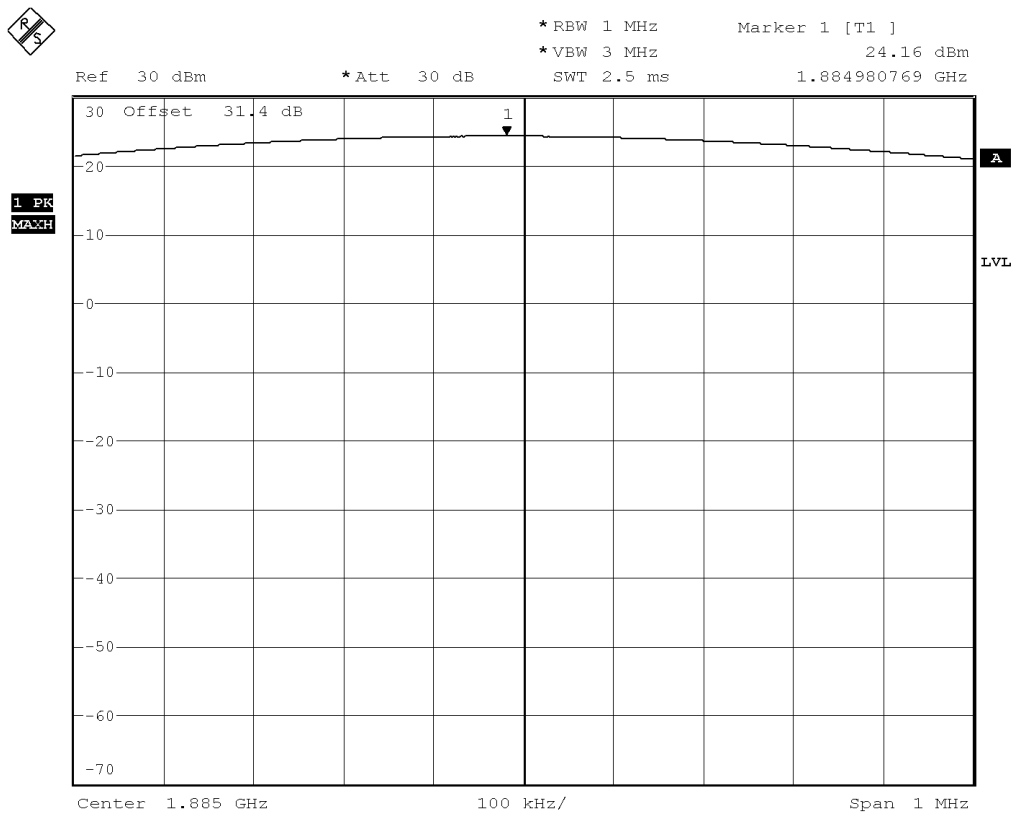
FIGURE 5: OUTPUT POWER PLOTS, UPLINK.

5969 Robinson Avenue Riverside, CA 92503 (951) 637-2630 FAX (951) 637-2704	<b>Output Power</b>	
DNB Job Number:	RV58031A	Date: 11 Sep 2004	<b>Conformance Standards</b> [X] FCC Part 24 [X] FCC Part 90 [X] IC RSS-131 Cl 4.3
Customer:	Janizary Holdings Inc		
Model Number:	LMSWDJHNEX	Serial Number:	
Description:	RF amplifier		
	Uplink 1885MHz

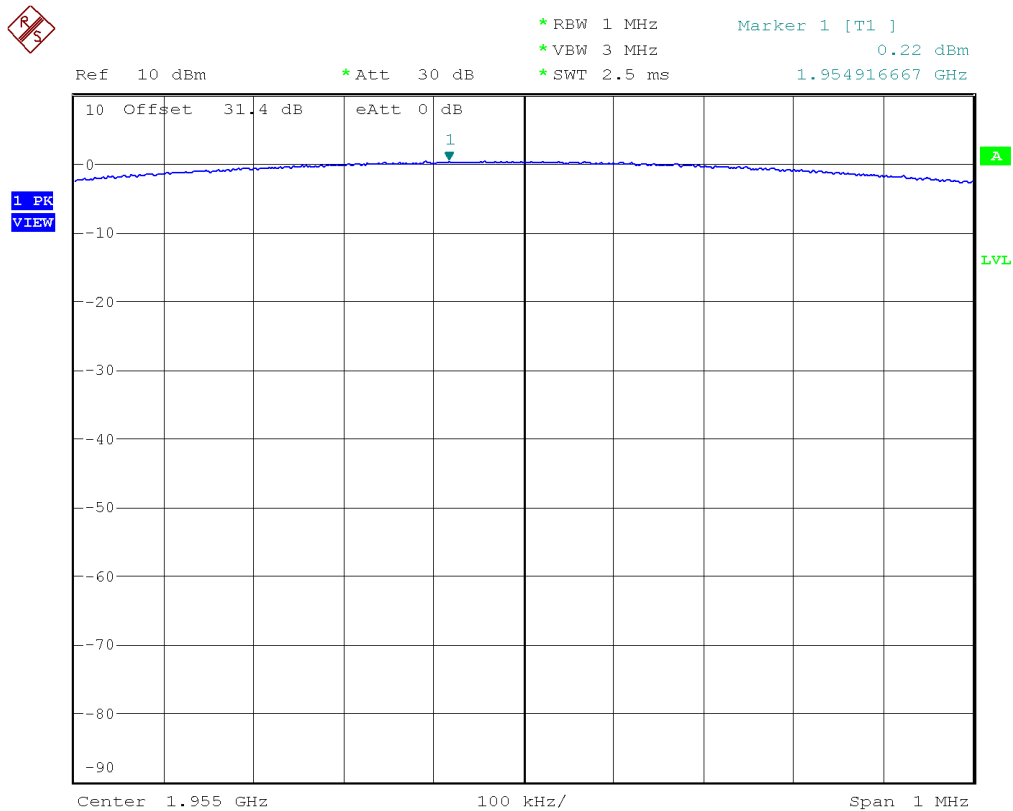
FIGURE 5: OUTPUT POWER PLOTS, UPLINK.

5969 Robinson Avenue Riverside, CA 92503 (951) 637-2630 FAX (951) 637-2704	<b>Output Power</b>	
DNB Job Number:	RV58031A	Date: 11 Sep 2004	<b>Conformance Standards</b> [X] FCC Part 24 [X] FCC Part 90 [X] IC RSS-131 Cl 4.3
Customer:	Janizary Holdings Inc		
Model Number:	LMSWDJHNEX	Serial Number:	
Description:	RF amplifier		
	Downlink 1910MHz

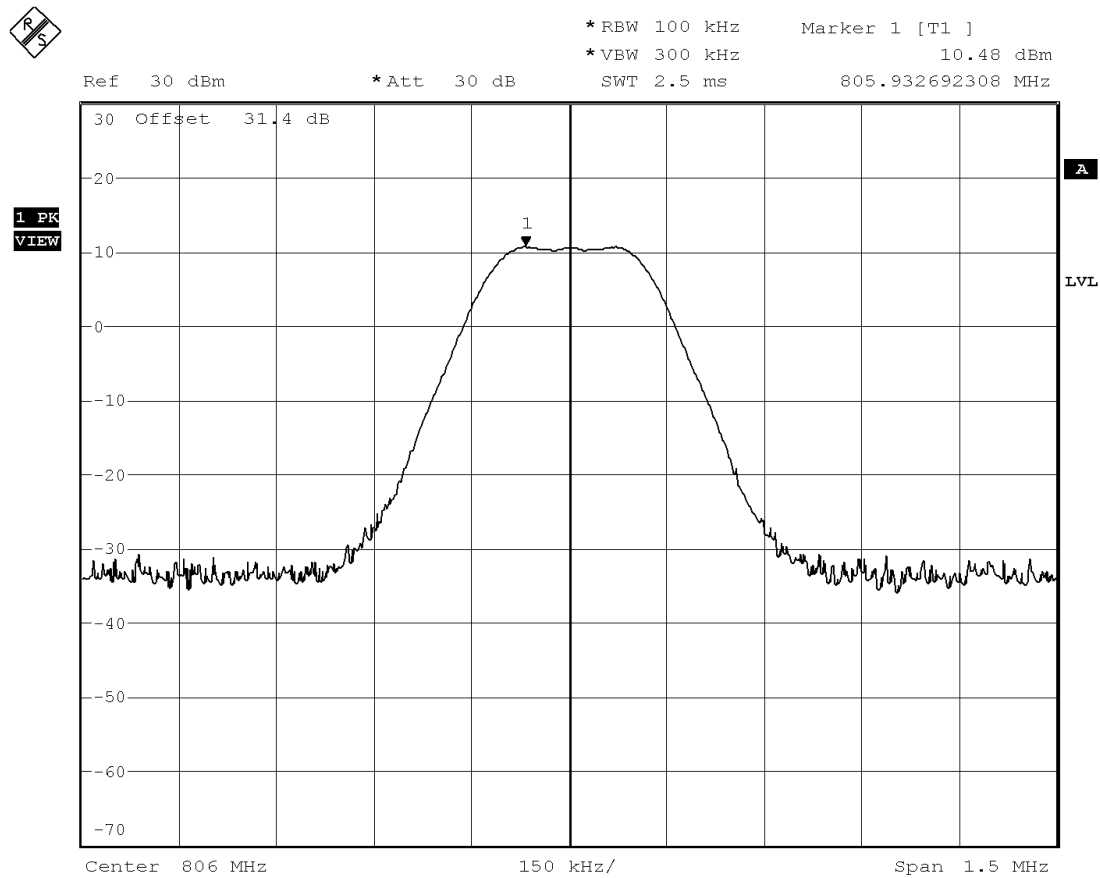
FIGURE 6: OCCUPIED BANDWIDTH

5969 Robinson Avenue Riverside, CA 92503 (951) 637-2630 FAX (951) 637-2704	<b>Occupied Bandwidth</b>	
DNB Job Number:	RV58031A	Date: 11 Sep 2004	<b>Conformance Standards</b>  [X] FCC Part 24 [X] FCC Part 90 [X] IC RSS-131 Cl 4.2
Customer:	Janizary Holdings Inc		
Model Number:	LMSWDJHNEX	Serial Number:	
Description:	RF amplifier		
	Uplink		
	Signal Source - GSM – Input – 806MHz

The center frequency of the signal did not shift with modulation. The Spectrum Bandwidth was well within the limits specified in the FCC Regulations.

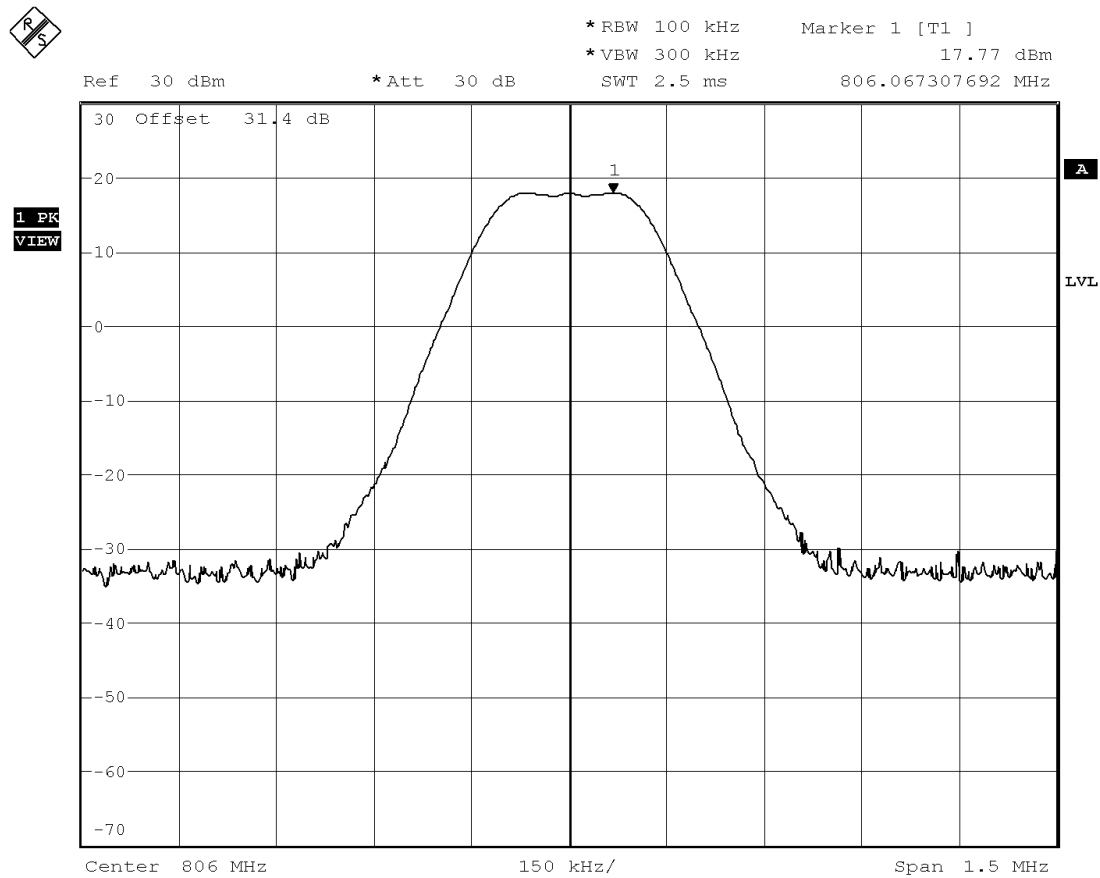
FIGURE 6: OCCUPIED BANDWIDTH

5969 Robinson Avenue Riverside, CA 92503 (951) 637-2630 FAX (951) 637-2704	<b>Occupied Bandwidth</b>	
DNB Job Number:	RV58031A	Date: 11 Sep 2004	<b>Conformance Standards</b>  [X] FCC Part 24 [X] FCC Part 90 [X] IC RSS-131 Cl 4.2
Customer:	Janizary Holdings Inc		
Model Number:	LMSWDJHNEX	Serial Number:	
Description:	RF amplifier		
	Uplink		
	Signal Source - GSM – Output – 806MHz

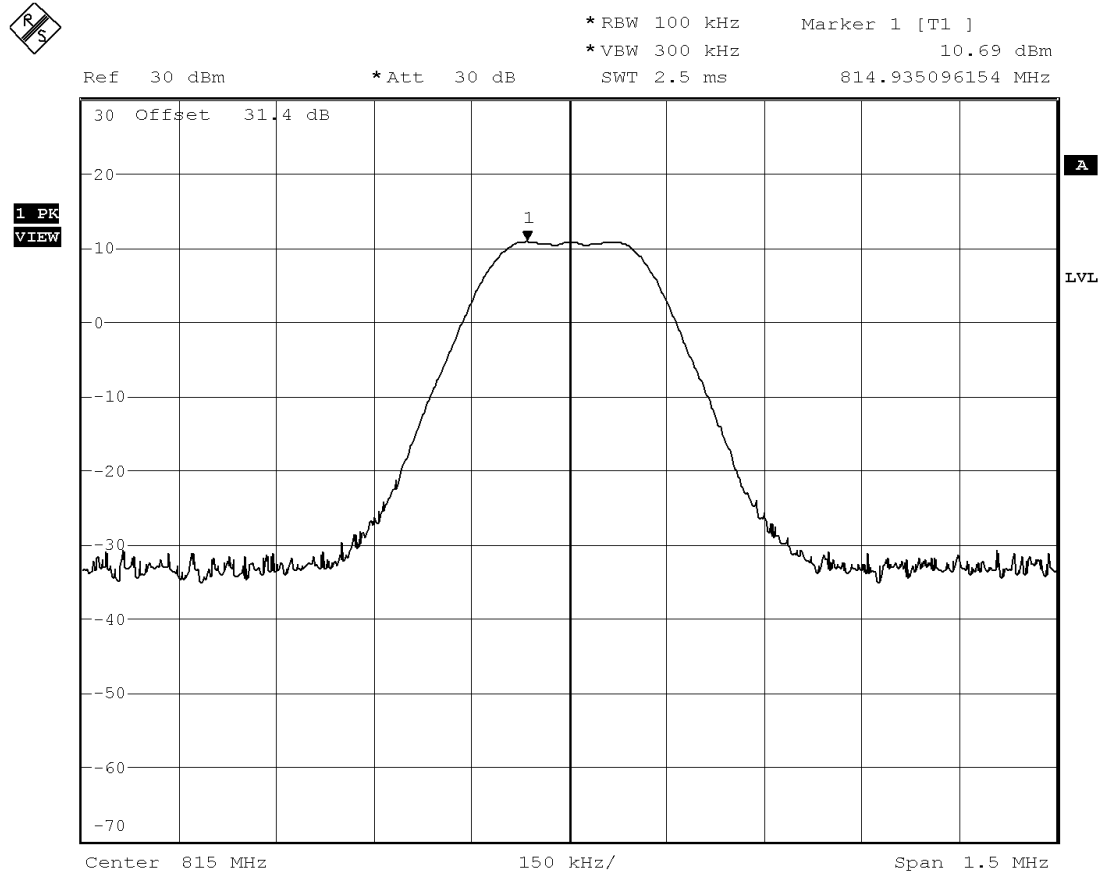
FIGURE 6: OCCUPIED BANDWIDTH

5969 Robinson Avenue Riverside, CA 92503 (951) 637-2630 FAX (951) 637-2704	<b>Occupied Bandwidth</b>	
DNB Job Number:	RV58031A	Date: 11 Sep 2004	<b>Conformance Standards</b>  [X] FCC Part 24 [X] FCC Part 90 [X] IC RSS-131 Cl 4.2
Customer:	Janizary Holdings Inc		
Model Number:	LMSWDJHNEX	Serial Number:	
Description:	RF amplifier		
	Uplink		
	Signal Source - GSM – Input – 815MHz

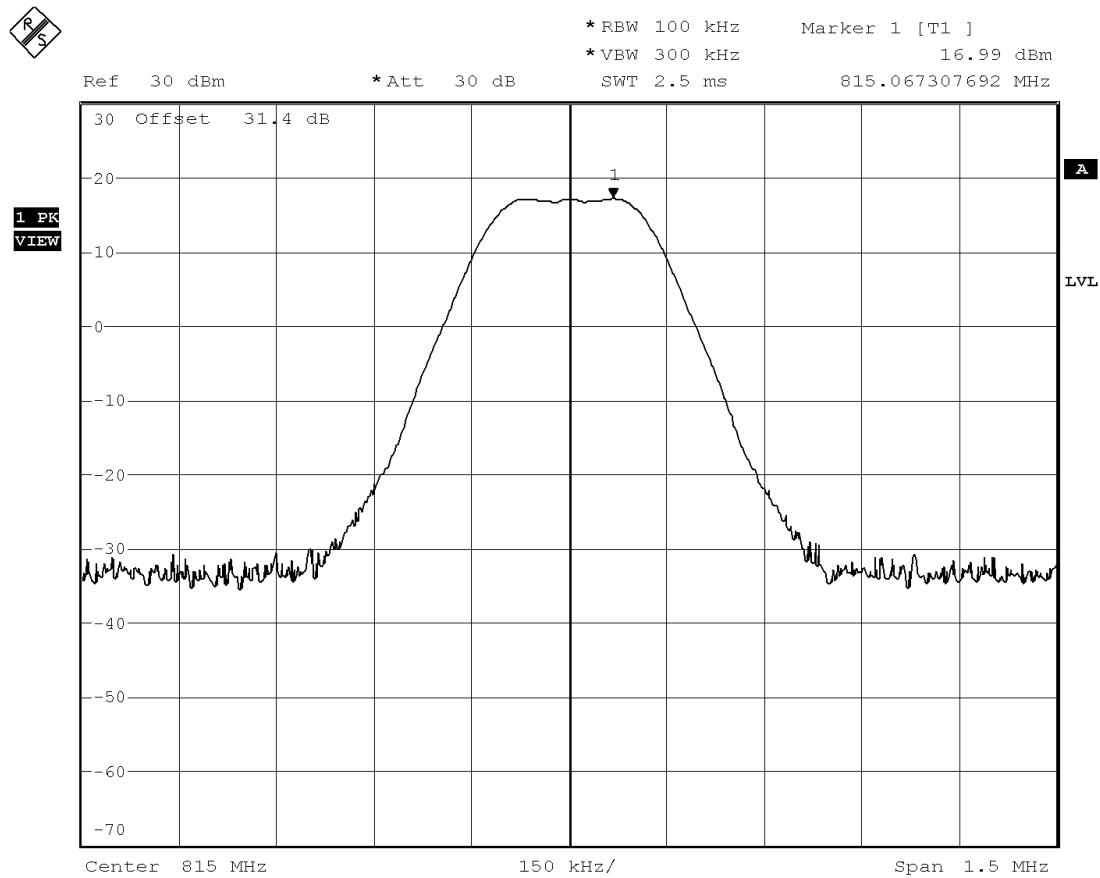
FIGURE 6: OCCUPIED BANDWIDTH

5969 Robinson Avenue Riverside, CA 92503 (951) 637-2630 FAX (951) 637-2704	<b>Occupied Bandwidth</b>	
DNB Job Number:	RV58031A	Date: 11 Sep 2004	<b>Conformance Standards</b>  [X] FCC Part 24 [X] FCC Part 90 [X] IC RSS-131 Cl 4.2
Customer:	Janizary Holdings Inc		
Model Number:	LMSWDJHNEX	Serial Number:	
Description:	RF amplifier		
	Uplink		
	Signal Source - GSM – Output – 815MHz

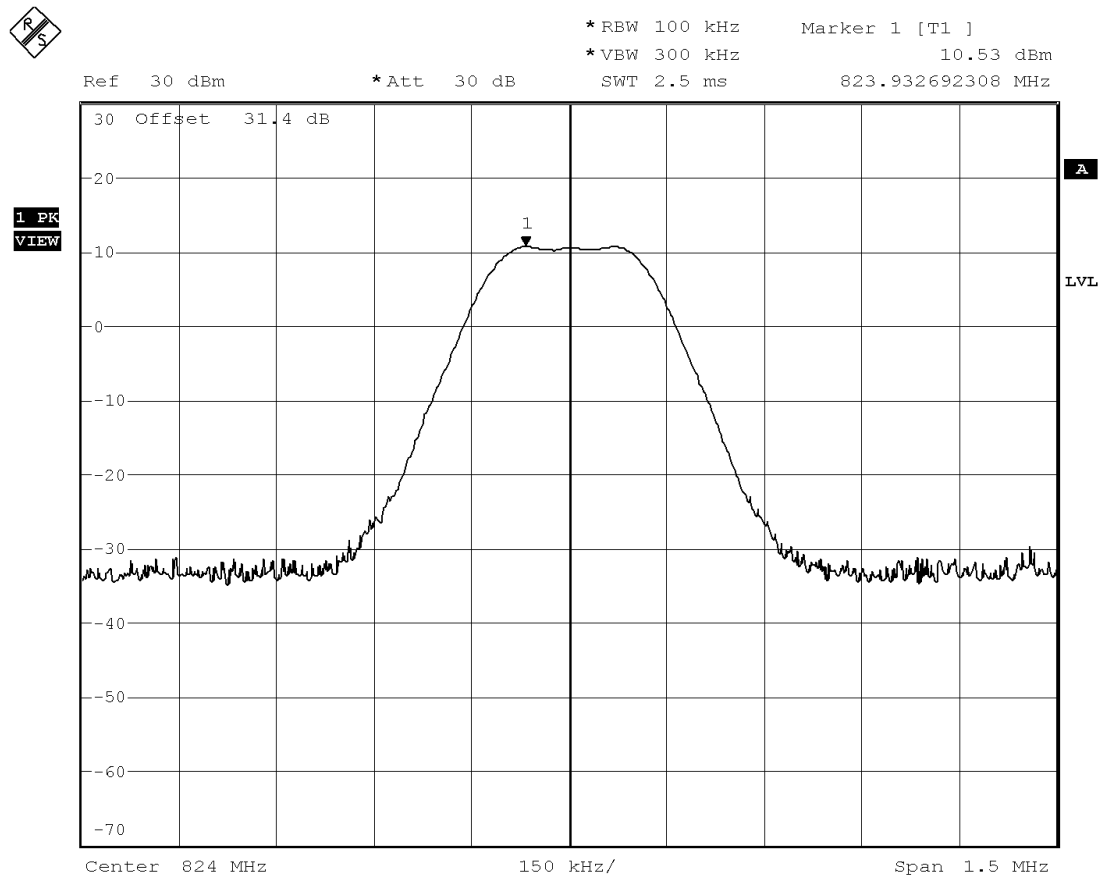
FIGURE 6: OCCUPIED BANDWIDTH

5969 Robinson Avenue Riverside, CA 92503 (951) 637-2630 FAX (951) 637-2704	<b>Occupied Bandwidth</b>	
DNB Job Number:	RV58031A	Date: 11 Sep 2004	<b>Conformance Standards</b>  [X] FCC Part 24 [X] FCC Part 90 [X] IC RSS-131 Cl 4.2
Customer:	Janizary Holdings Inc		
Model Number:	LMSWDJHNEX	Serial Number:	
Description:	RF amplifier		
	Uplink		
	Signal Source - GSM – Input – 824MHz

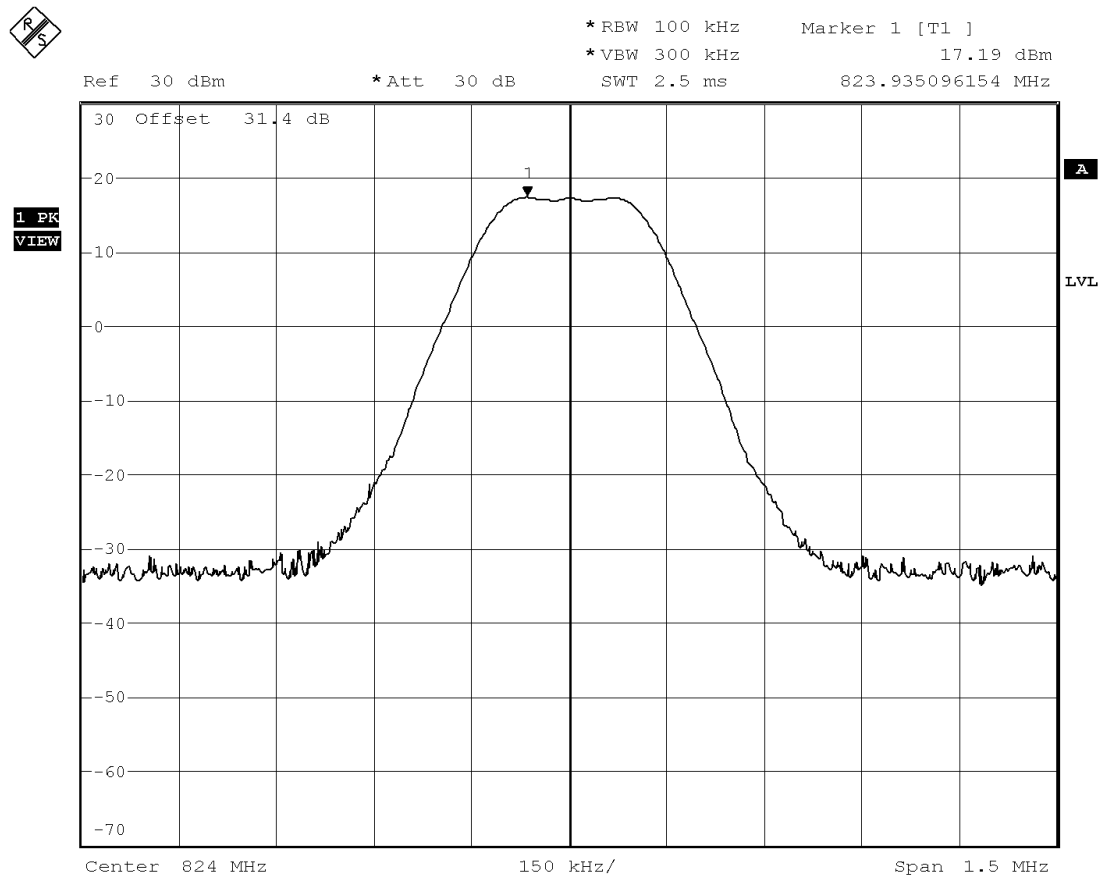
FIGURE 6: OCCUPIED BANDWIDTH

5969 Robinson Avenue Riverside, CA 92503 (951) 637-2630 FAX (951) 637-2704	<b>Occupied Bandwidth</b>	
DNB Job Number:	RV58031A	Date: 11 Sep 2004	<b>Conformance Standards</b>  [X] FCC Part 24 [X] FCC Part 90 [X] IC RSS-131 Cl 4.2
Customer:	Janizary Holdings Inc		
Model Number:	LMSWDJHNEX	Serial Number:	
Description:	RF amplifier		
	Uplink		
	Signal Source - GSM – Output – 824MHz

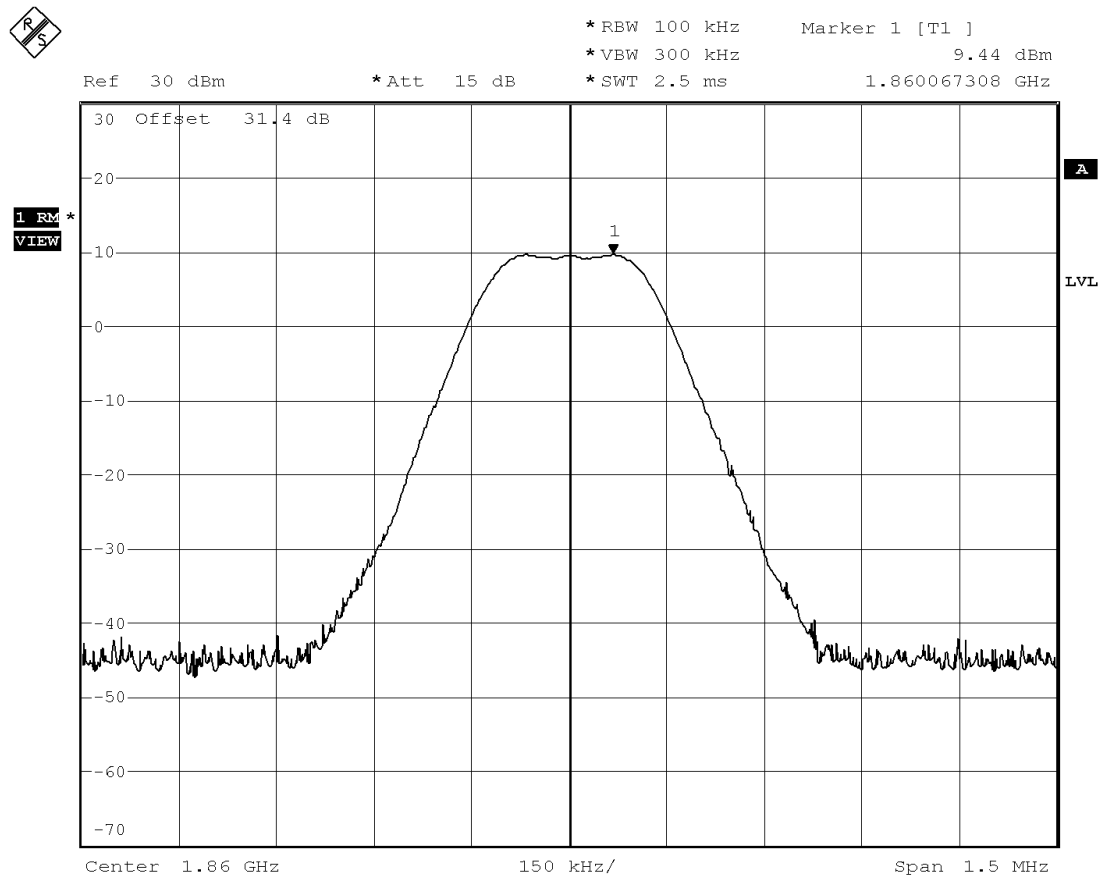
FIGURE 6: OCCUPIED BANDWIDTH

5969 Robinson Avenue Riverside, CA 92503 (951) 637-2630 FAX (951) 637-2704	<b>Occupied Bandwidth</b>	
DNB Job Number:	RV58031A	Date: 8 Sep 2004	<b>Conformance Standards</b>  [X] FCC Part 24 [X] FCC Part 90 [X] IC RSS-131 Cl 4.2
Customer:	Janizary Holdings Inc		
Model Number:	LMSWDJHNEX	Serial Number:	
Description:	RF amplifier		
	Uplink		
	Signal Source - GSM – Input – 1860MHz

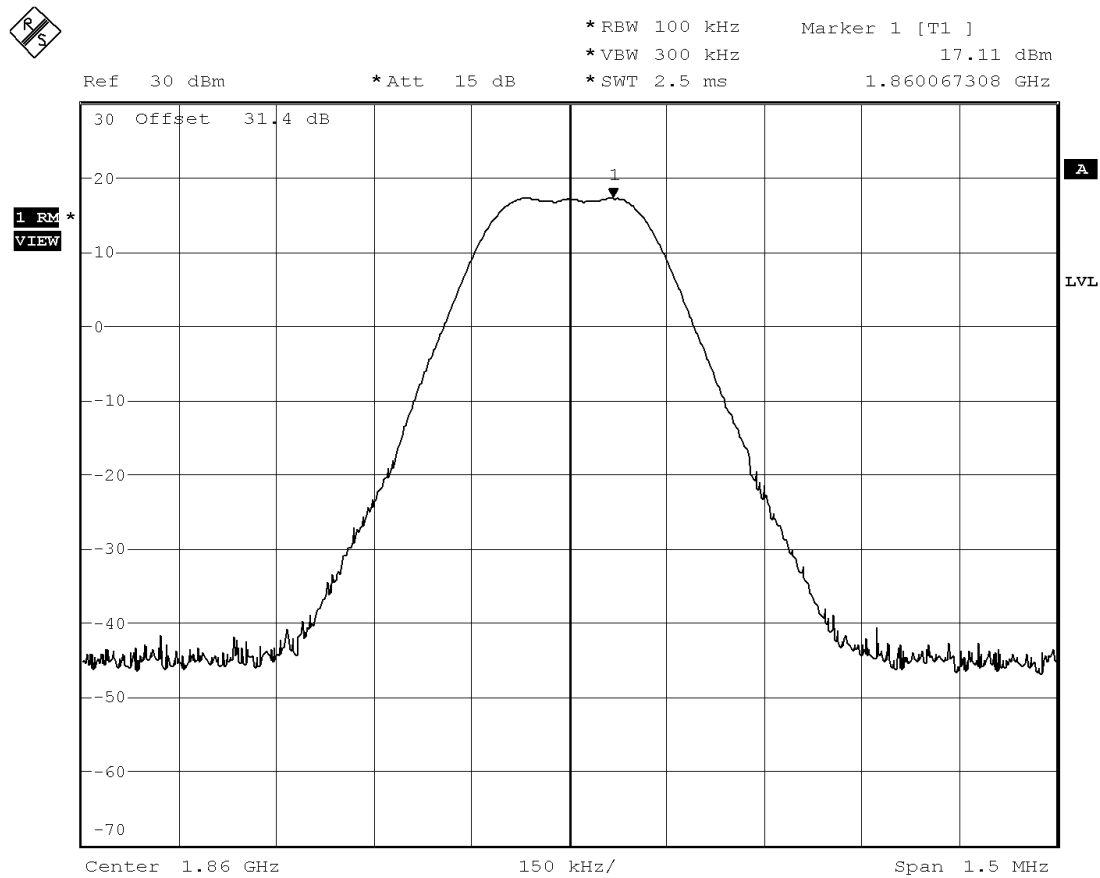
FIGURE 6: OCCUPIED BANDWIDTH

5969 Robinson Avenue Riverside, CA 92503 (951) 637-2630 FAX (951) 637-2704	<b>Occupied Bandwidth</b>	
DNB Job Number:	RV58031A	Date: 8 Sep 2004	<b>Conformance Standards</b>  [X] FCC Part 24 [X] FCC Part 90 [X] IC RSS-131 Cl 4.2
Customer:	Janizary Holdings Inc		
Model Number:	LMSWDJHNEX	Serial Number:	
Description:	RF amplifier		
	Uplink		
	Signal Source - GSM – Output – 1860MHz

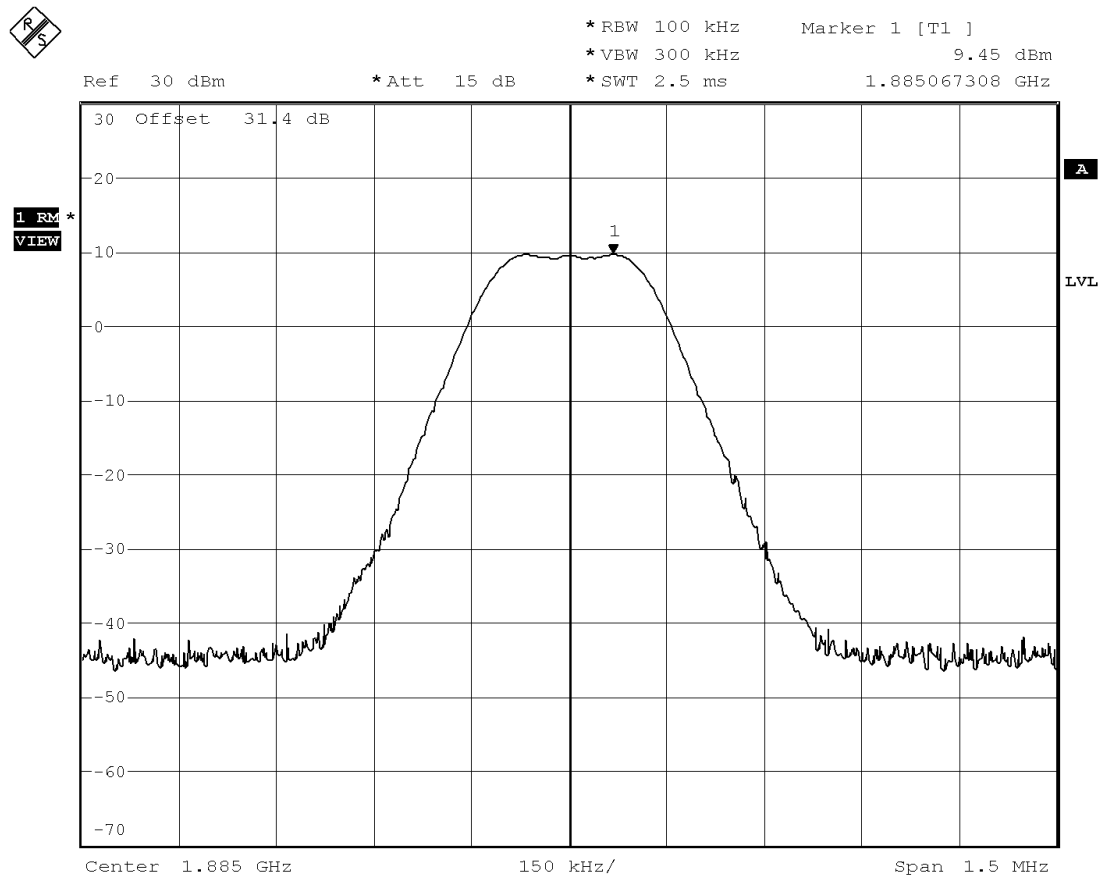
FIGURE 6: OCCUPIED BANDWIDTH

5969 Robinson Avenue Riverside, CA 92503 (951) 637-2630 FAX (951) 637-2704	<b>Occupied Bandwidth</b>	
DNB Job Number:	RV58031A	Date: 8 Sep 2004	<b>Conformance Standards</b>  [X] FCC Part 24 [X] FCC Part 90 [X] IC RSS-131 Cl 4.2
Customer:	Janizary Holdings Inc		
Model Number:	LMSWDJHNEX	Serial Number:	
Description:	RF amplifier		
	Uplink		
	Signal Source - GSM – Input – 1885MHz

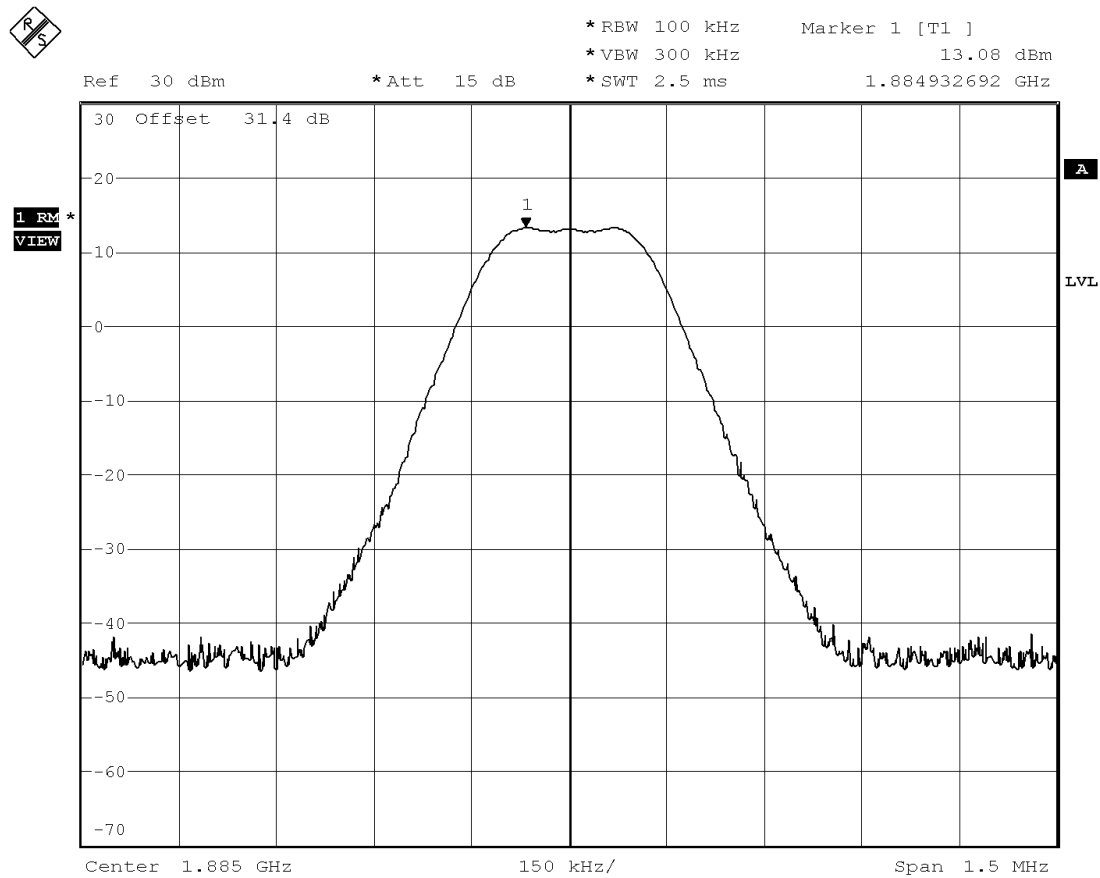
FIGURE 6: OCCUPIED BANDWIDTH

5969 Robinson Avenue Riverside, CA 92503 (951) 637-2630 FAX (951) 637-2704	<b>Occupied Bandwidth</b>	
DNB Job Number:	RV58031A	Date: 8 Sep 2004	<b>Conformance Standards</b>  [X] FCC Part 24 [X] FCC Part 90 [X] IC RSS-131 Cl 4.2
Customer:	Janizary Holdings Inc		
Model Number:	LMSWDJHNEX	Serial Number:	
Description:	RF amplifier		
	Uplink		
	Signal Source - GSM – Output – 1885MHz

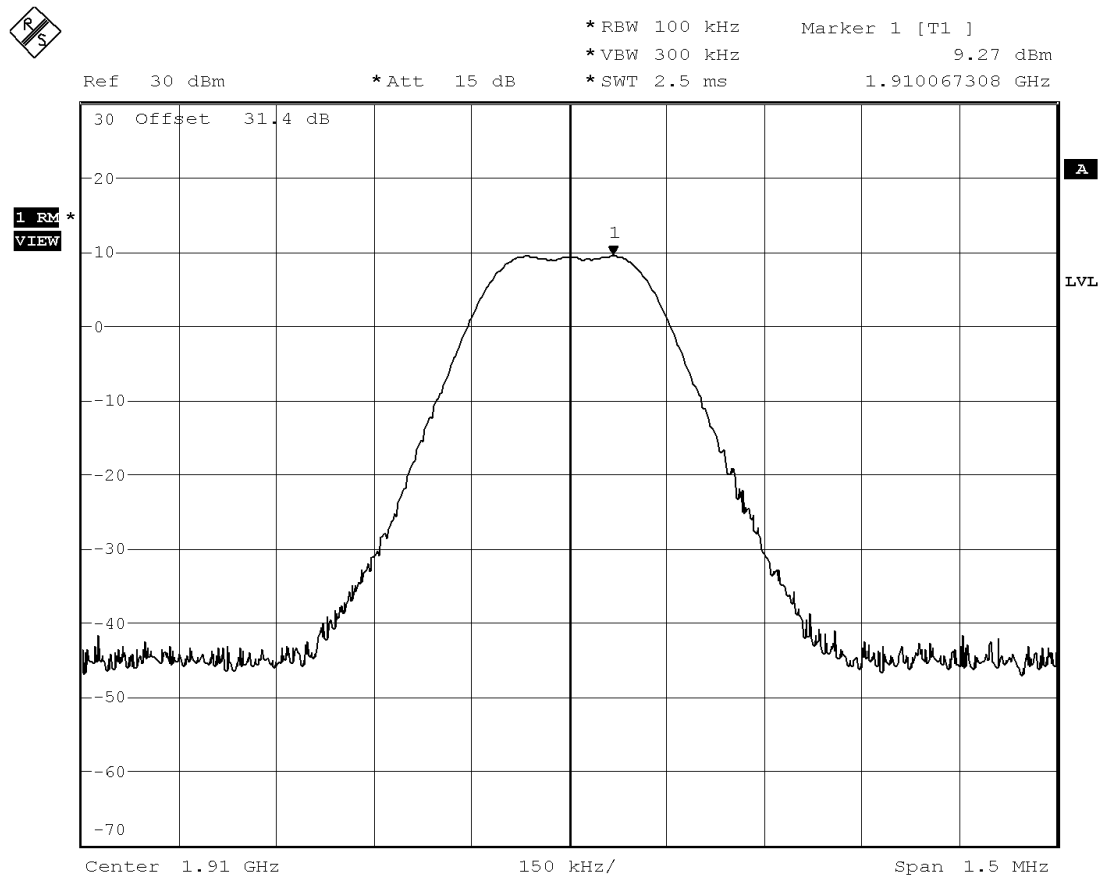
FIGURE 6: OCCUPIED BANDWIDTH

5969 Robinson Avenue Riverside, CA 92503 (951) 637-2630 FAX (951) 637-2704	<b>Occupied Bandwidth</b>	
DNB Job Number:	RV58031A	Date: 8 Sep 2004	<b>Conformance Standards</b>  [X] FCC Part 24 [X] FCC Part 90 [X] IC RSS-131 Cl 4.2
Customer:	Janizary Holdings Inc		
Model Number:	LMSWDJHNEX	Serial Number:	
Description:	RF amplifier		
	Uplink		
	Signal Source - GSM – Input – 1910MHz

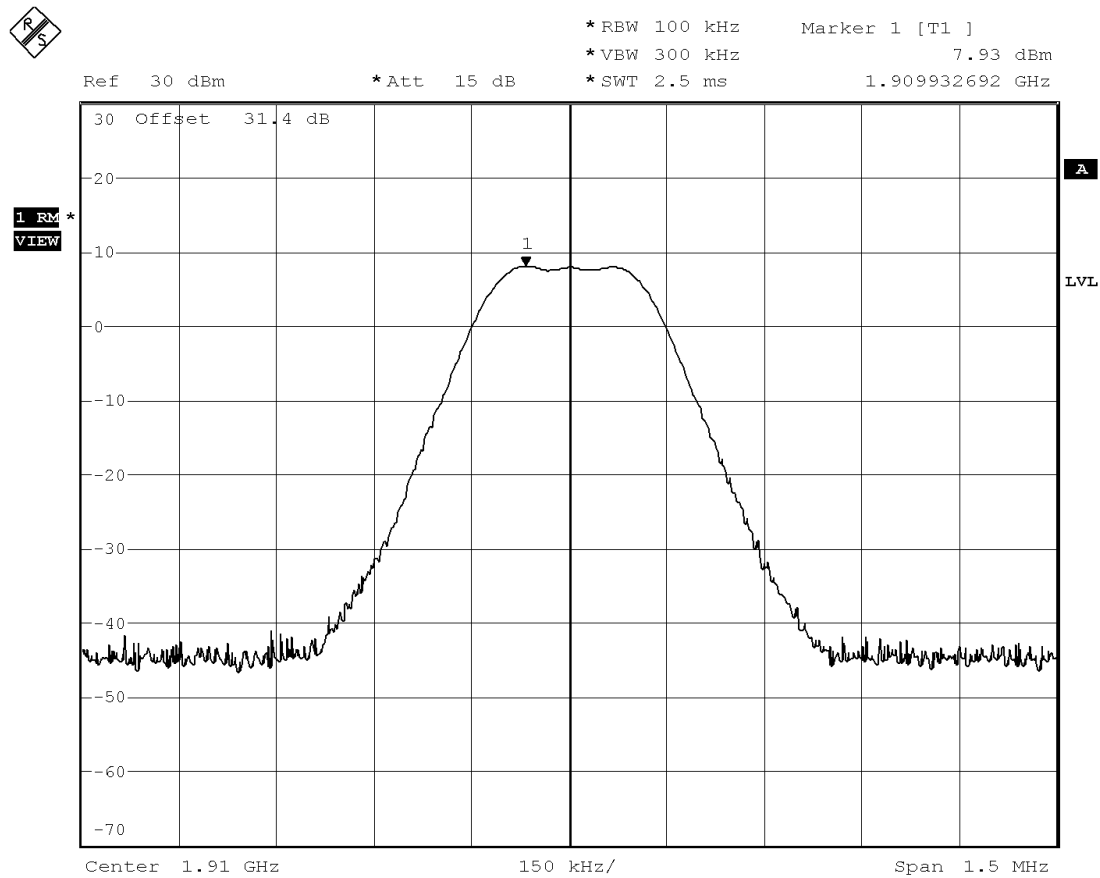
FIGURE 6: OCCUPIED BANDWIDTH

5969 Robinson Avenue Riverside, CA 92503 (951) 637-2630 FAX (951) 637-2704	<b>Occupied Bandwidth</b>	
DNB Job Number:	RV58031A	Date: 8 Sep 2004	<b>Conformance Standards</b>  [X] FCC Part 24 [X] FCC Part 90 [X] IC RSS-131 Cl 4.2
Customer:	Janizary Holdings Inc		
Model Number:	LMSWDJHNEX	Serial Number:	
Description:	RF amplifier		
	Uplink		
	Signal Source - GSM – Output – 1910MHz

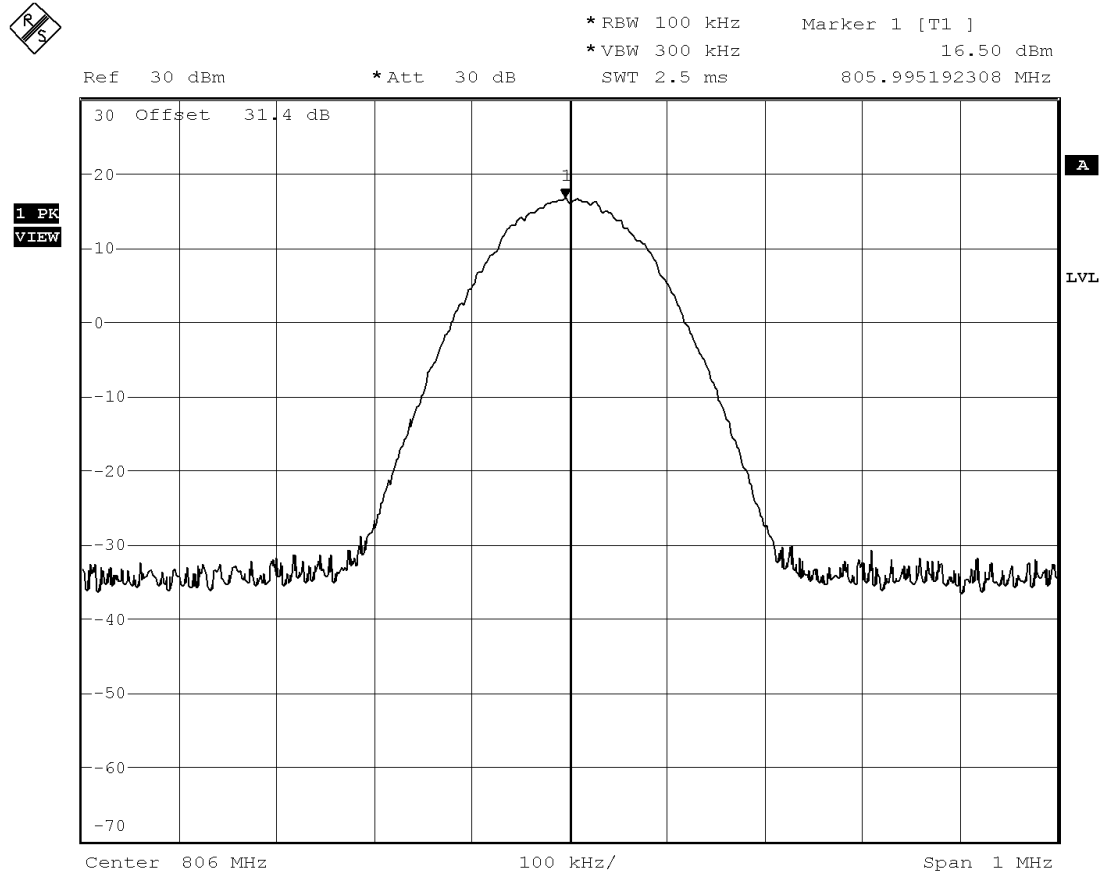
FIGURE 6: OCCUPIED BANDWIDTH

5969 Robinson Avenue Riverside, CA 92503 (951) 637-2630 FAX (951) 637-2704	<b>Occupied Bandwidth</b>	
DNB Job Number:	RV58031A	Date: 11 Sep 2004	<b>Conformance Standards</b>  [X] FCC Part 24 [X] FCC Part 90 [X] IC RSS-131 Cl 4.2
Customer:	Janizary Holdings Inc		
Model Number:	LMSWDJHNEX	Serial Number:	
Description:	RF amplifier		
	Uplink		
	Signal Source - TDMA – Input – 806MHz

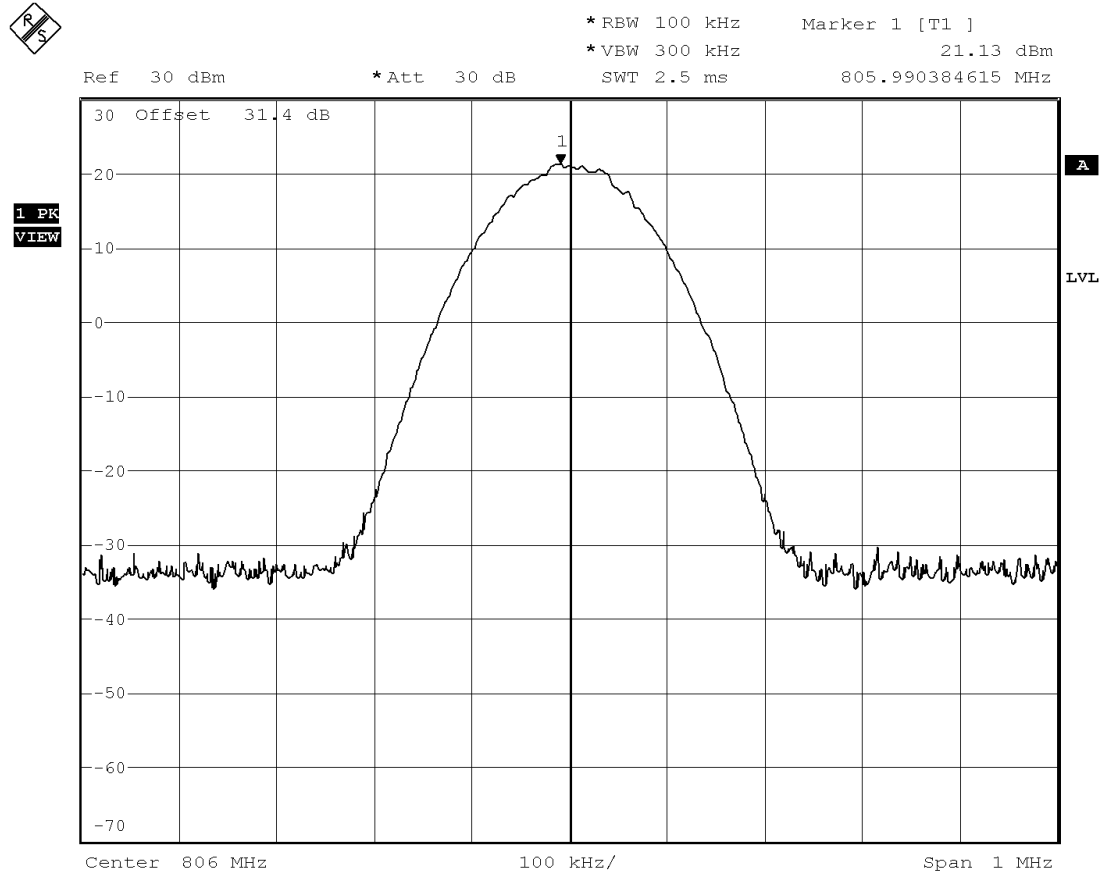
FIGURE 6: OCCUPIED BANDWIDTH

5969 Robinson Avenue Riverside, CA 92503 (951) 637-2630 FAX (951) 637-2704	<b>Occupied Bandwidth</b>	
DNB Job Number:	RV58031A	Date: 11 Sep 2004	<b>Conformance Standards</b>  [X] FCC Part 24 [X] FCC Part 90 [X] IC RSS-131 Cl 4.2
Customer:	Janizary Holdings Inc		
Model Number:	LMSWDJHNEX	Serial Number:	
Description:	RF amplifier		
	Uplink		
	Signal Source - TDMA – Output – 806MHz

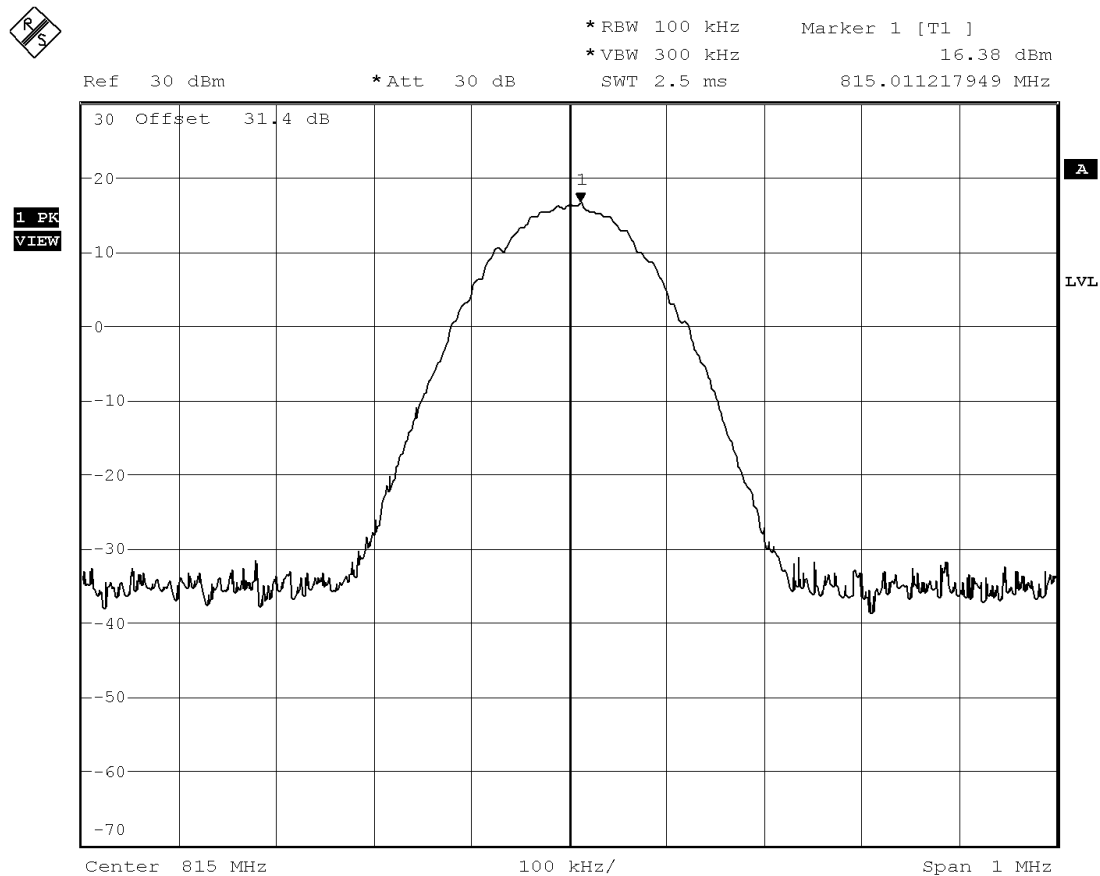
FIGURE 6: OCCUPIED BANDWIDTH

5969 Robinson Avenue Riverside, CA 92503 (951) 637-2630 FAX (951) 637-2704	<b>Occupied Bandwidth</b>	
DNB Job Number:	RV58031A	Date: 11 Sep 2004	<b>Conformance Standards</b>  [X] FCC Part 24 [X] FCC Part 90 [X] IC RSS-131 Cl 4.2
Customer:	Janizary Holdings Inc		
Model Number:	LMSWDJHNEX	Serial Number:	
Description:	RF amplifier		
	Uplink		
	Signal Source - TDMA – Input – 815MHz

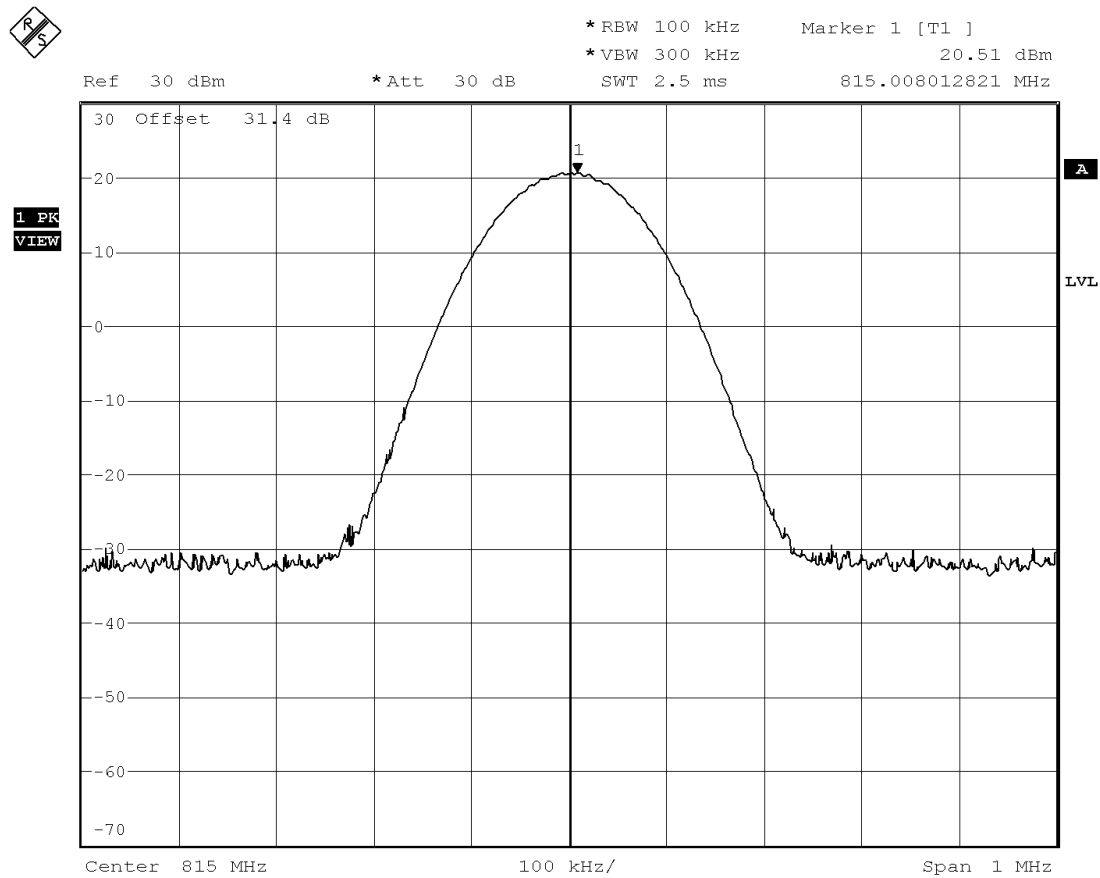
FIGURE 6: OCCUPIED BANDWIDTH

5969 Robinson Avenue Riverside, CA 92503 (951) 637-2630 FAX (951) 637-2704	<b>Occupied Bandwidth</b>	
DNB Job Number:	RV58031A	Date: 11 Sep 2004	<b>Conformance Standards</b>  [X] FCC Part 24 [X] FCC Part 90 [X] IC RSS-131 Cl 4.2
Customer:	Janizary Holdings Inc		
Model Number:	LMSWDJHNEX	Serial Number:	
Description:	RF amplifier		
	Uplink		
	Signal Source - TDMA – Output – 815MHz
