**Application for Certification  
For an RF amplifier**

**RF amplifier**

**FCC ID: RFK-LMSWDJHNEX**

**REPORT # RV58031A-001**

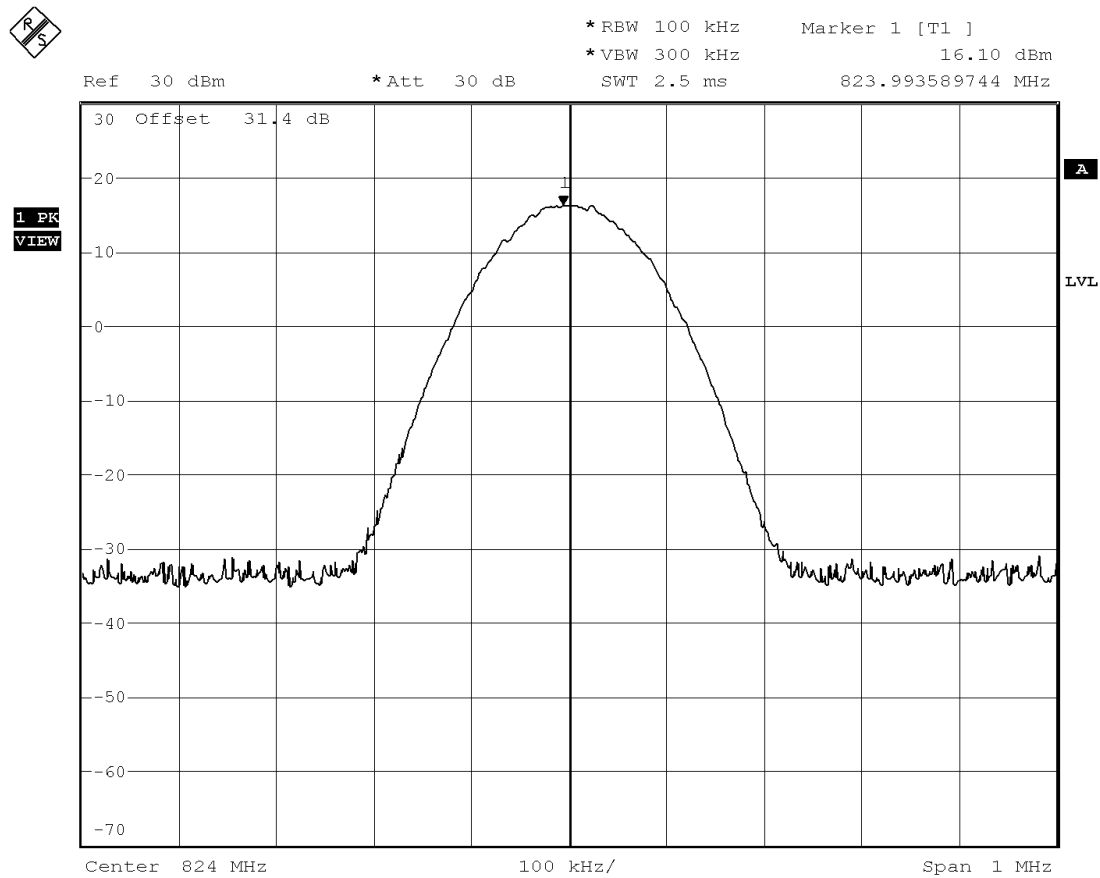
FIGURE 6: OCCUPIED BANDWIDTH

5969 Robinson Avenue Riverside, CA 92503 (951) 637-2630 FAX (951) 637-2704	<b>Occupied Bandwidth</b>	
DNB Job Number:	RV58031A	Date: 11 Sep 2004	<b>Conformance Standards</b>  [X] FCC Part 24 [X] FCC Part 90 [X] IC RSS-131 Cl 4.2
Customer:	Janizary Holdings Inc		
Model Number:	LMSWDJHNEX	Serial Number:	
Description:	RF amplifier		
	Uplink		
	Signal Source - TDMA – Input – 824MHz

The center frequency of the signal did not shift with modulation. The Spectrum Bandwidth was well within the limits specified in the FCC Regulations.

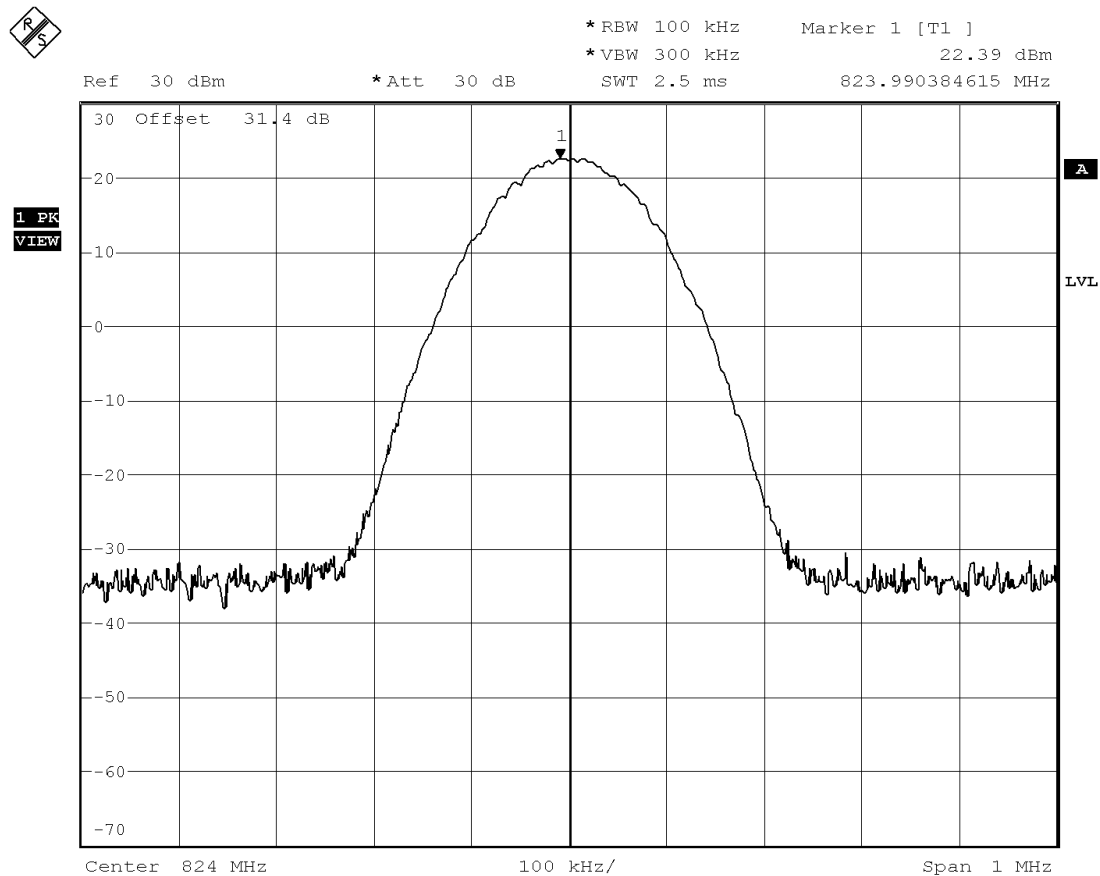
FIGURE 6: OCCUPIED BANDWIDTH

5969 Robinson Avenue Riverside, CA 92503 (951) 637-2630 FAX (951) 637-2704	<b>Occupied Bandwidth</b>	
<b>DNB Job Number:</b>	RV58031A	<b>Date:</b> 11 Sep 2004	<b>Conformance Standards</b> [X] FCC Part 24 [X] FCC Part 90 [X] IC RSS-131 Cl 4.2
<b>Customer:</b>	Janizary Holdings Inc		
<b>Model Number:</b>	LMSWDJHNEX	<b>Serial Number:</b>	
<b>Description:</b>	RF amplifier		
	Uplink		
	Signal Source - TDMA – Output – 824MHz

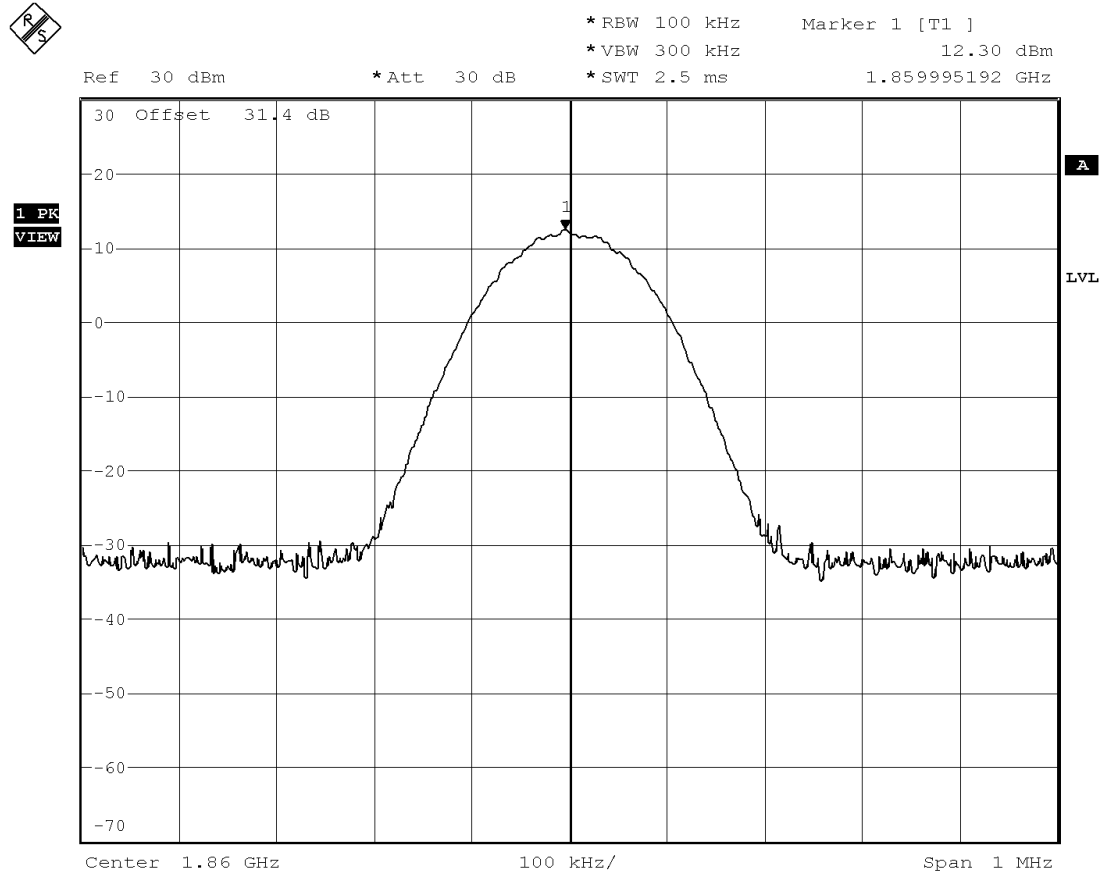
FIGURE 6: OCCUPIED BANDWIDTH

5969 Robinson Avenue Riverside, CA 92503 (951) 637-2630 FAX (951) 637-2704	<b>Occupied Bandwidth</b>	
DNB Job Number:	RV58031A	Date: 10 Sep 2004	<b>Conformance Standards</b>  [X] FCC Part 24 [X] FCC Part 90 [X] IC RSS-131 Cl 4.2
Customer:	Janizary Holdings Inc		
Model Number:	LMSWDJHNEX	Serial Number:	
Description:	RF amplifier		
	Uplink		
	Signal Source - TDMA – Input – 1860MHz

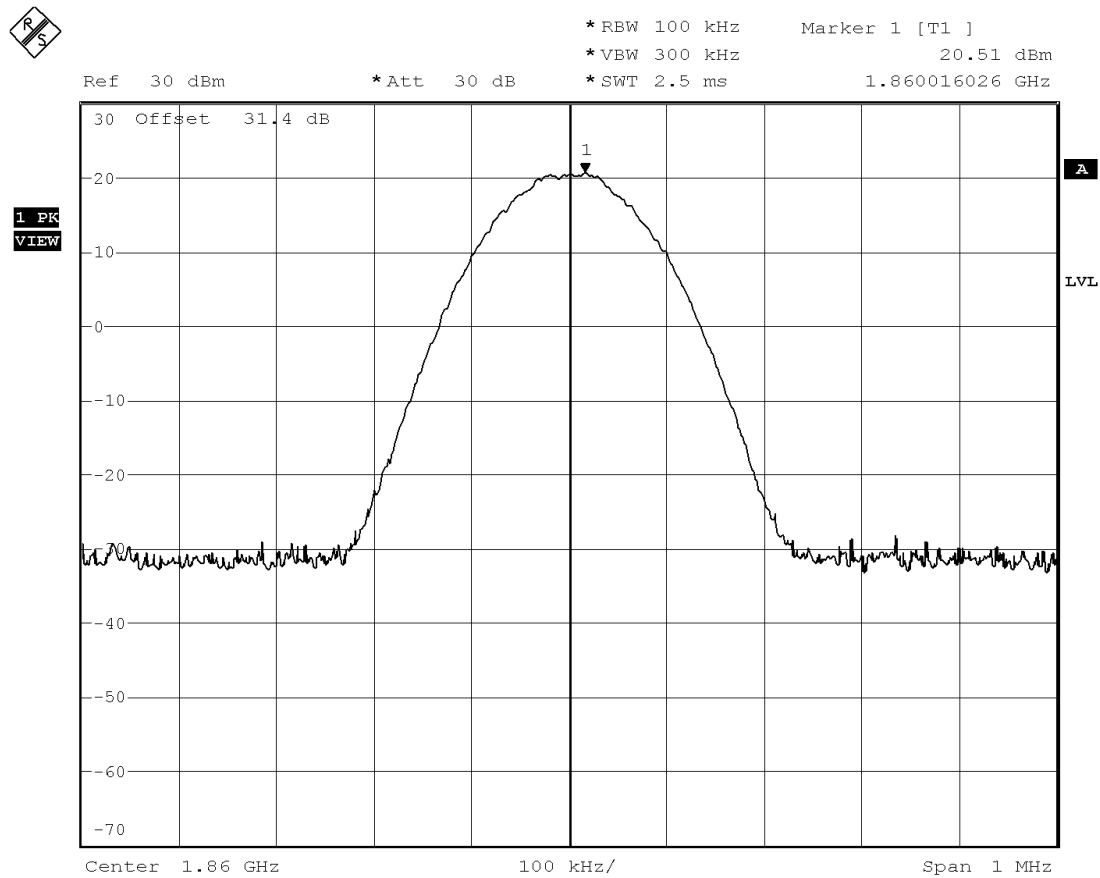
FIGURE 6: OCCUPIED BANDWIDTH

5969 Robinson Avenue Riverside, CA 92503 (951) 637-2630 FAX (951) 637-2704	<b>Occupied Bandwidth</b>	
DNB Job Number:	RV58031A	Date: 10 Sep 2004	<b>Conformance Standards</b>  [X] FCC Part 24 [X] FCC Part 90 [X] IC RSS-131 Cl 4.2
Customer:	Janizary Holdings Inc		
Model Number:	LMSWDJHNEX	Serial Number:	
Description:	RF amplifier		
	Uplink		
	Signal Source - TDMA – Output – 1860MHz

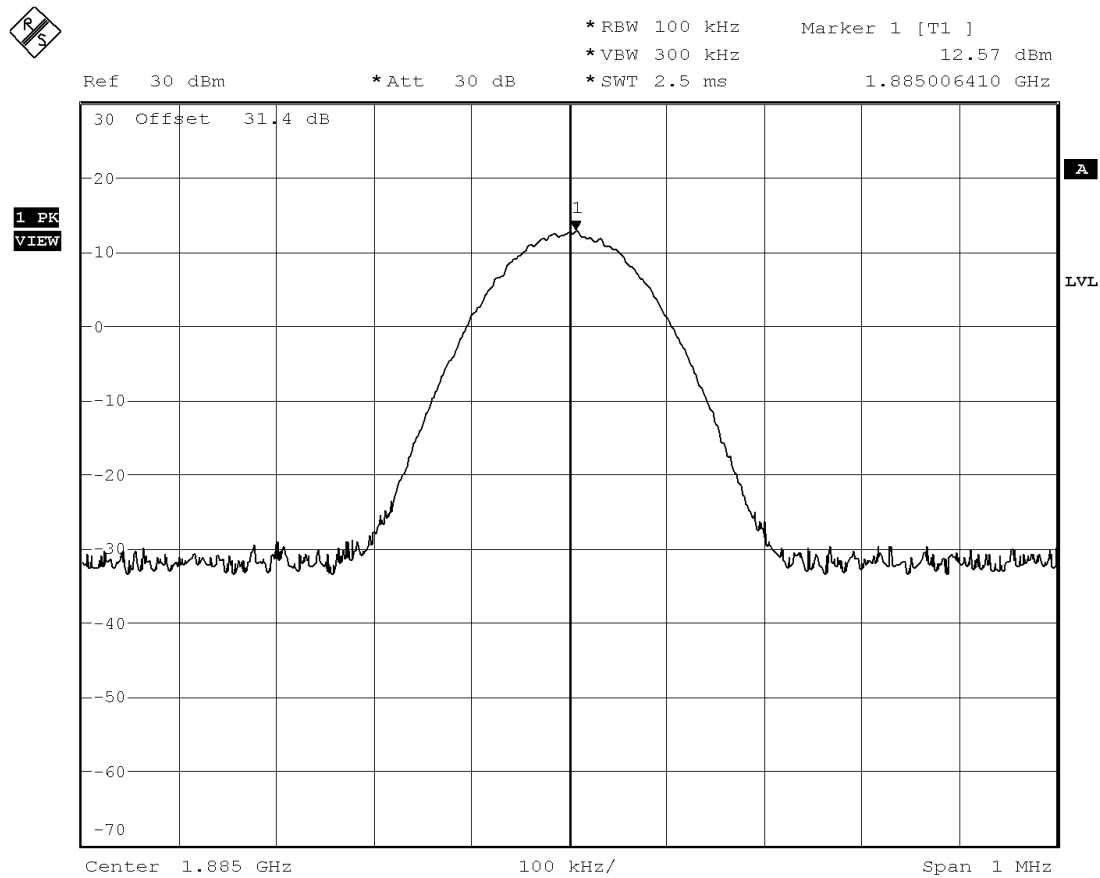
FIGURE 6: OCCUPIED BANDWIDTH

5969 Robinson Avenue Riverside, CA 92503 (951) 637-2630 FAX (951) 637-2704	<b>Occupied Bandwidth</b>	
DNB Job Number:	RV58031A	Date: 10 Sep 2004	<b>Conformance Standards</b>  [X] FCC Part 24 [X] FCC Part 90 [X] IC RSS-131 Cl 4.2
Customer:	Janizary Holdings Inc		
Model Number:	LMSWDJHNEX	Serial Number:	
Description:	RF amplifier		
	Uplink		
	Signal Source - TDMA – Input – 1885MHz

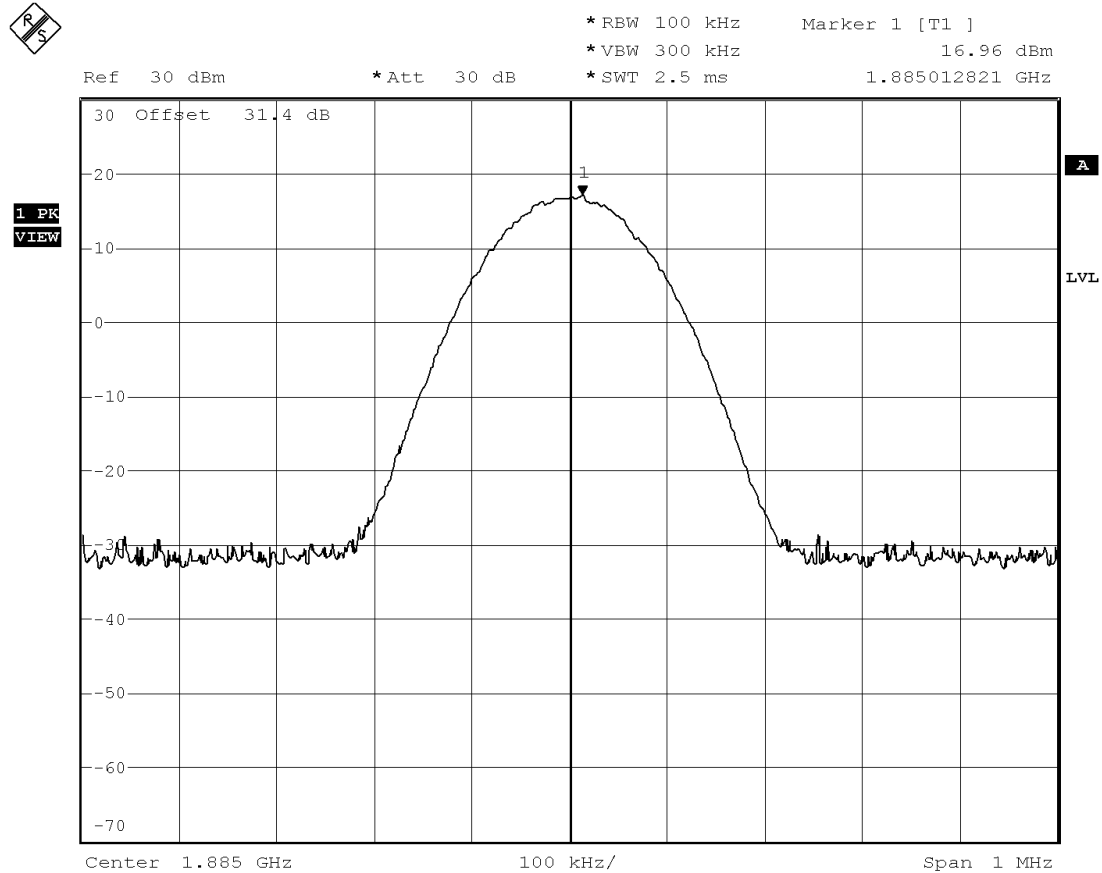
FIGURE 6: OCCUPIED BANDWIDTH

5969 Robinson Avenue Riverside, CA 92503 (951) 637-2630 FAX (951) 637-2704	<b>Occupied Bandwidth</b>	
DNB Job Number:	RV58031A	Date: 10 Sep 2004	<b>Conformance Standards</b>  [X] FCC Part 24 [X] FCC Part 90 [X] IC RSS-131 Cl 4.2
Customer:	Janizary Holdings Inc		
Model Number:	LMSWDJHNEX	Serial Number:	
Description:	RF amplifier		
	Uplink		
	Signal Source - TDMA – Output – 1885MHz

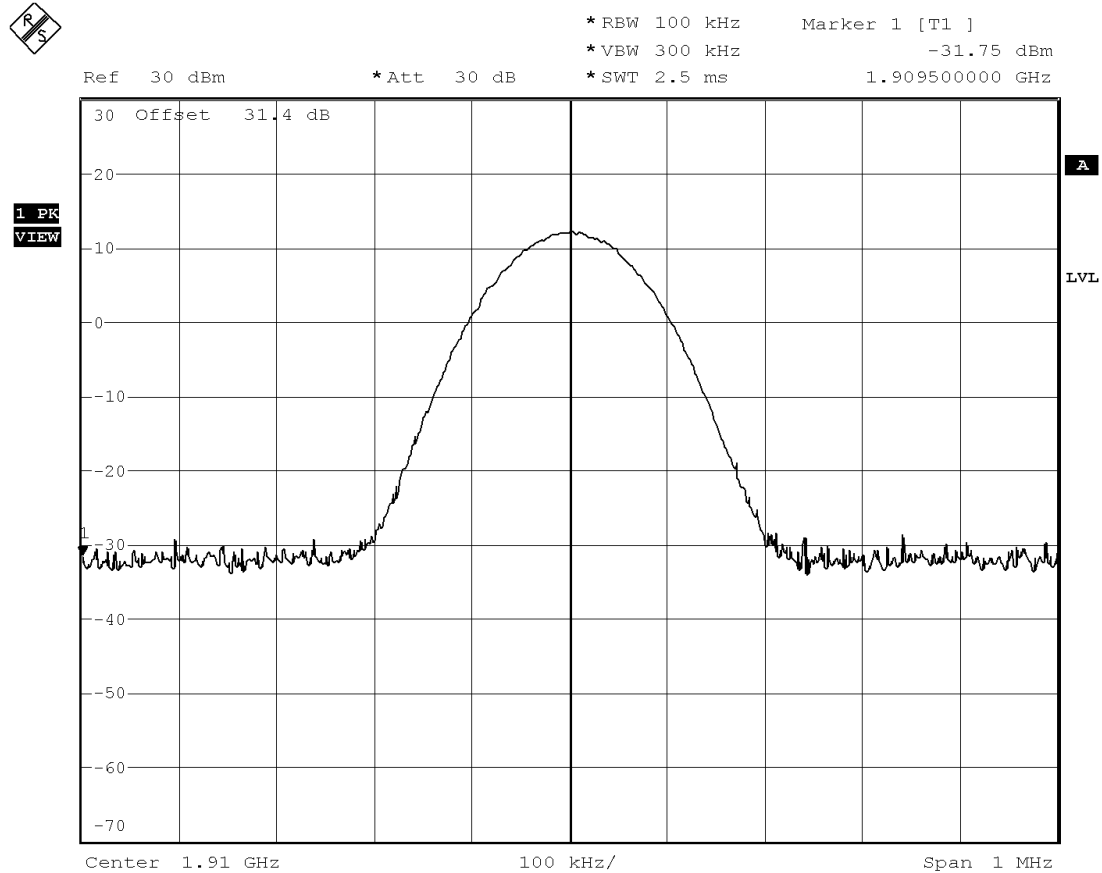
FIGURE 6: OCCUPIED BANDWIDTH

5969 Robinson Avenue Riverside, CA 92503 (951) 637-2630 FAX (951) 637-2704	<b>Occupied Bandwidth</b>	
DNB Job Number:	RV58031A	Date: 10 Sep 2004	<b>Conformance Standards</b>  [X] FCC Part 24 [X] FCC Part 90 [X] IC RSS-131 Cl 4.2
Customer:	Janizary Holdings Inc		
Model Number:	LMSWDJHNEX	Serial Number:	
Description:	RF amplifier		
	Uplink		
	Signal Source - TDMA – Input – 1910MHz

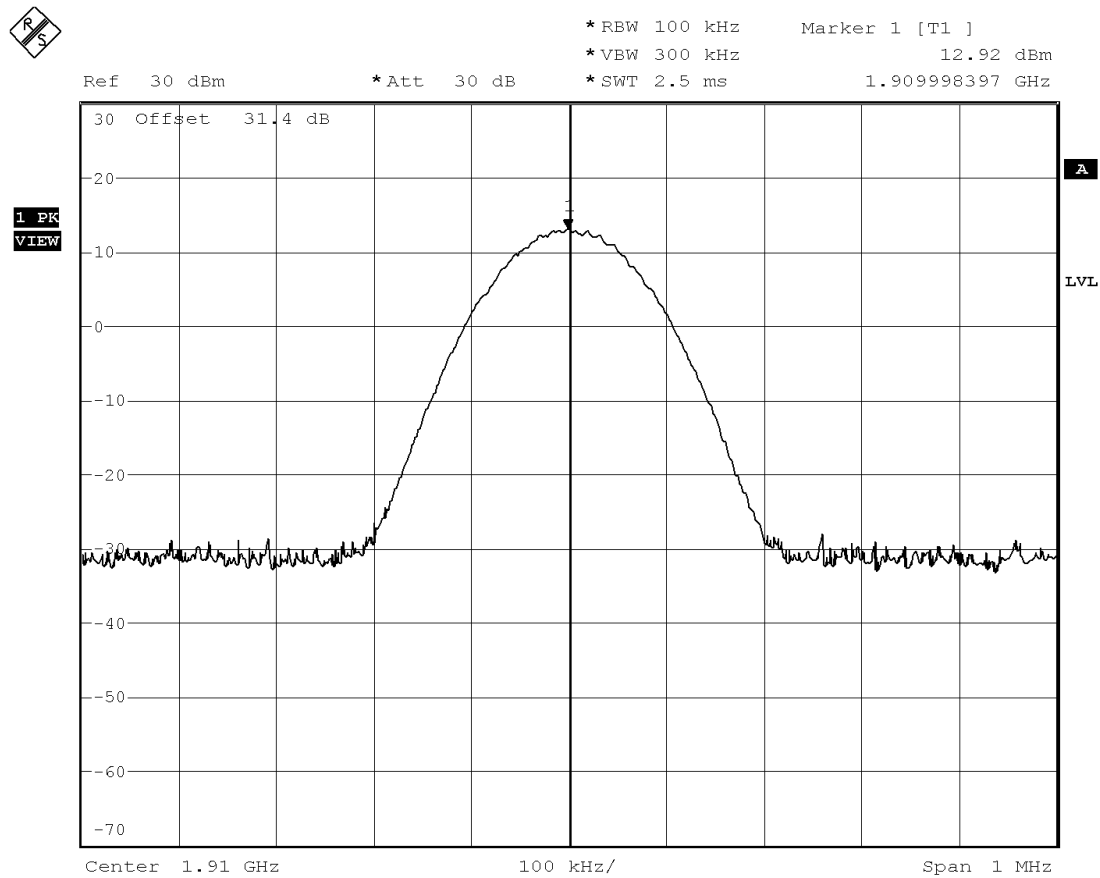
FIGURE 6: OCCUPIED BANDWIDTH

5969 Robinson Avenue Riverside, CA 92503 (951) 637-2630 FAX (951) 637-2704	<b>Occupied Bandwidth</b>	
DNB Job Number:	RV58031A	Date: 10 Sep 2004	<b>Conformance Standards</b>  [X] FCC Part 24 [X] FCC Part 90 [X] IC RSS-131 Cl 4.2
Customer:	Janizary Holdings Inc		
Model Number:	LMSWDJHNEX	Serial Number:	
Description:	RF amplifier		
	Uplink		
	Signal Source - TDMA – Output – 1910MHz

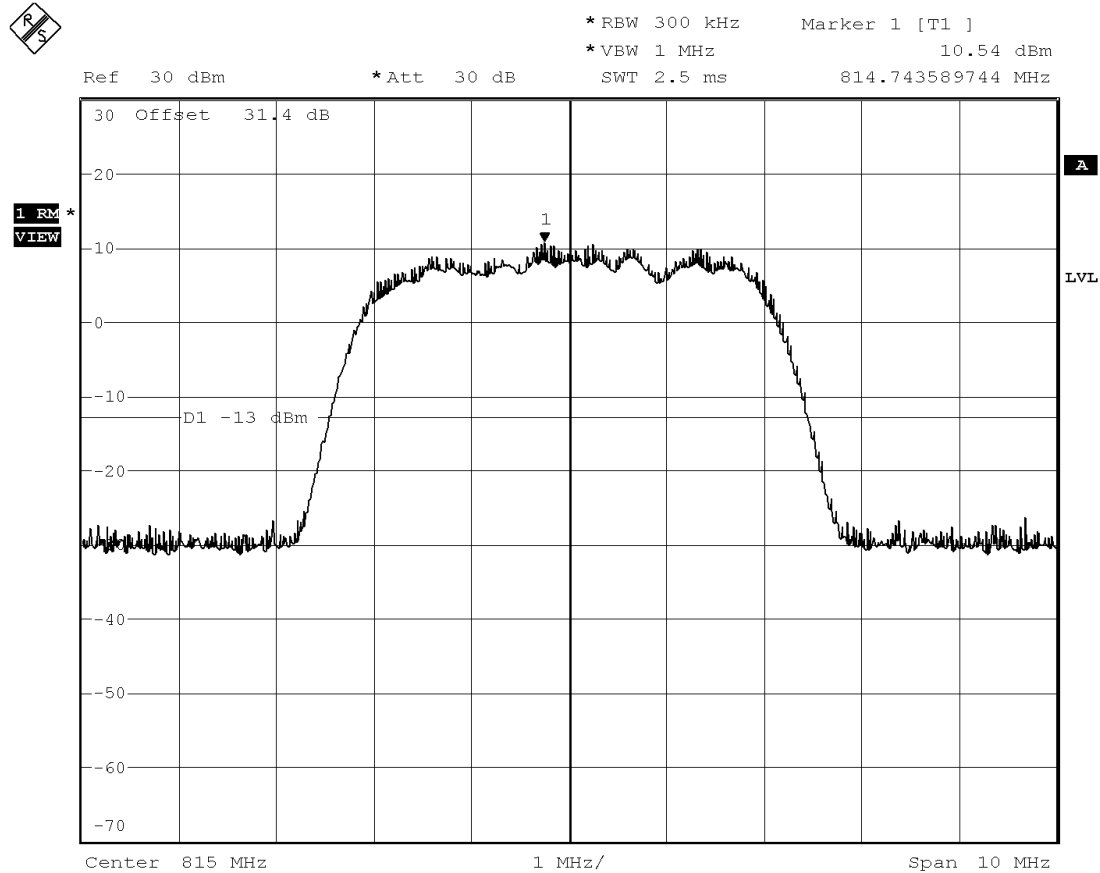
FIGURE 6: OCCUPIED BANDWIDTH

5969 Robinson Avenue Riverside, CA 92503 (951) 637-2630 FAX (951) 637-2704	<b>Occupied Bandwidth</b>	
DNB Job Number:	RV58031A	Date: 11 Sep 2004	<b>Conformance Standards</b>  [X] FCC Part 24 [X] FCC Part 90 [X] IC RSS-131 Cl 4.2
Customer:	Janizary Holdings Inc		
Model Number:	LMSWDJHNEX	Serial Number:	
Description:	RF amplifier		
	Uplink		
	Signal Source - CDMA – Input – 815MHz

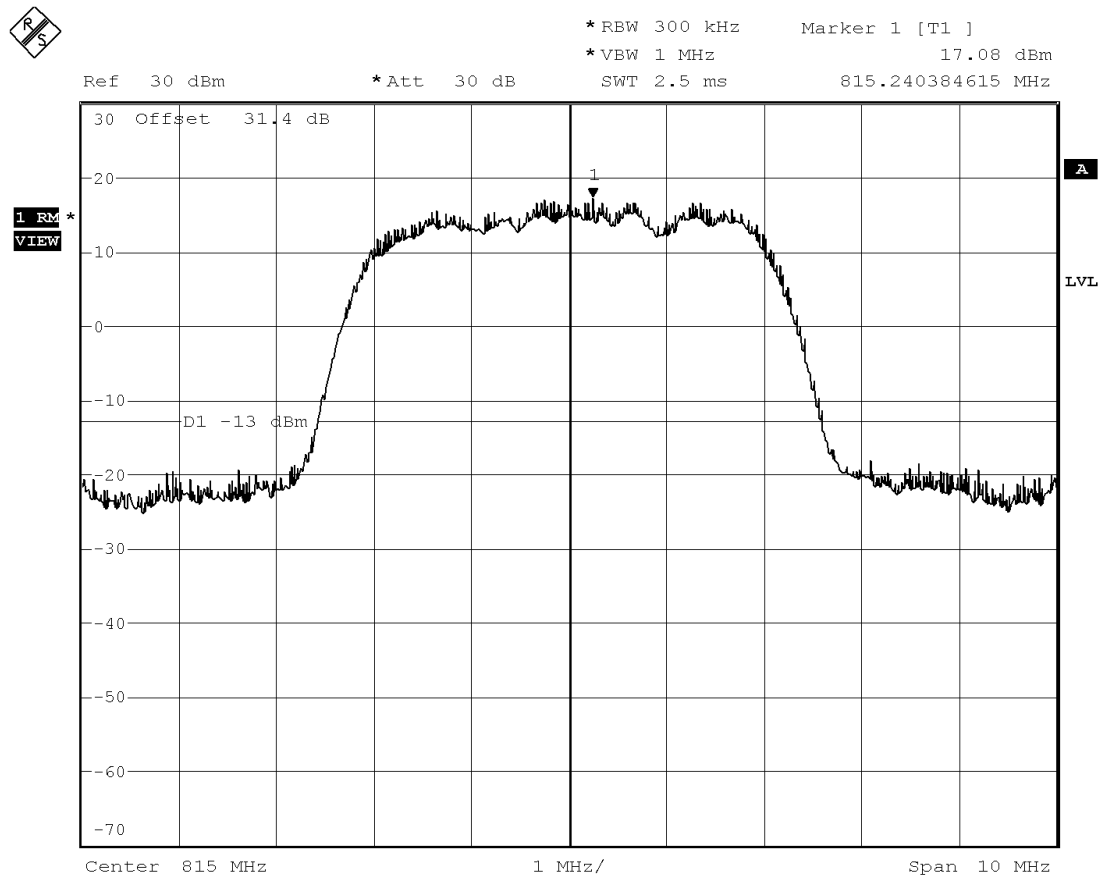
FIGURE 6: OCCUPIED BANDWIDTH

5969 Robinson Avenue Riverside, CA 92503 (951) 637-2630 FAX (951) 637-2704	<b>Occupied Bandwidth</b>	
DNB Job Number:	RV58031A	Date: 11 Sep 2004	<b>Conformance Standards</b>  [X] FCC Part 24 [X] FCC Part 90 [X] IC RSS-131 Cl 4.2
Customer:	Janizary Holdings Inc		
Model Number:	LMSWDJHNEX	Serial Number:	
Description:	RF amplifier		
	Uplink		
	Signal Source - CDMA – Output – 815MHz

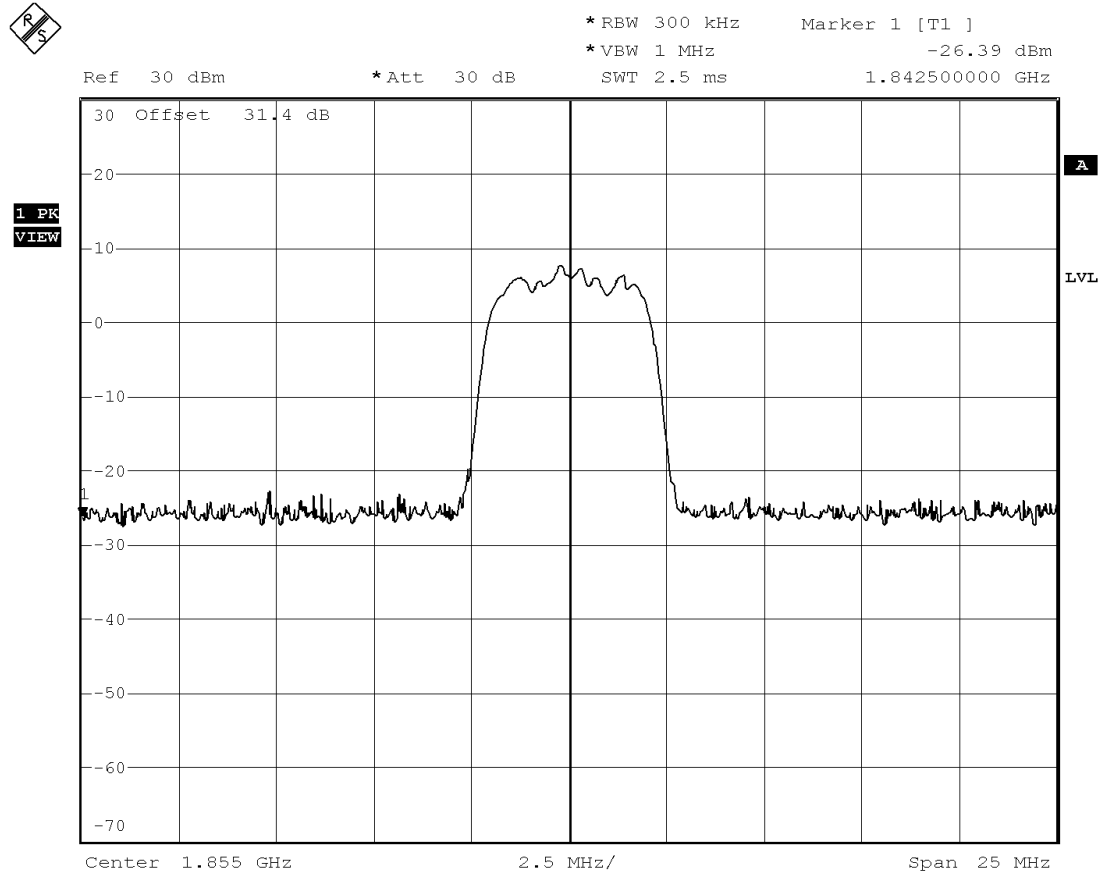
FIGURE 6: OCCUPIED BANDWIDTH

5969 Robinson Avenue Riverside, CA 92503 (951) 637-2630 FAX (951) 637-2704	<b>Occupied Bandwidth</b>	
DNB Job Number:	RV58031A	Date: 10 Sep 2004	<b>Conformance Standards</b>  [X] FCC Part 24 [X] FCC Part 90 [X] IC RSS-131 Cl 4.2
Customer:	Janizary Holdings Inc		
Model Number:	LMSWDJHNEX	Serial Number:	
Description:	RF amplifier		
	Uplink		
	Signal Source - CDMA – Input – 1885MHz

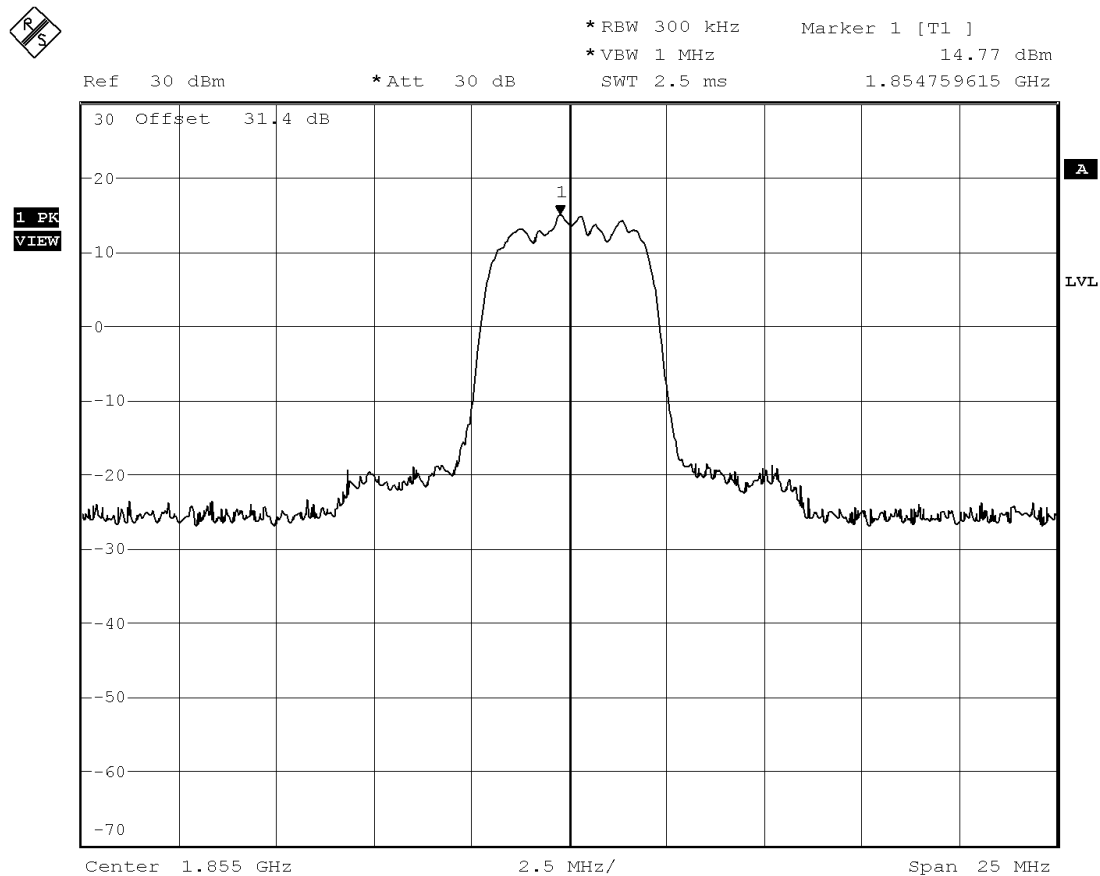
FIGURE 6: OCCUPIED BANDWIDTH

5969 Robinson Avenue Riverside, CA 92503 (951) 637-2630 FAX (951) 637-2704	<b>Occupied Bandwidth</b>	
DNB Job Number:	RV58031A	Date: 10 Sep 2004	<b>Conformance Standards</b>  [X] FCC Part 24 [X] FCC Part 90 [X] IC RSS-131 Cl 4.2
Customer:	Janizary Holdings Inc		
Model Number:	LMSWDJHNEX	Serial Number:	
Description:	RF amplifier		
	Uplink		
	Signal Source - CDMA – Output – 1885MHz

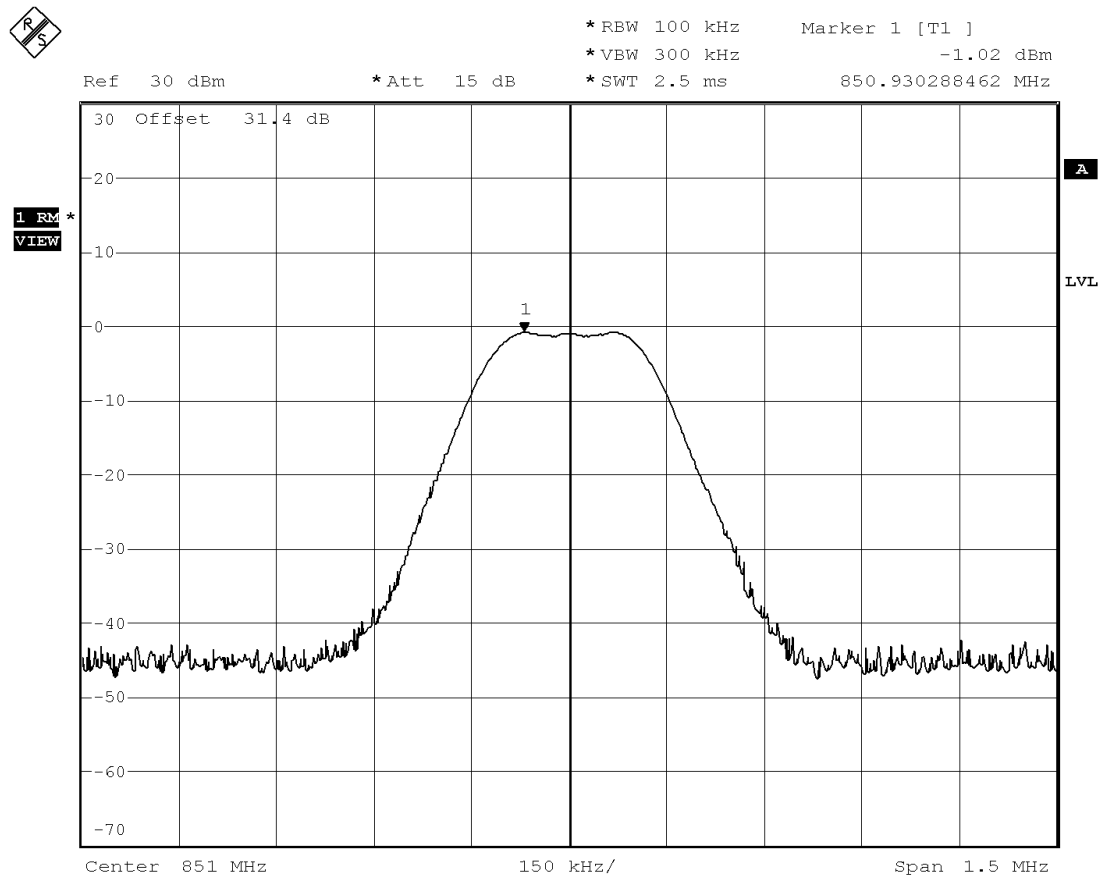
FIGURE 6: OCCUPIED BANDWIDTH

5969 Robinson Avenue Riverside, CA 92503 (951) 637-2630 FAX (951) 637-2704	<b>Occupied Bandwidth</b>	
DNB Job Number:	RV58031A	Date: 8 Sep 2004	<b>Conformance Standards</b>  [X] FCC Part 24 [X] FCC Part 90 [X] IC RSS-131 Cl 4.2
Customer:	Janizary Holdings Inc		
Model Number:	LMSWDJHNEX	Serial Number:	
Description:	RF amplifier		
	Downlink		
	Signal Source - GSM – Output – 851MHz

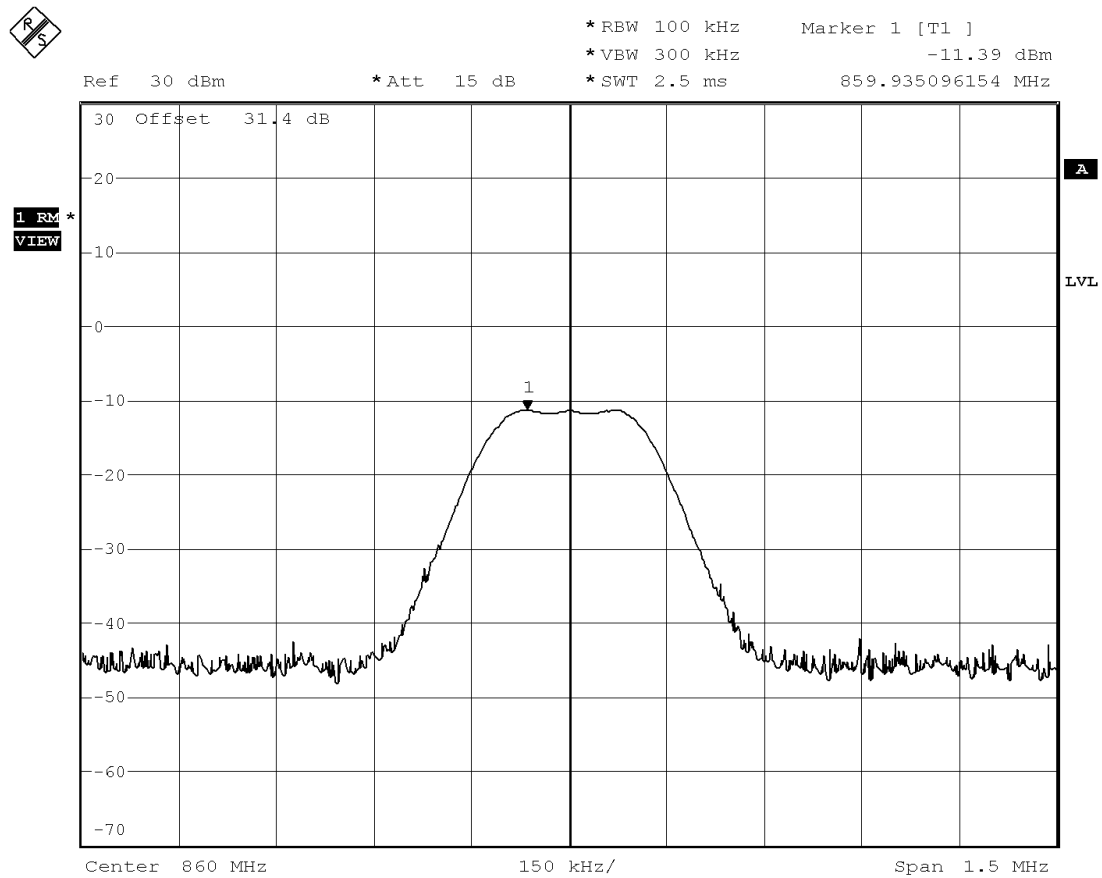
FIGURE 6: OCCUPIED BANDWIDTH

5969 Robinson Avenue Riverside, CA 92503 (951) 637-2630 FAX (951) 637-2704	<b>Occupied Bandwidth</b>	
DNB Job Number:	RV58031A	Date: 8 Sep 2004	<b>Conformance Standards</b>  [X] FCC Part 24 [X] FCC Part 90 [X] IC RSS-131 Cl 4.2
Customer:	Janizary Holdings Inc		
Model Number:	LMSWDJHNEX	Serial Number:	
Description:	RF amplifier		
	Downlink		
	Signal Source - GSM – Input – 860MHz

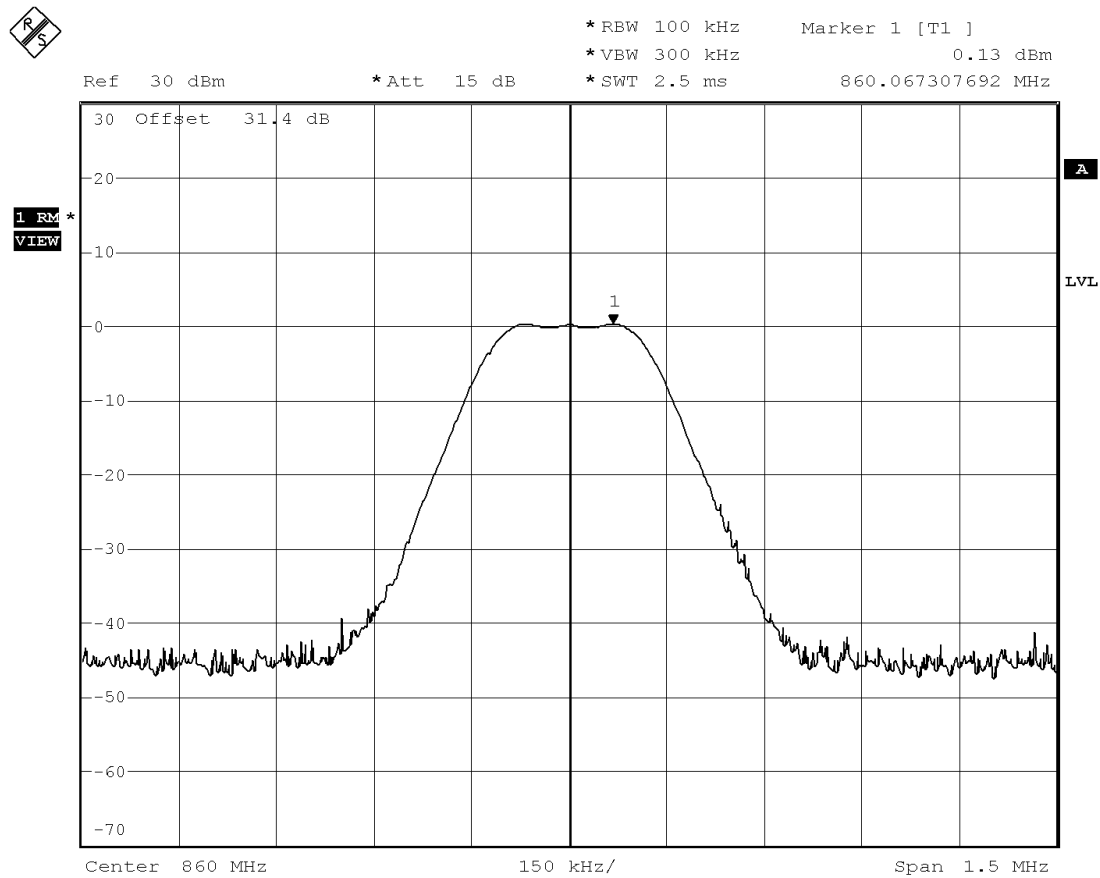
FIGURE 6: OCCUPIED BANDWIDTH

5969 Robinson Avenue Riverside, CA 92503 (951) 637-2630 FAX (951) 637-2704	<b>Occupied Bandwidth</b>	
DNB Job Number:	RV58031A	Date: 8 Sep 2004	<b>Conformance Standards</b>  [X] FCC Part 24 [X] FCC Part 90 [X] IC RSS-131 Cl 4.2
Customer:	Janizary Holdings Inc		
Model Number:	LMSWDJHNEX	Serial Number:	
Description:	RF amplifier		
	Downlink		
	Signal Source - GSM – Output – 860MHz

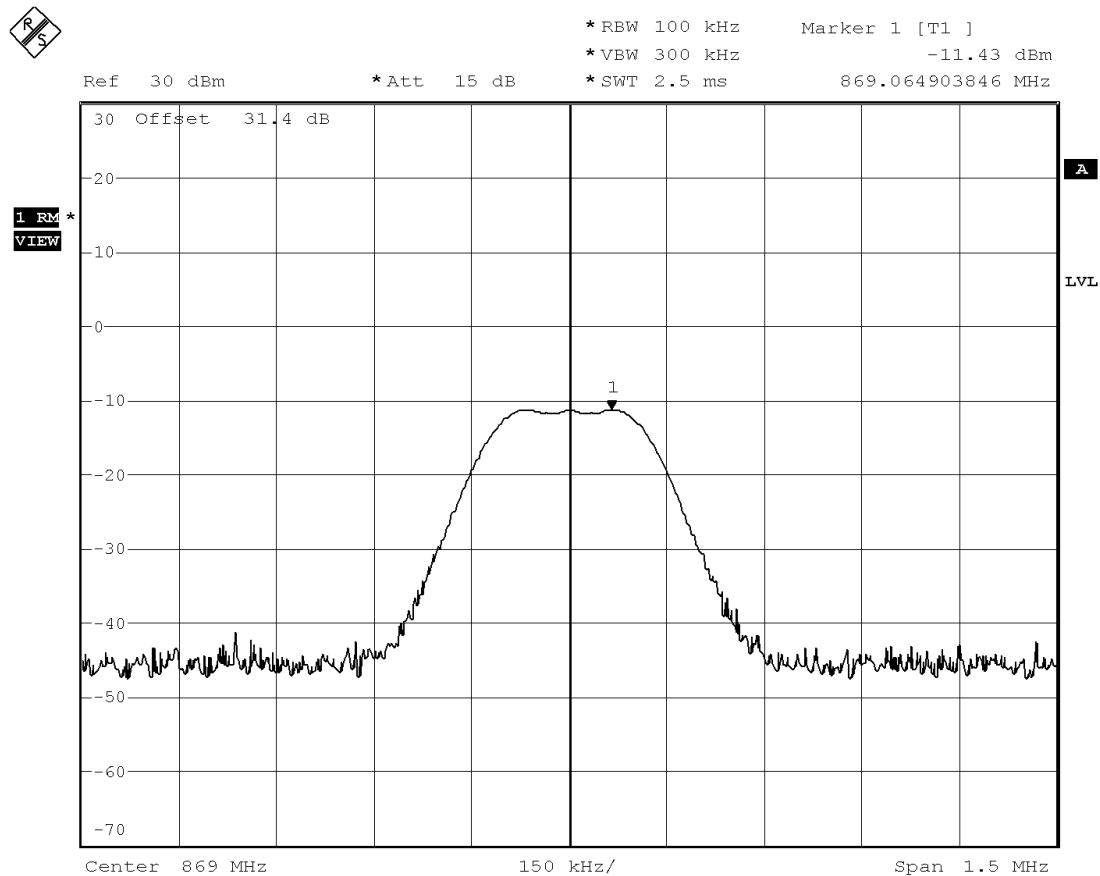
FIGURE 6: OCCUPIED BANDWIDTH

5969 Robinson Avenue Riverside, CA 92503 (951) 637-2630 FAX (951) 637-2704	<b>Occupied Bandwidth</b>	
<b>DNB Job Number:</b>	RV58031A	<b>Date:</b> 8 Sep 2004	<b>Conformance Standards</b> [X] FCC Part 24 [X] FCC Part 90 [X] IC RSS-131 Cl 4.2
<b>Customer:</b>	Janizary Holdings Inc		
<b>Model Number:</b>	LMSWDJHNEX	<b>Serial Number:</b>	
<b>Description:</b>	RF amplifier		
	Downlink		
	Signal Source - GSM - Input - 869MHz

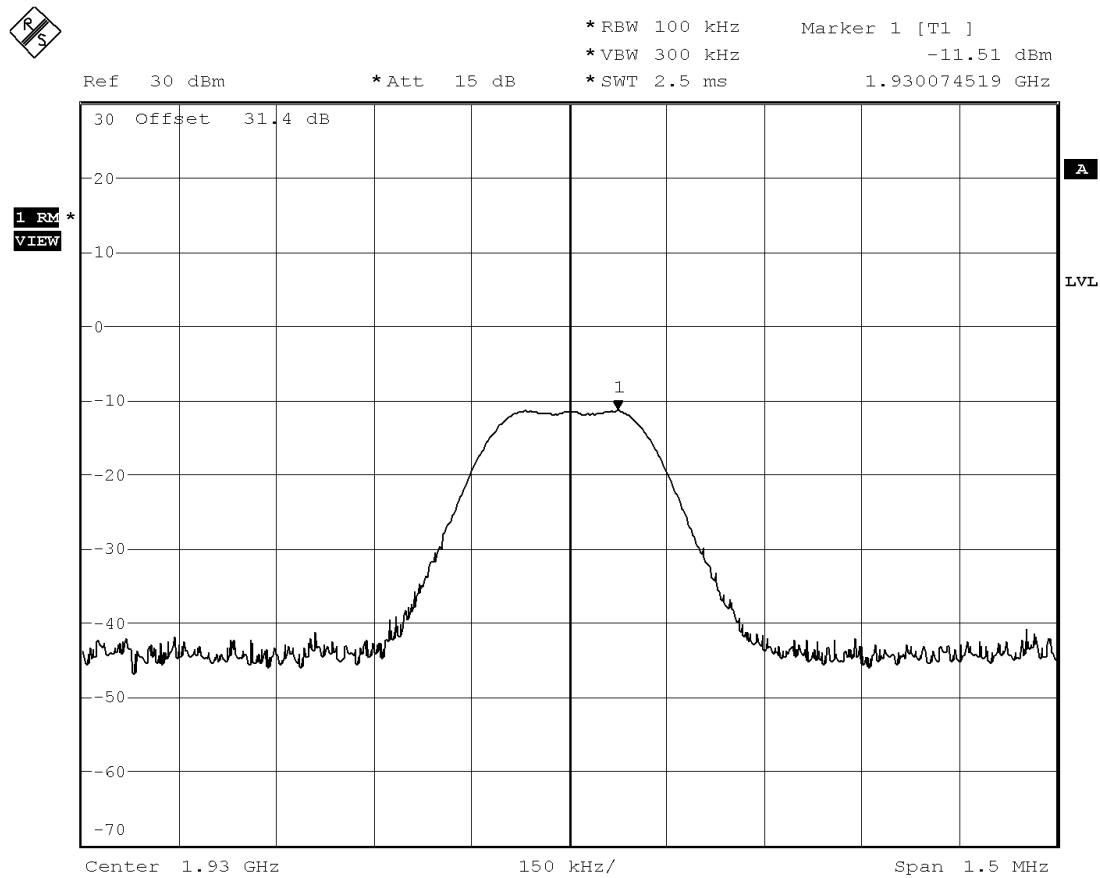
FIGURE 6: OCCUPIED BANDWIDTH

5969 Robinson Avenue Riverside, CA 92503 (951) 637-2630 FAX (951) 637-2704	<b>Occupied Bandwidth</b>	
DNB Job Number:	RV58031A	Date: 8 Sep 2004	<b>Conformance Standards</b>  [X] FCC Part 24 [X] FCC Part 90 [X] IC RSS-131 Cl 4.2
Customer:	Janizary Holdings Inc		
Model Number:	LMSWDJHNEX	Serial Number:	
Description:	RF amplifier		
	Downlink		
	Signal Source - GSM – Input – 1930MHz

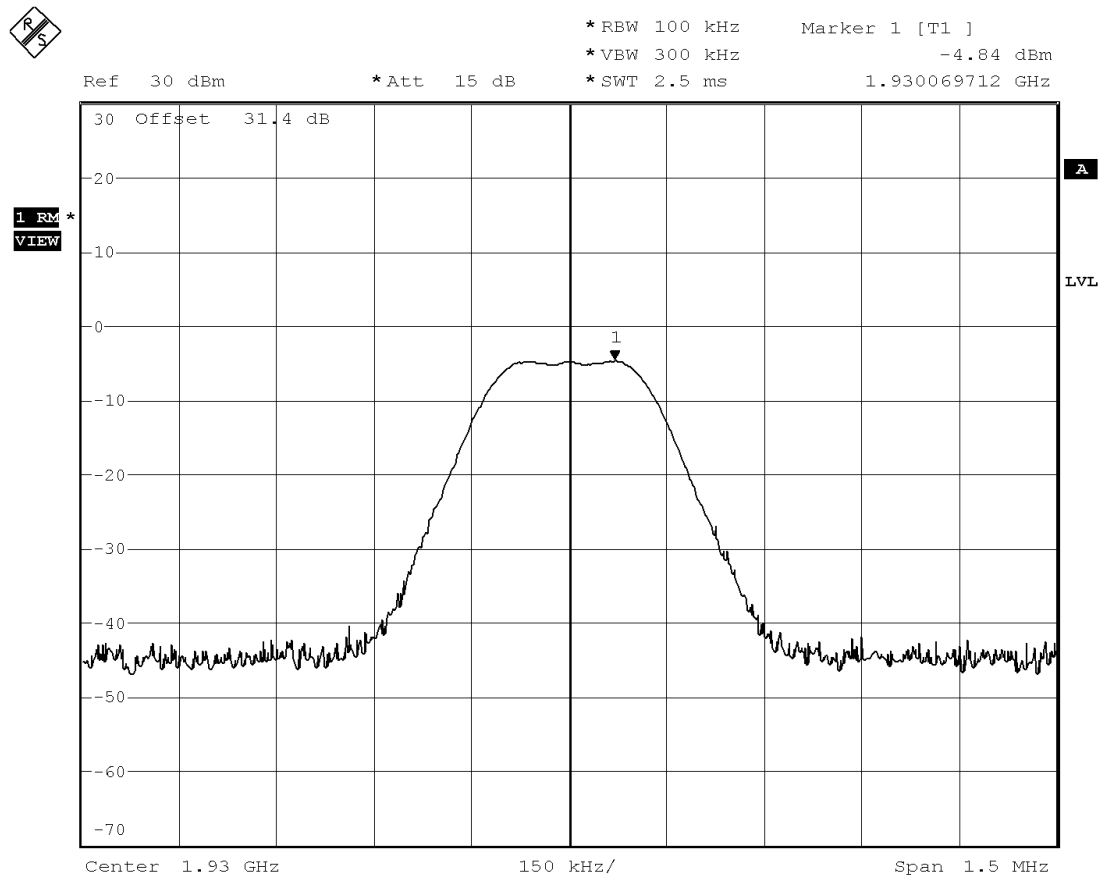
FIGURE 6: OCCUPIED BANDWIDTH

5969 Robinson Avenue Riverside, CA 92503 (951) 637-2630 FAX (951) 637-2704	<b>Occupied Bandwidth</b>		
DNB Job Number:	RV58031A	Date:	8 Sep 2004	<b>Conformance Standards</b>  [X] FCC Part 24 [X] FCC Part 90 [X] IC RSS-131 Cl 4.2
Customer:	Janizary Holdings Inc			
Model Number:	LMSWDJHNEX	Serial Number:		
Description:	RF amplifier			
	Downlink			
	Signal Source - GSM – Output – 1930MHz

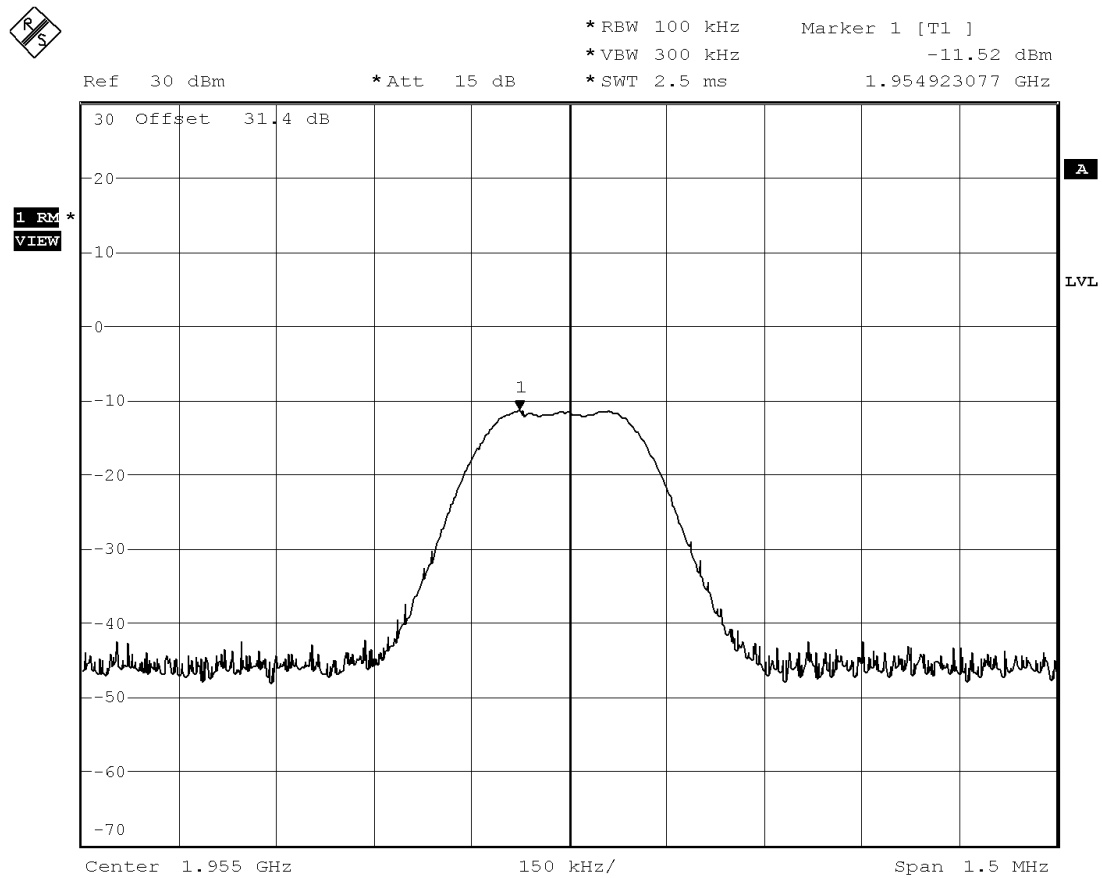
FIGURE 6: OCCUPIED BANDWIDTH

5969 Robinson Avenue Riverside, CA 92503 (951) 637-2630 FAX (951) 637-2704	<b>Occupied Bandwidth</b>	
DNB Job Number:	RV58031A	Date: 8 Sep 2004	<b>Conformance Standards</b>  [X] FCC Part 24 [X] FCC Part 90 [X] IC RSS-131 Cl 4.2
Customer:	Janizary Holdings Inc		
Model Number:	LMSWDJHNEX	Serial Number:	
Description:	RF amplifier		
	Downlink		
	Signal Source - GSM – Input – 1955MHz

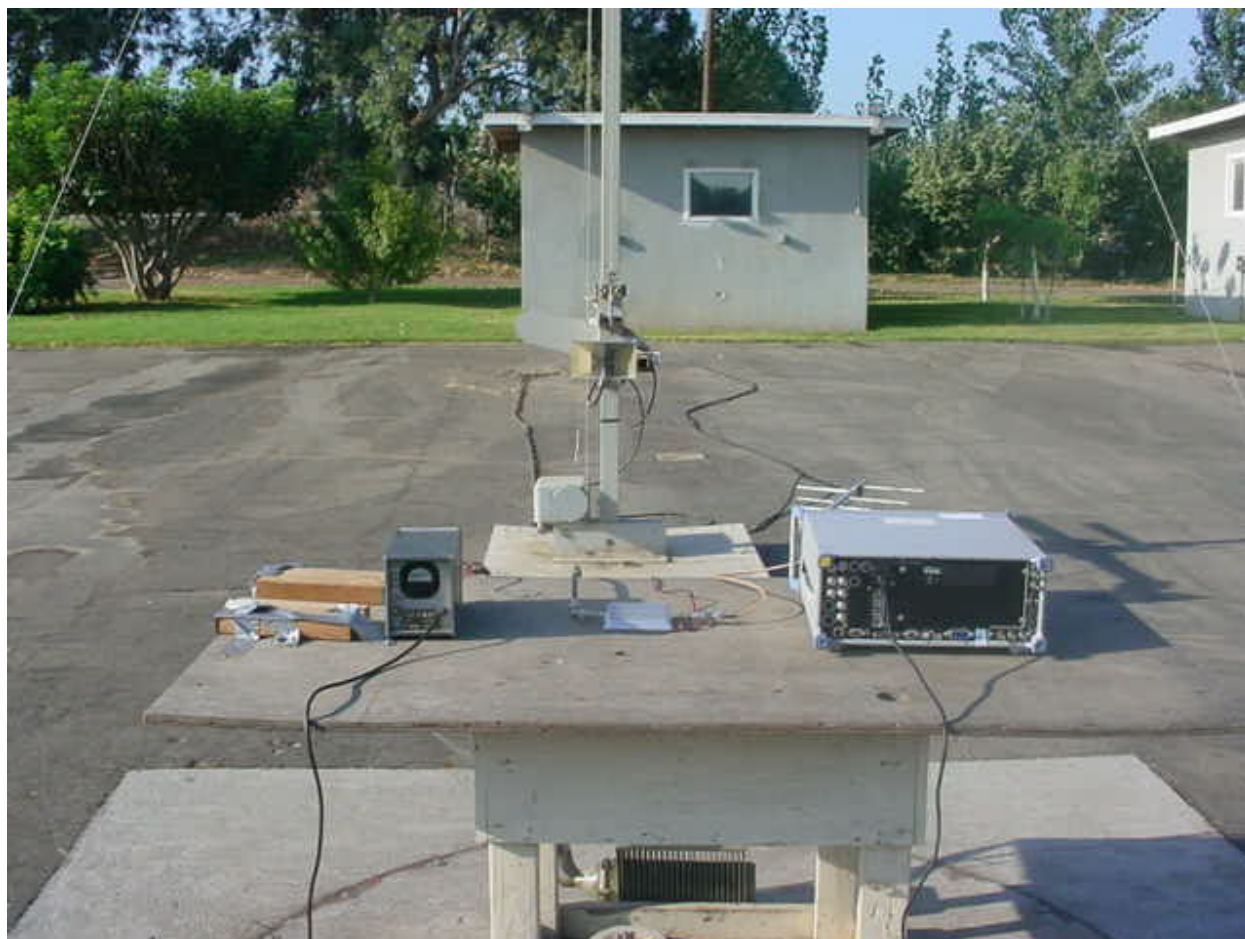
**PHOTO: RF POWER OUTPUT, EMISSIONS LIMITATIONS  
GSM/TDMA, OCCUPIED BANDWIDTH  
GSM/TDMA, CONDUCTED SPURIOUS  
EMISSIONS AT ANTENNA TERMINALS**
