## n5A / 15KHz / 20MHz

## 6. Conducted Spurious Emission

## 7. Frequency Stability

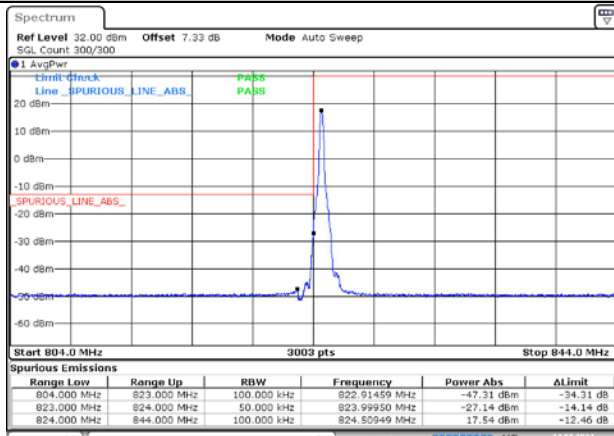
## LCH / DFT-Pi2BPSK / Edge\_1RB\_Left

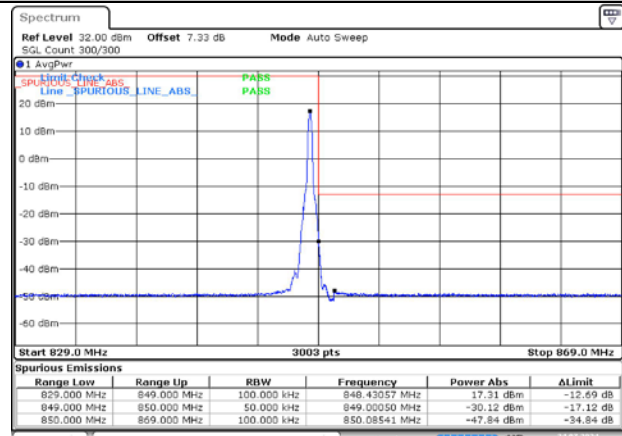
## HCH / DFT-Pi2BPSK / Edge\_1RB\_Right

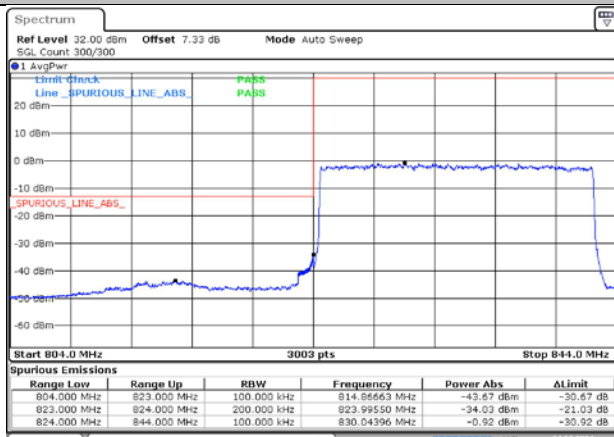
## LCH / DFT-Pi2BPSK / Outer\_Full

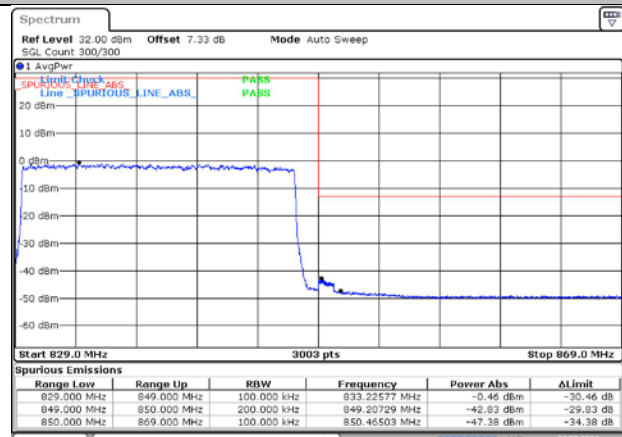
## HCH / DFT-Pi2BPSK / Outer\_Full

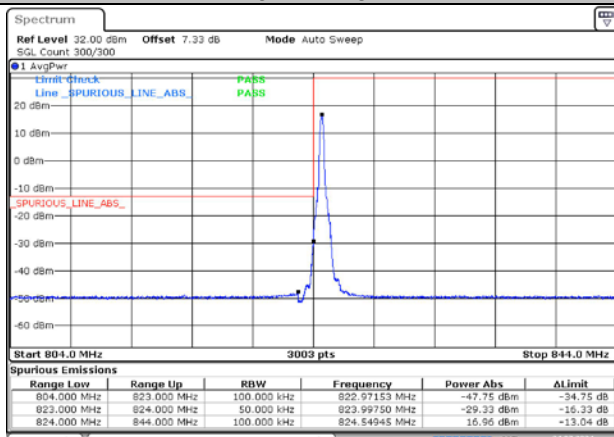
## LCH / DFT-QPSK / Edge\_1RB\_Left

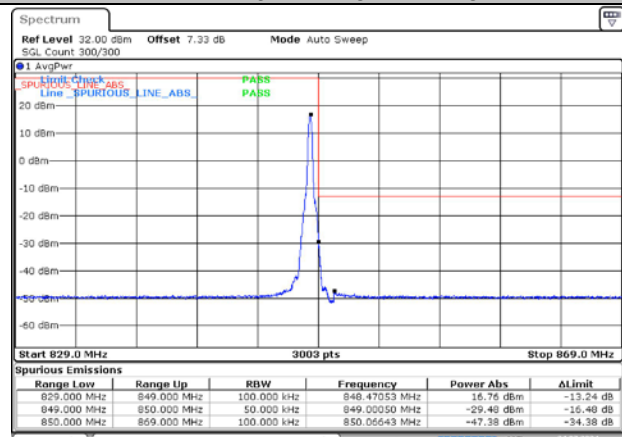
## HCH / DFT-QPSK / Edge\_1RB\_Right
