## DC\_66A\_n38A / 30KHz / 20MHz

## 7. Frequency Stability

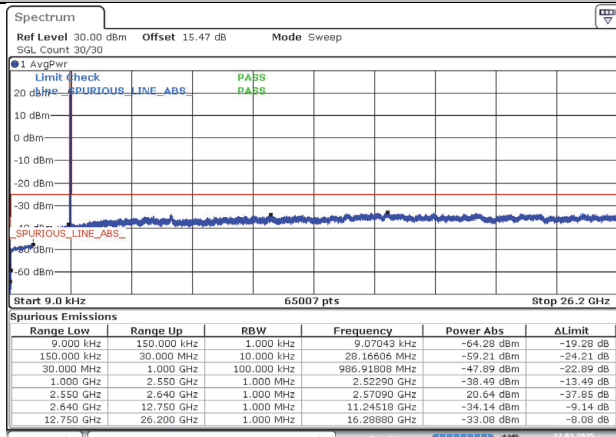
## LCH / DFT-Pi2BPSK / Edge\_1RB\_Left

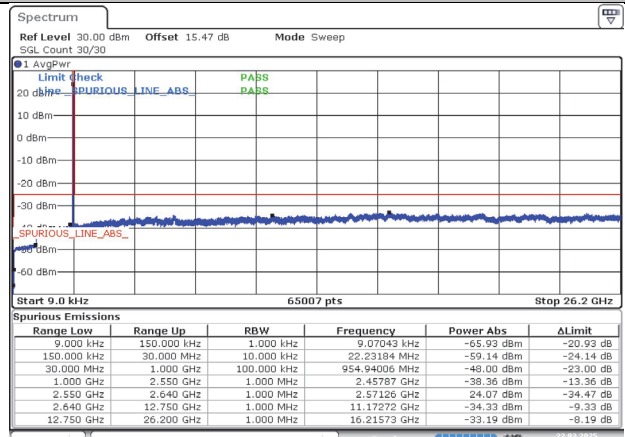
## LCH / DFT-QPSK / Edge\_1RB\_Left

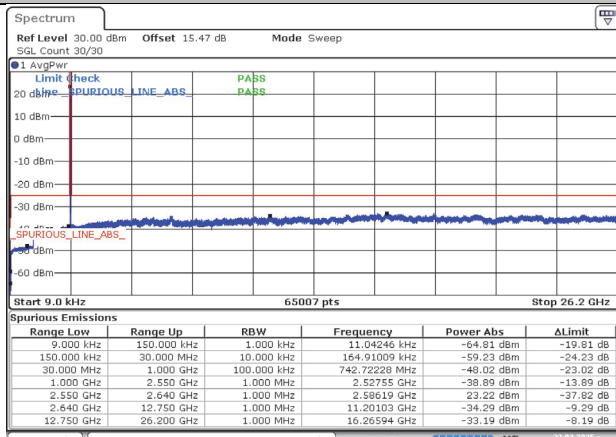
## MCH / DFT-Pi2BPSK / Edge\_1RB\_Left

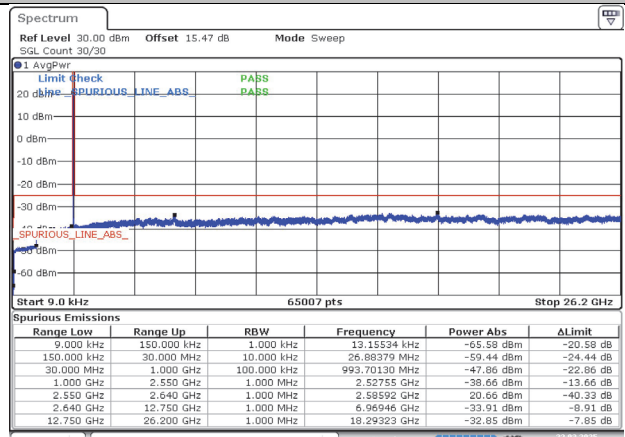
## MCH / DFT-QPSK / Edge\_1RB\_Left

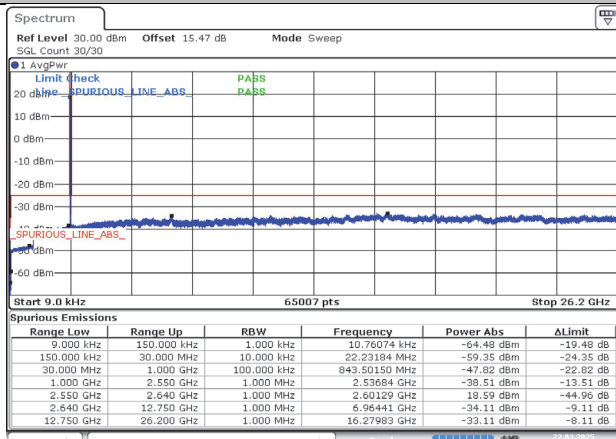
## HCH / DFT-Pi2BPSK / Edge\_1RB\_Left

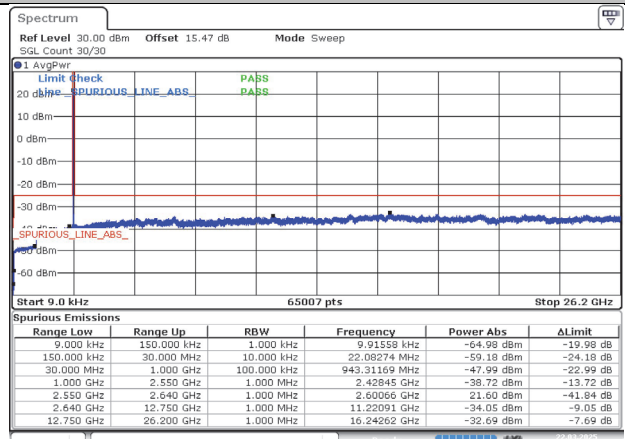
## HCH / DFT-QPSK / Edge\_1RB\_Left
