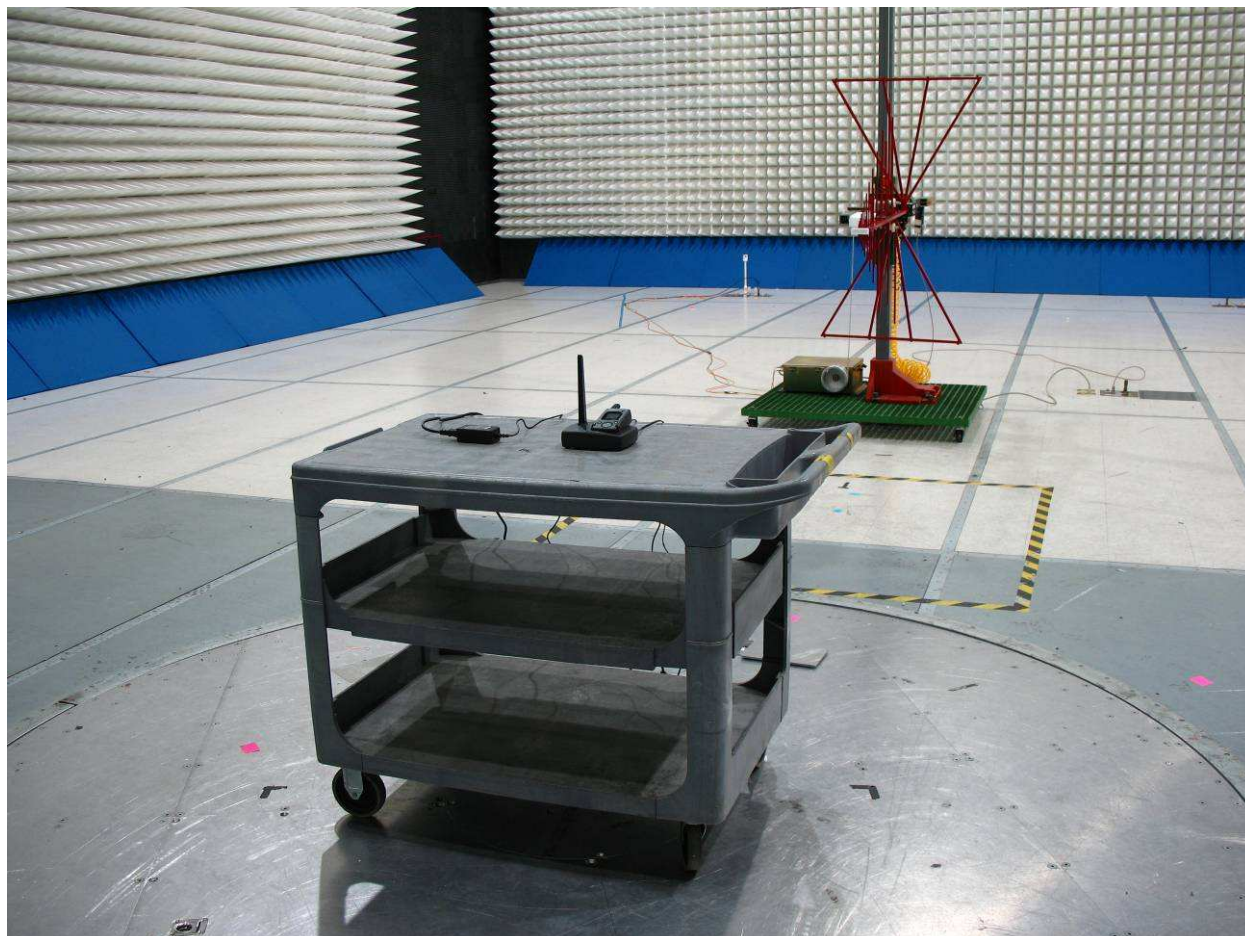
*Exhibit 8*

*Photograph of Radiated Emissions Test Setup – Front*

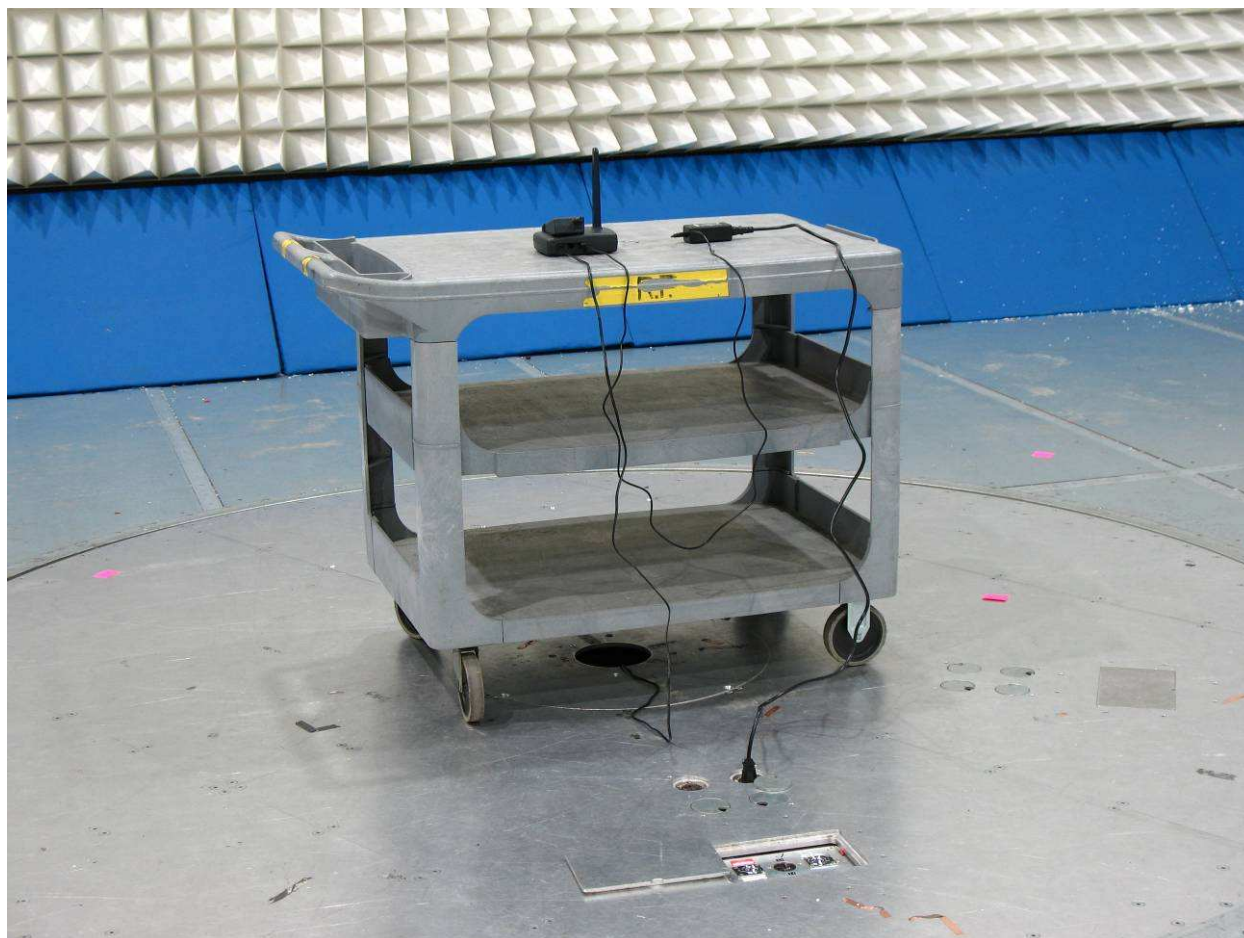
*Exhibit 9*

*Photograph of Radiated Emissions Test Setup – Back*

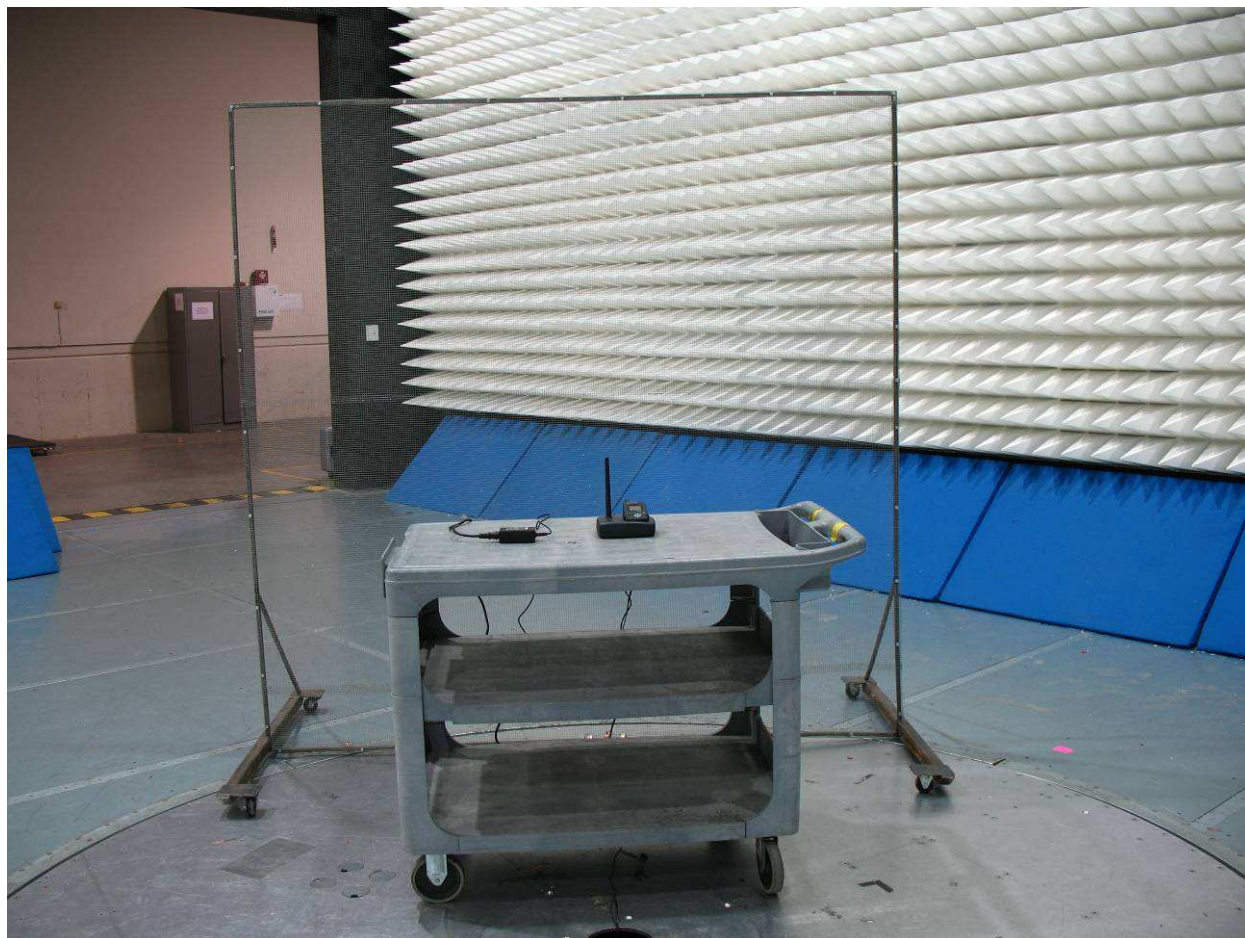
*Exhibit 13*

*Photograph of the Conducted Voltage Emissions Test Setup - Front*

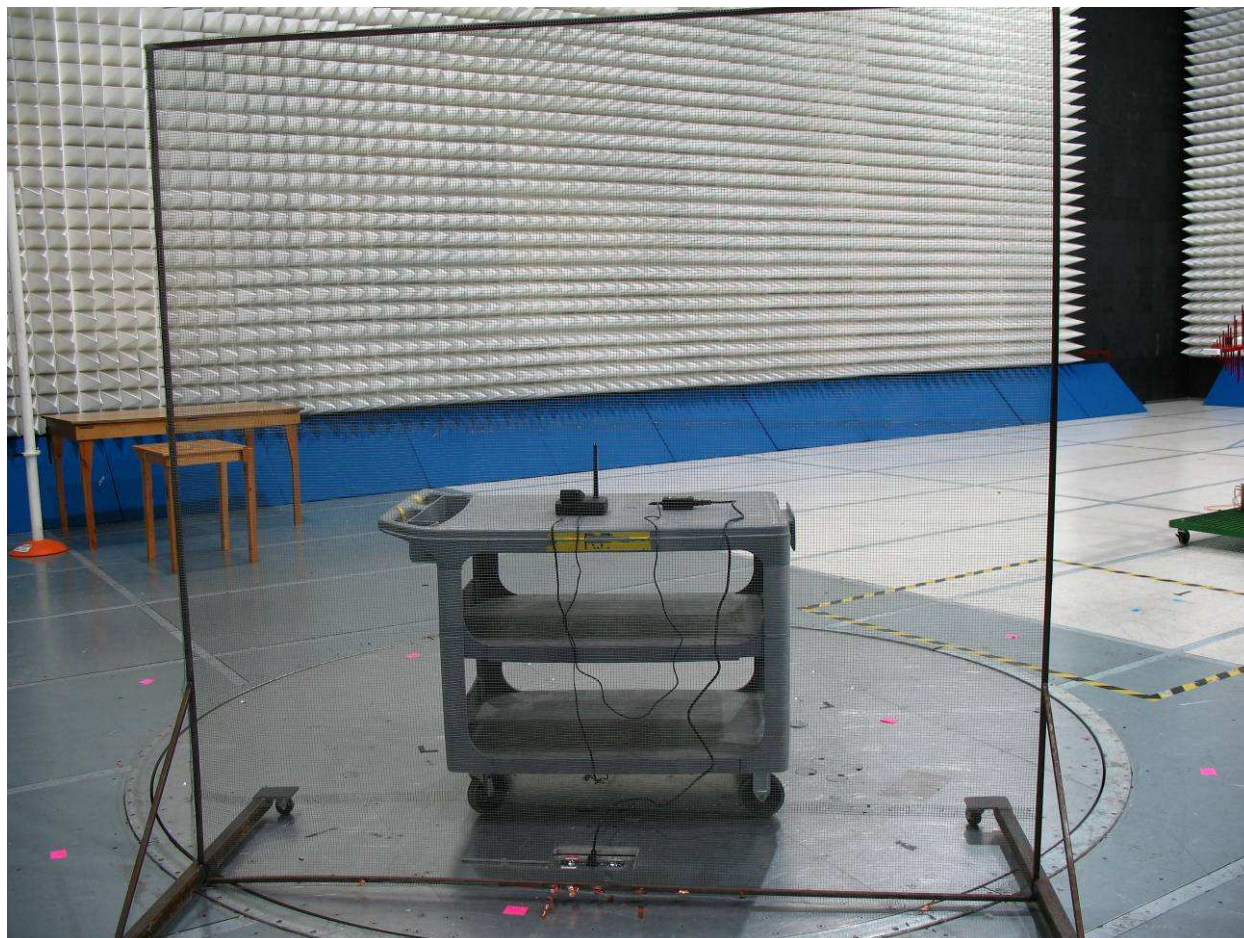
*Exhibit 14*

*Photograph of the Conducted Voltage Emissions Test Setup - Back*
