Annex C Photo documentation

Appendix to Test Report No.: 1-2977/11-100-03

CETECOM ICT Services GmbH

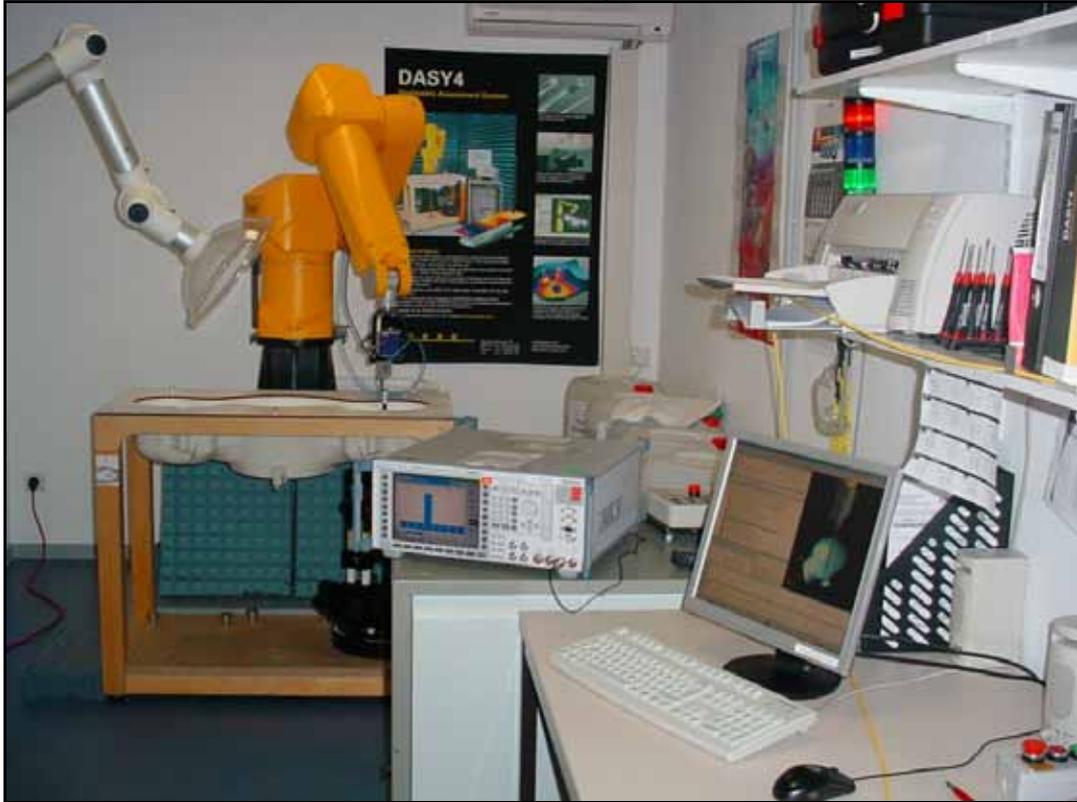
Photo 1: Measurement System DASY 4

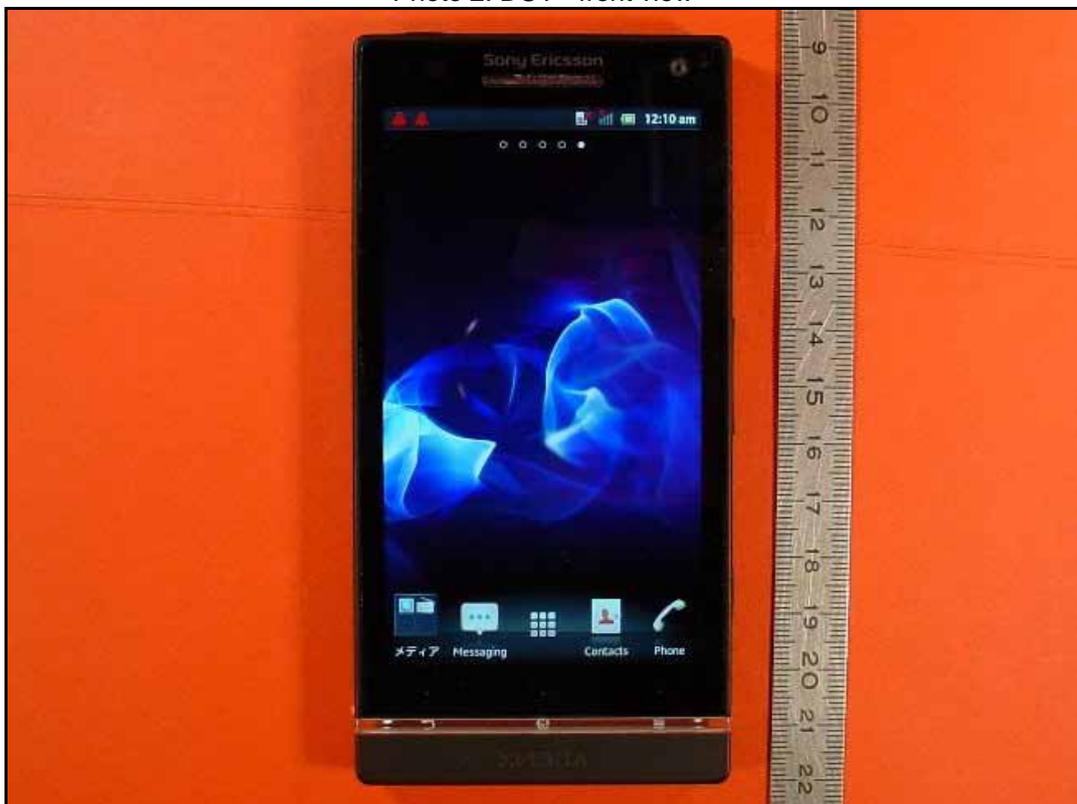
Photo 2: DUT - front view

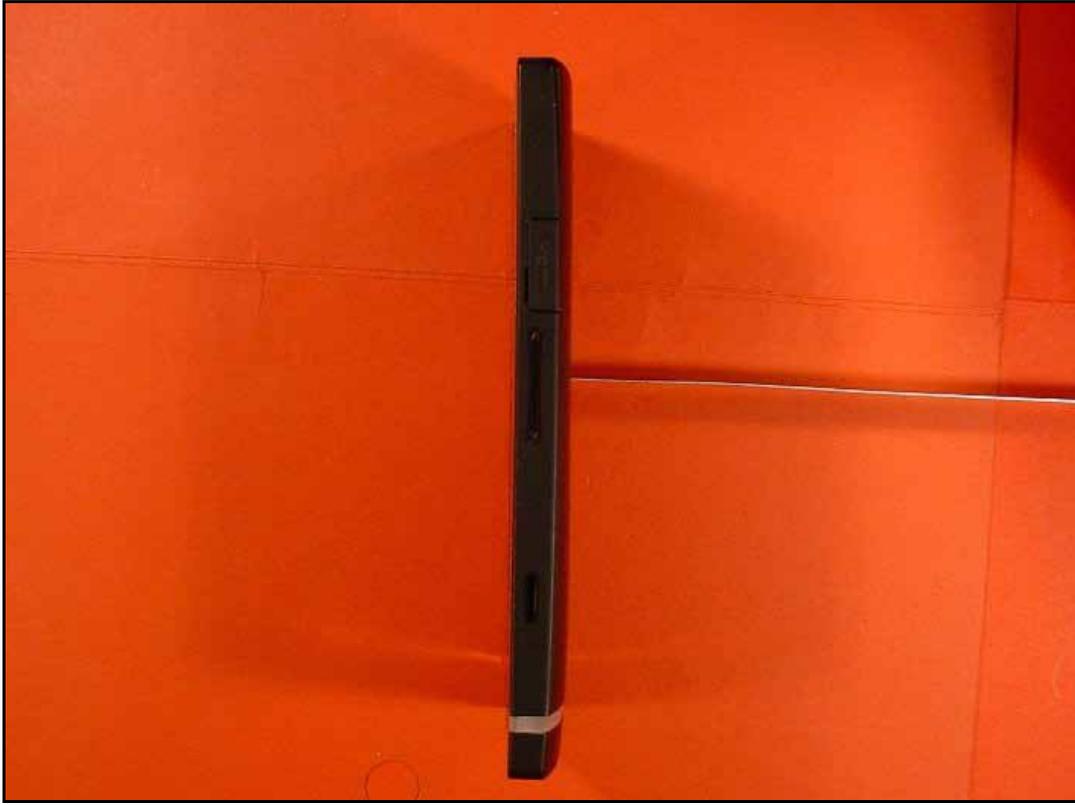
Photo 3: DUT - side view

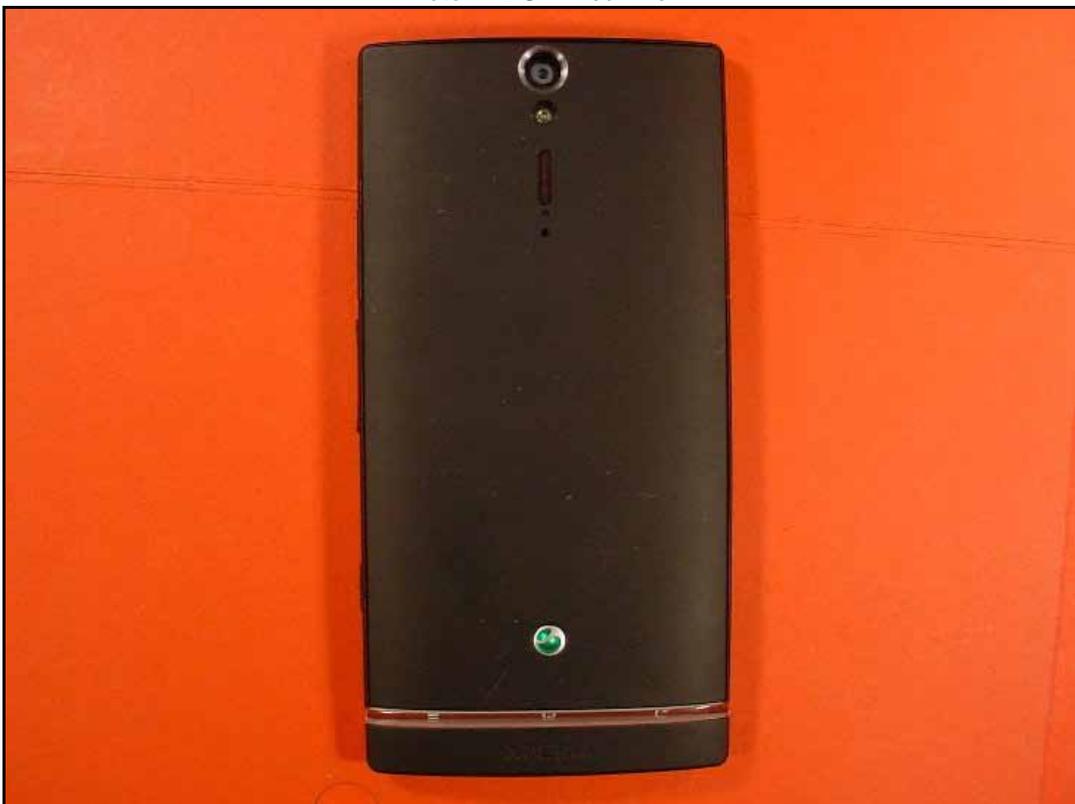
Photo 4: DUT - rear view

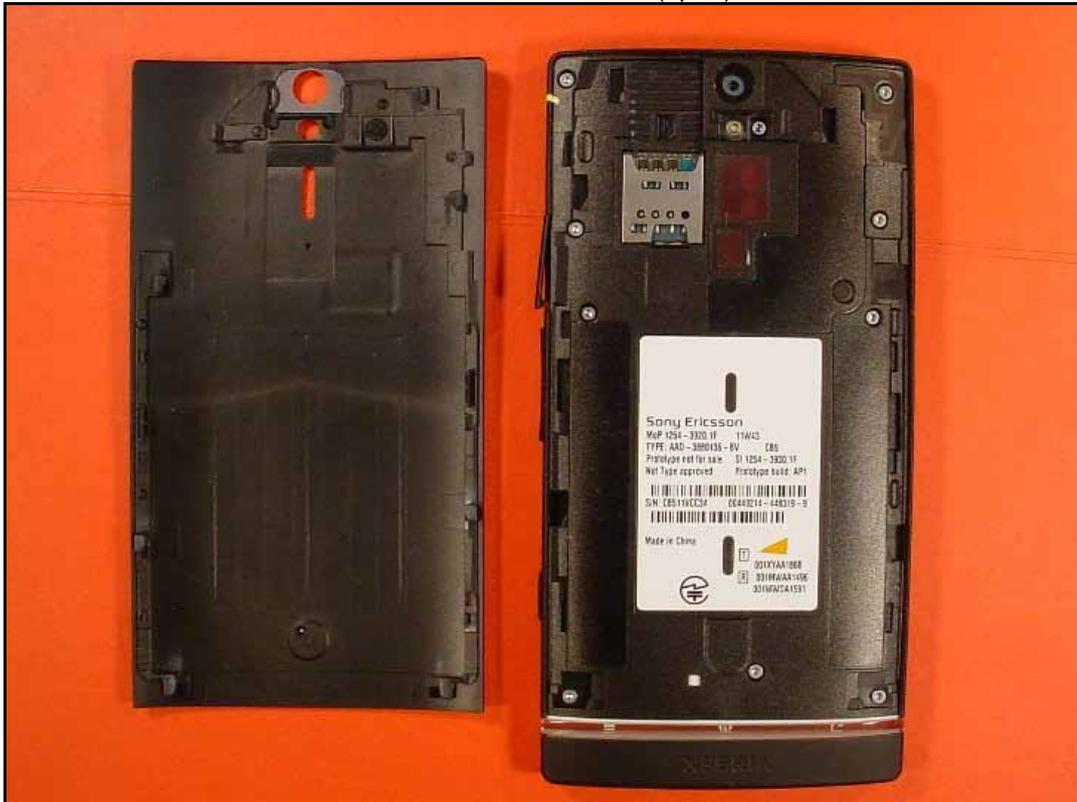
Photo 5: DUT - rear view (open)

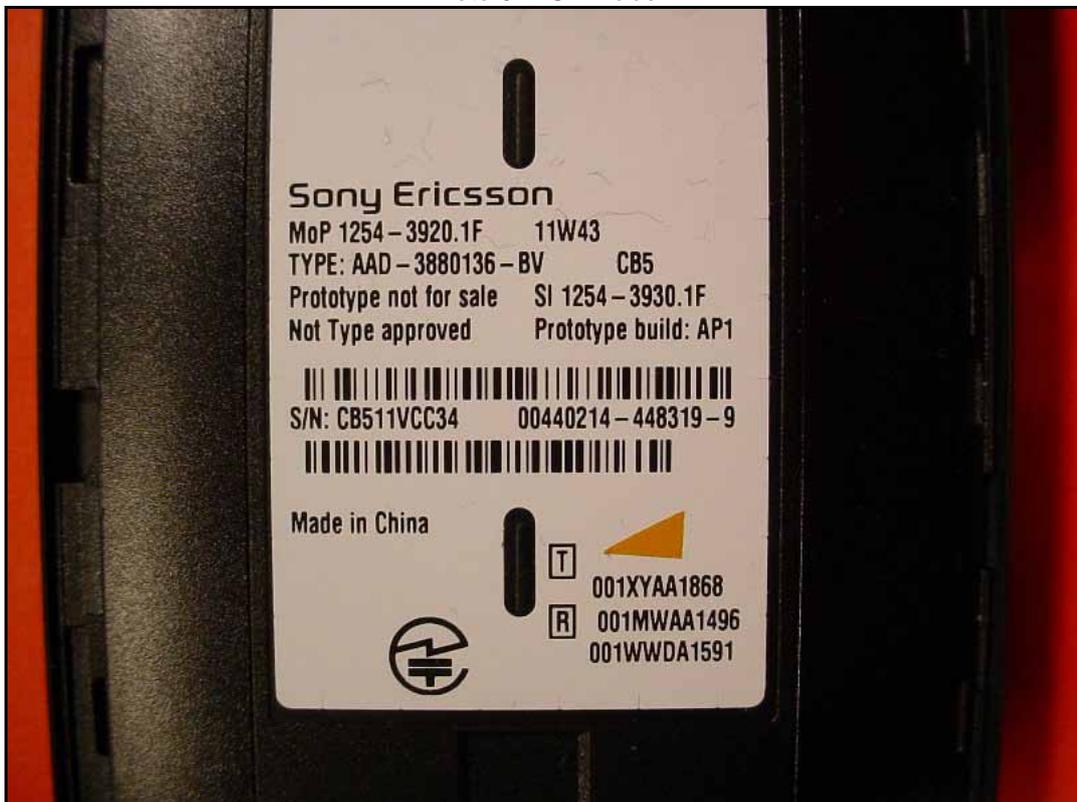
Photo 6: DUT - label

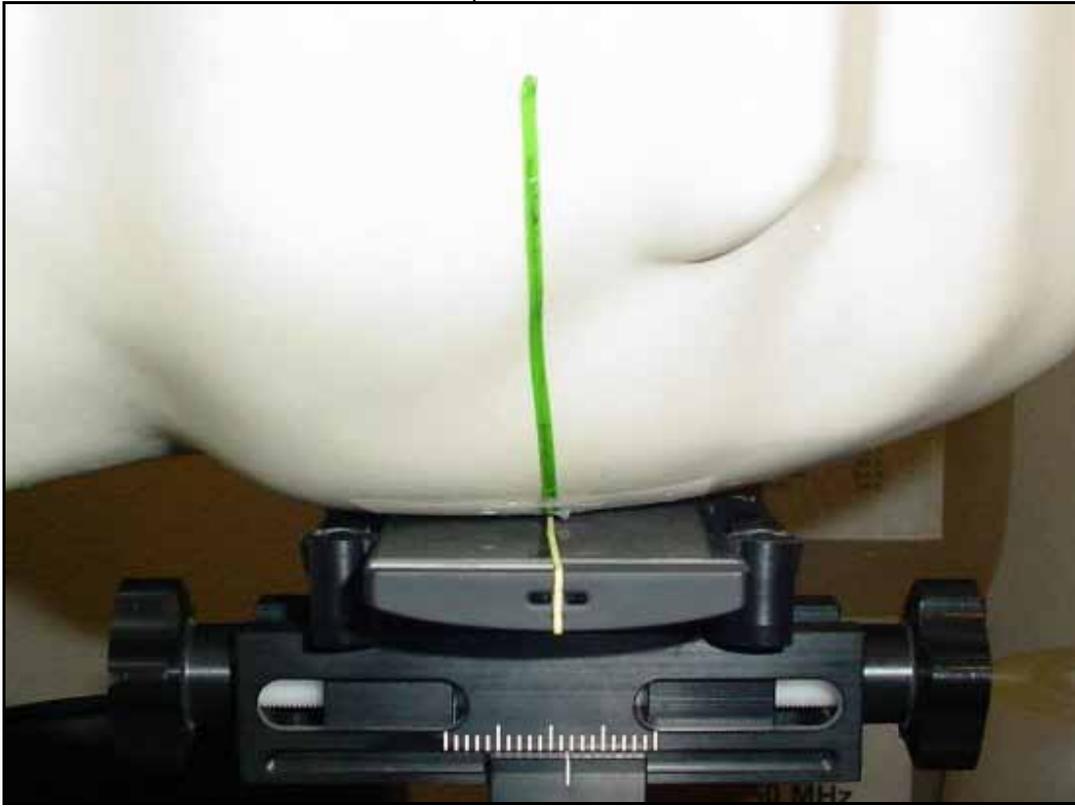
Photo 7: Test position left hand touched

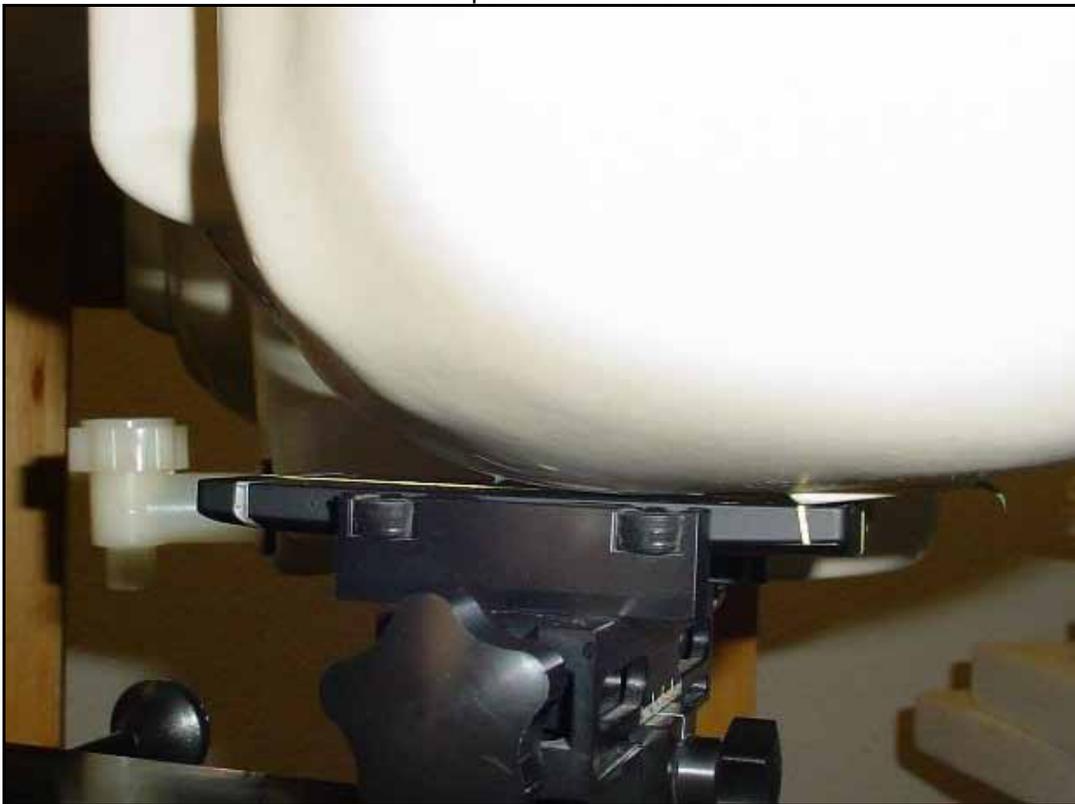
Photo 8: Test position left hand touched

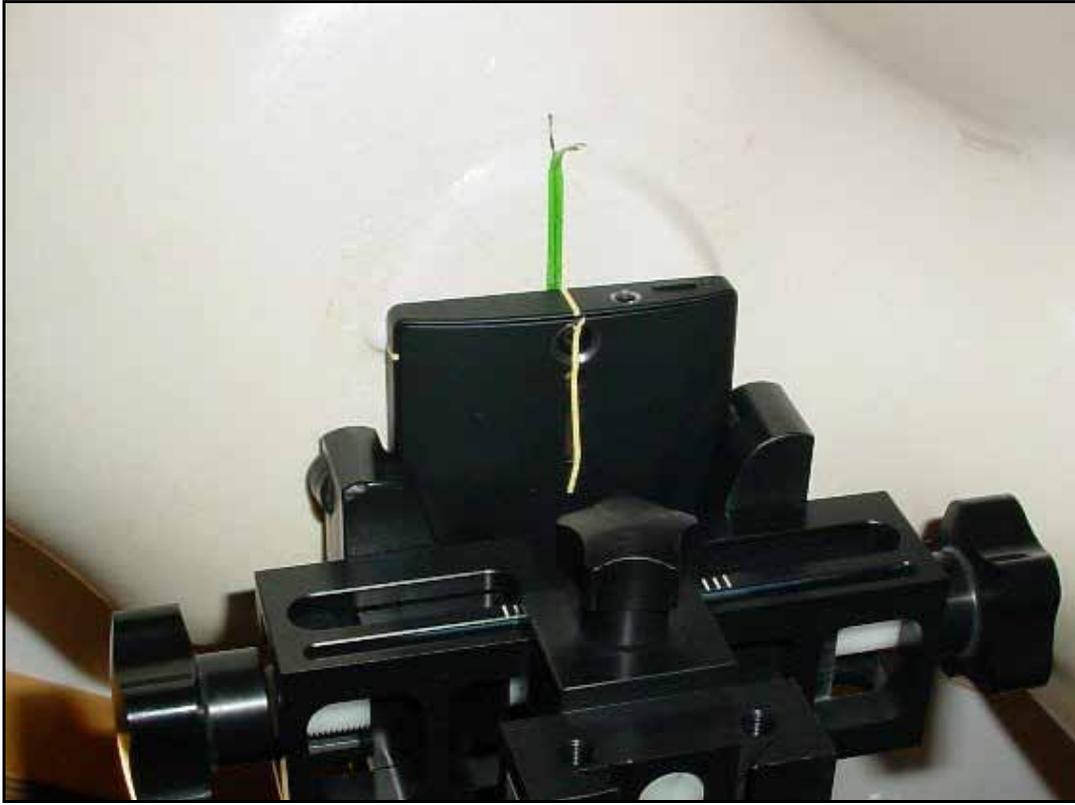
Photo 9: Test position left hand touched

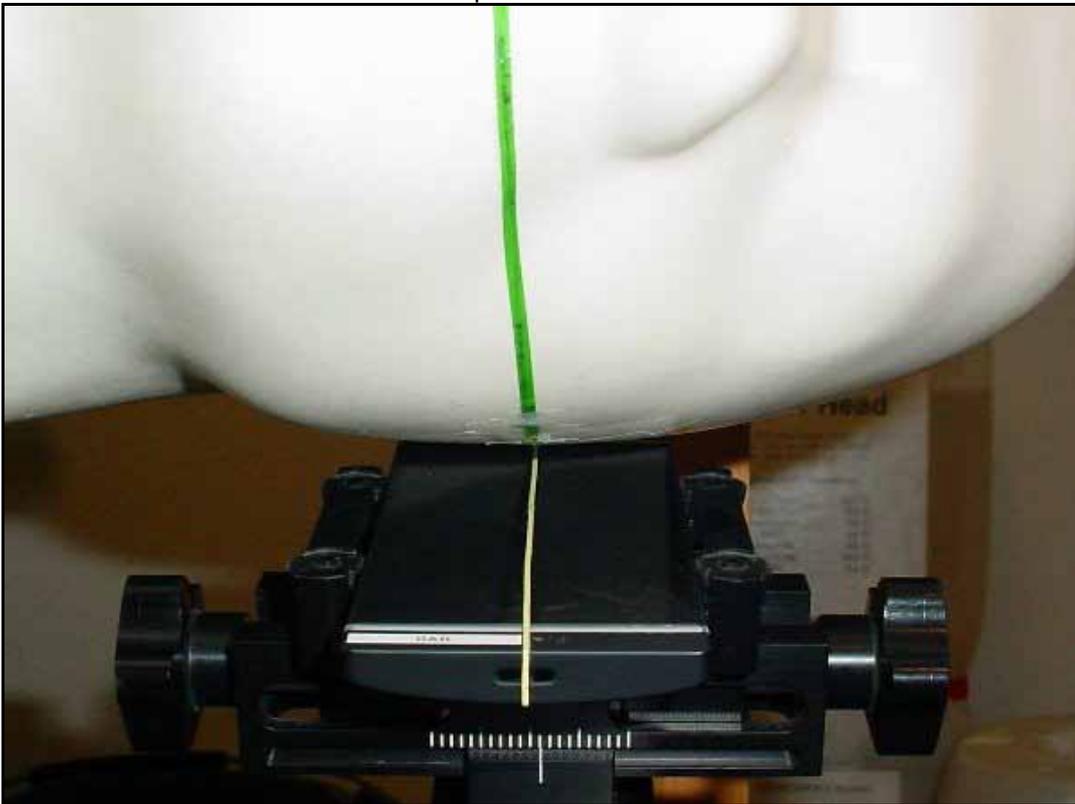
Photo 10: Test position left hand tilted 15°

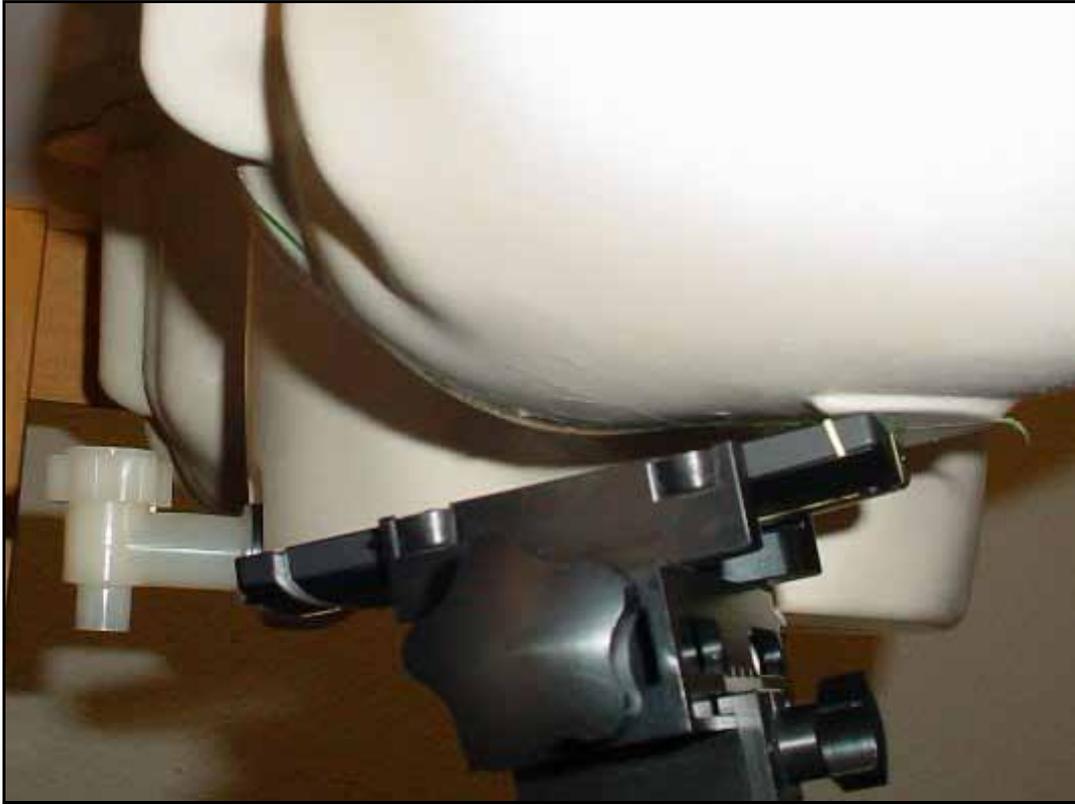
Photo 11: Test position left hand tilted 15°

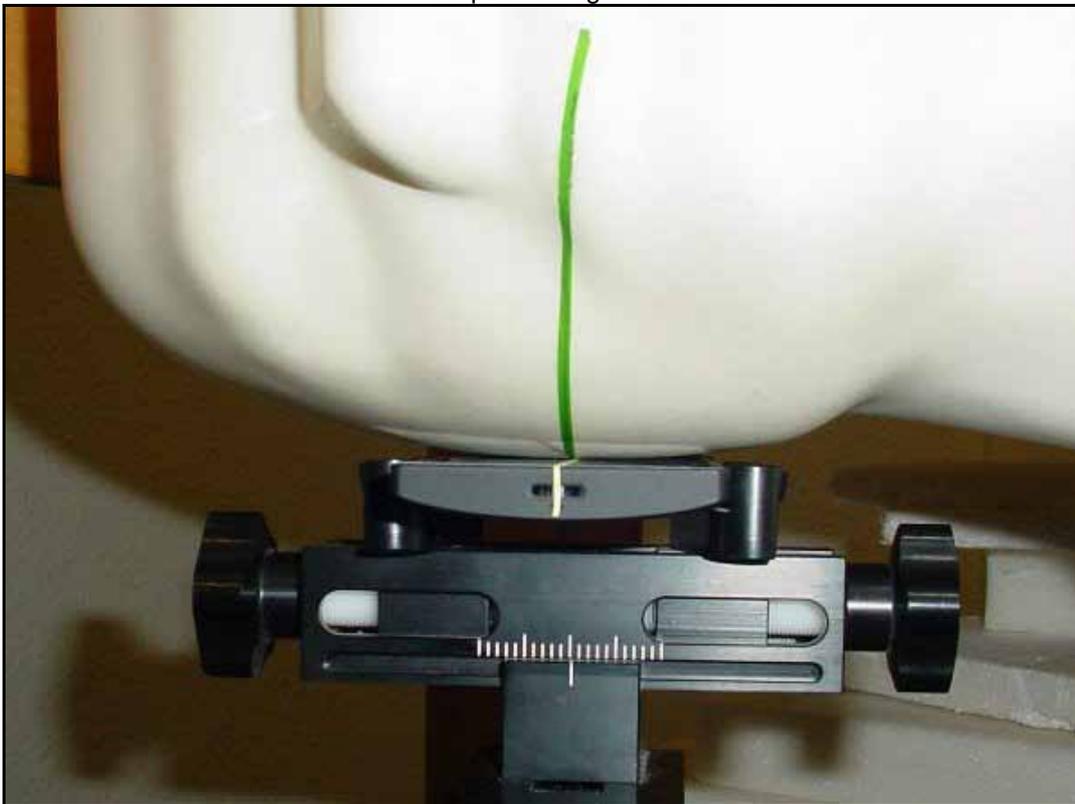
Photo 12: Test position right hand touched

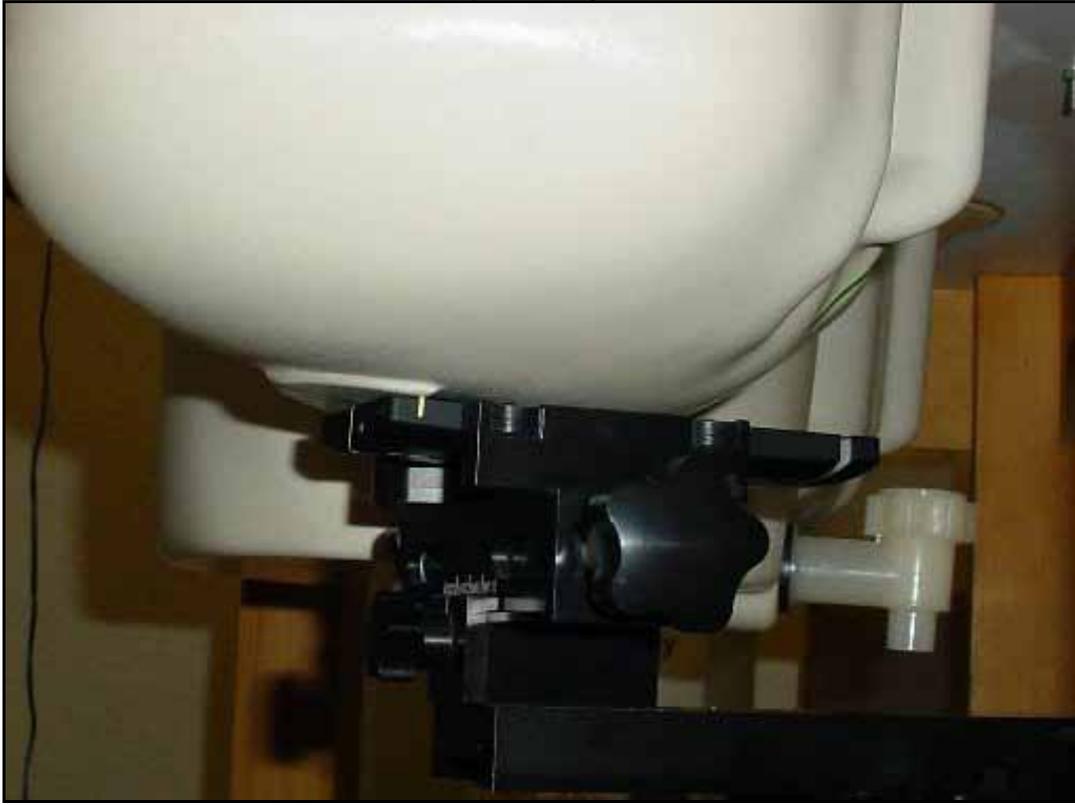
Photo 13: Test position right hand touched

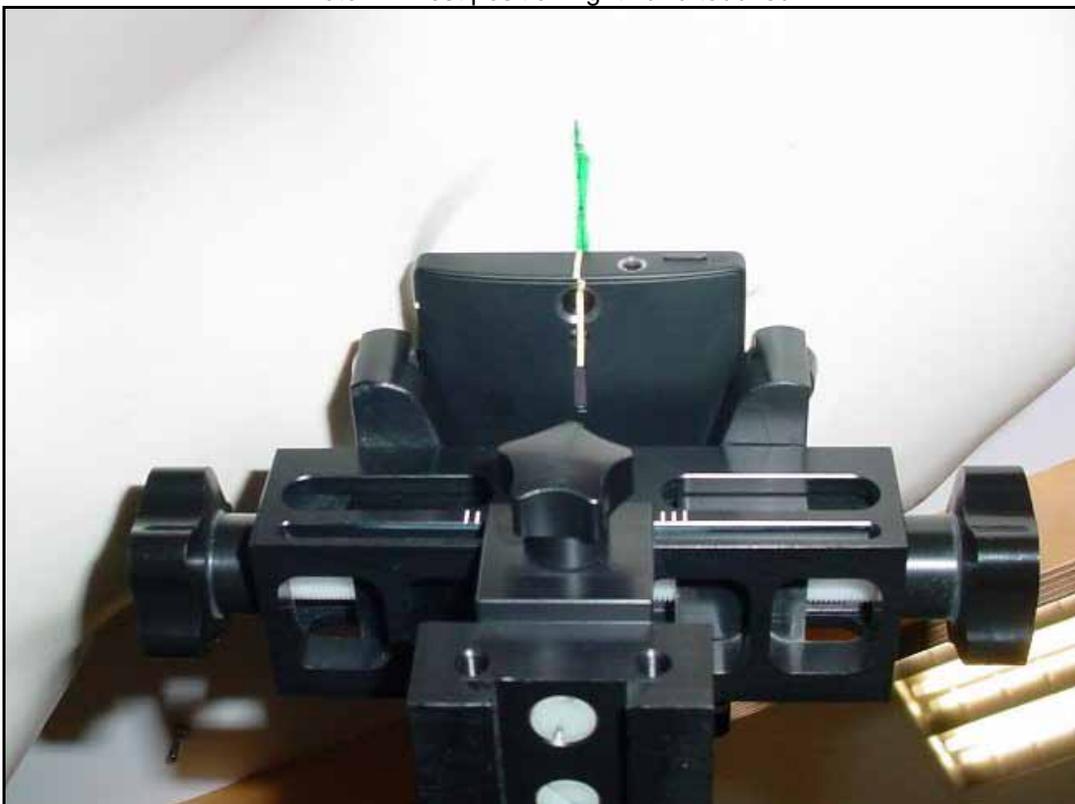
Photo 14: Test position right hand touched

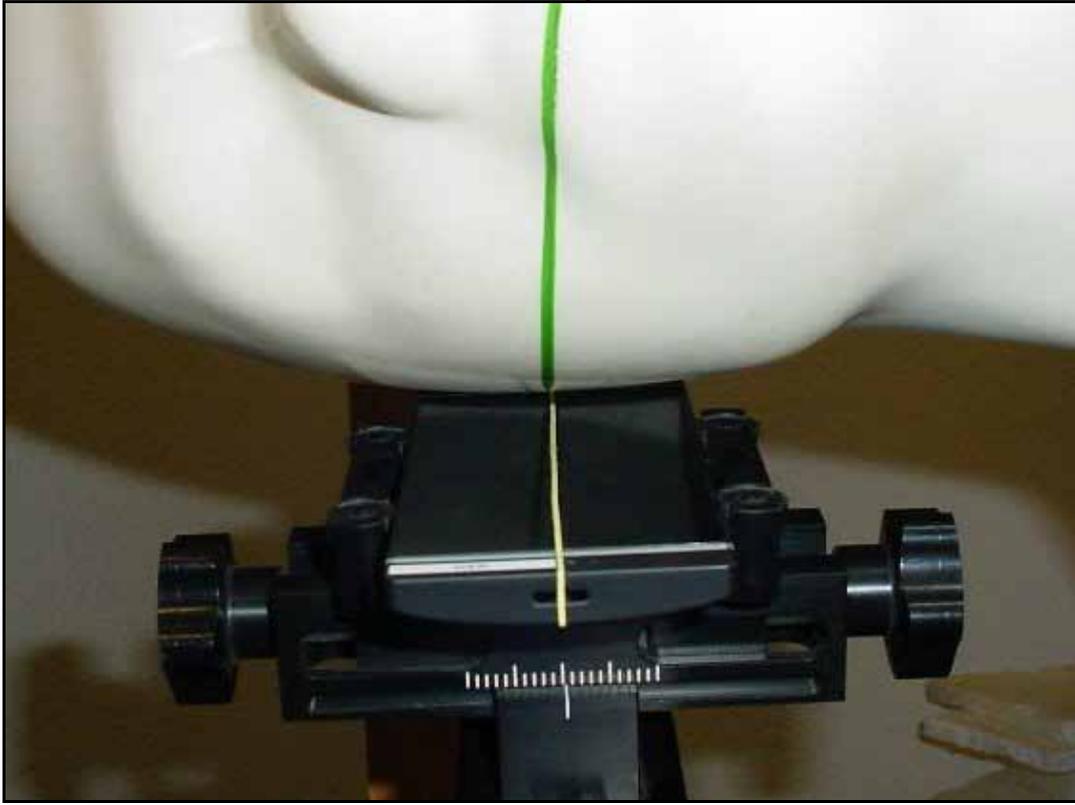
Photo 15: Test position right hand tilted 15°

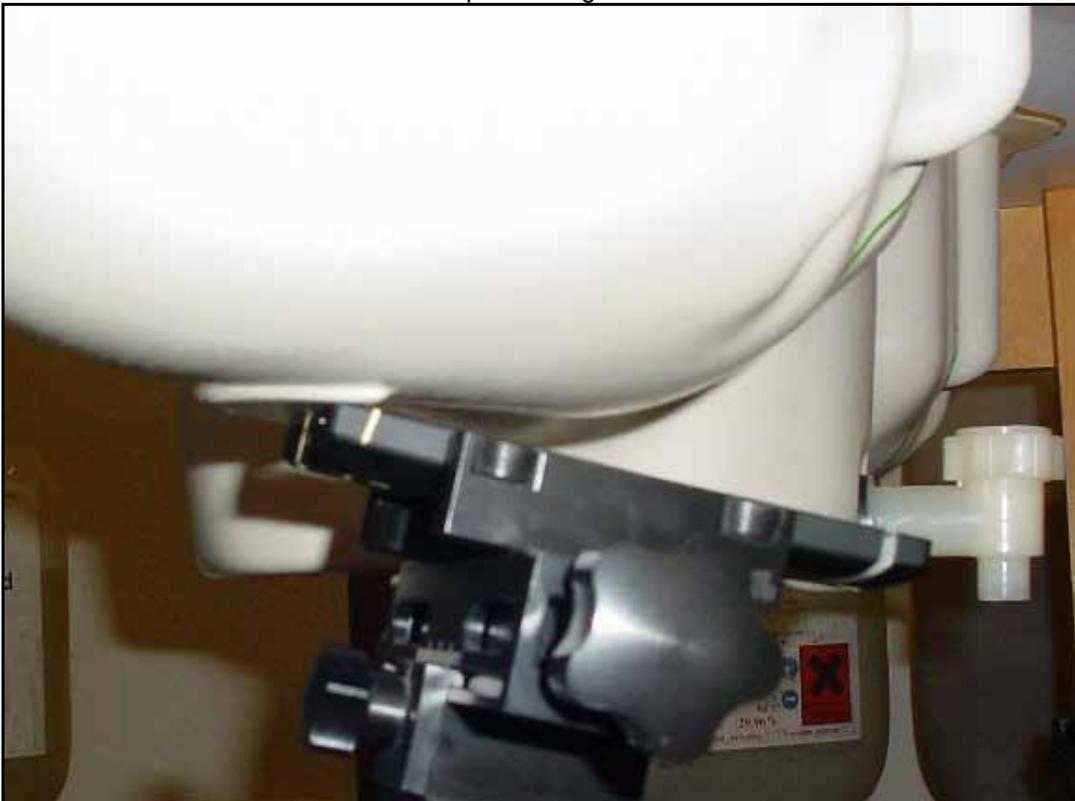
Photo 16: Test position right hand tilted 15°

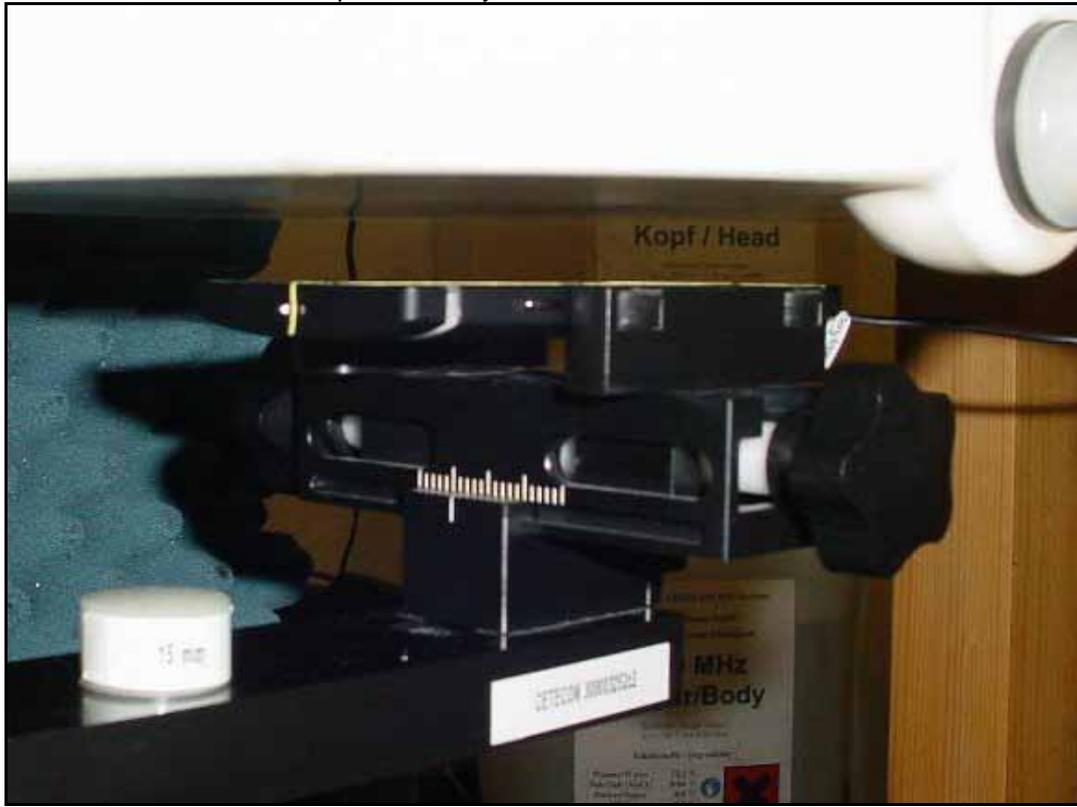
Photo 17: Test position body worn front side with 15 mm distance

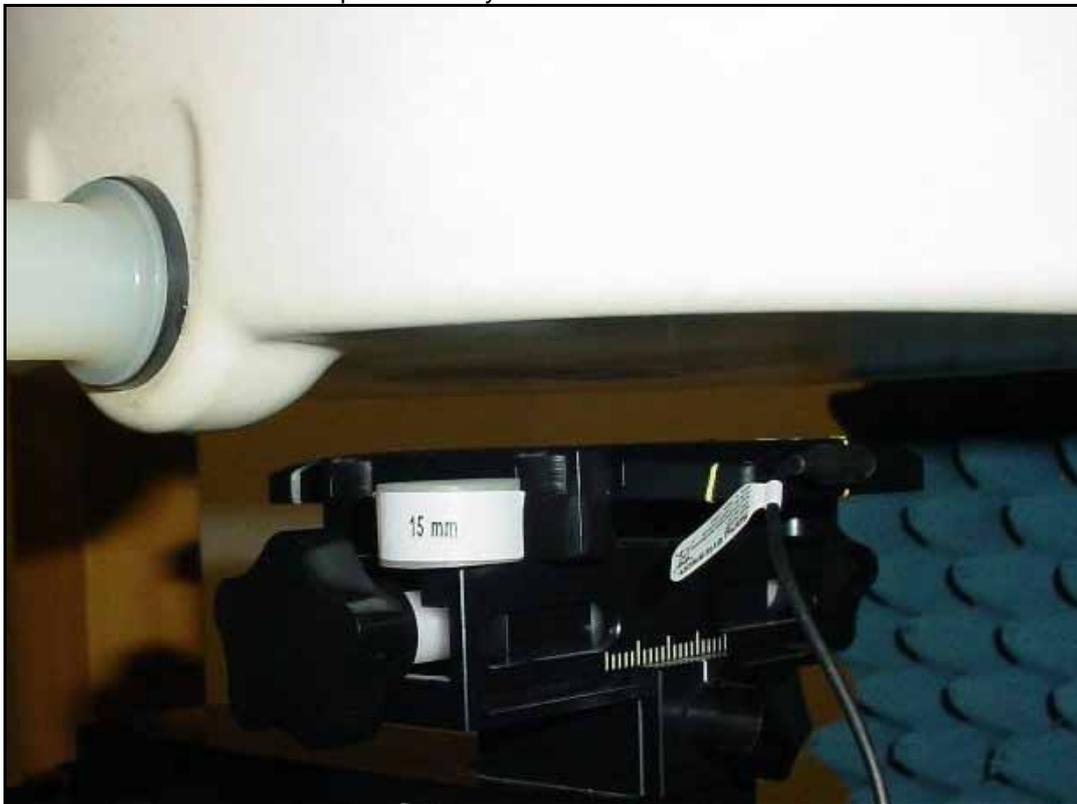
Photo 18: Test position body worn rear side with 15 mm distance

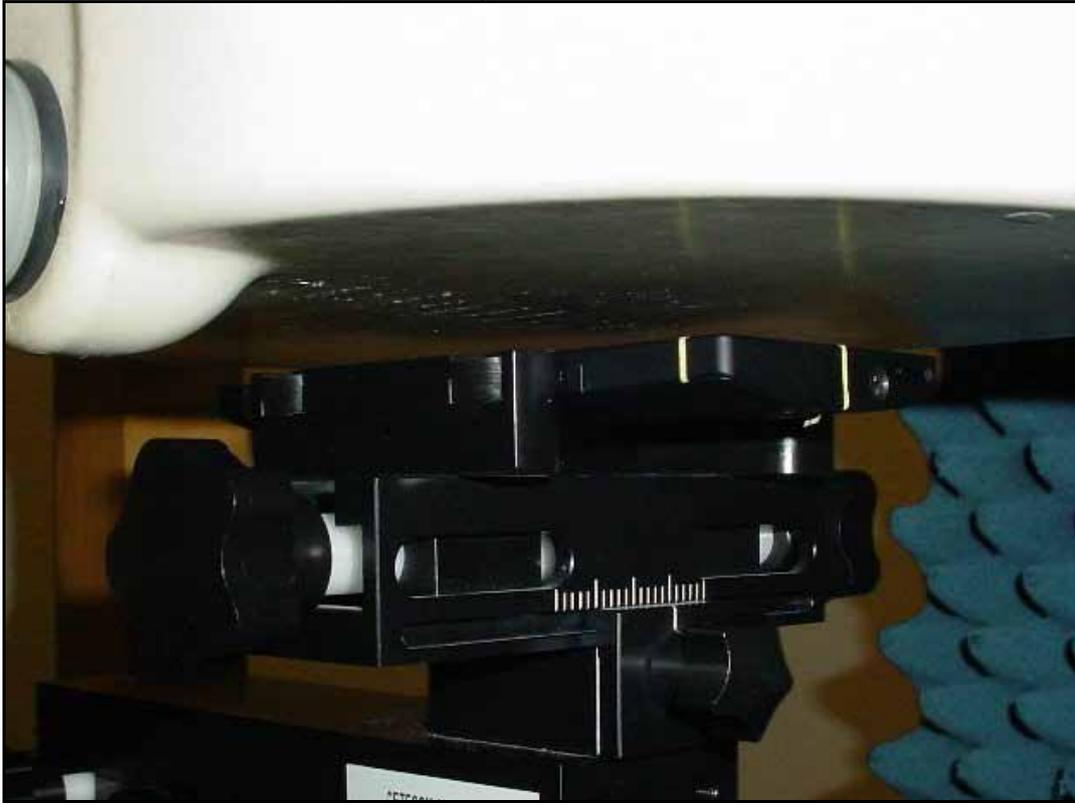
Photo 19: Test position body worn front side with 10 mm distance

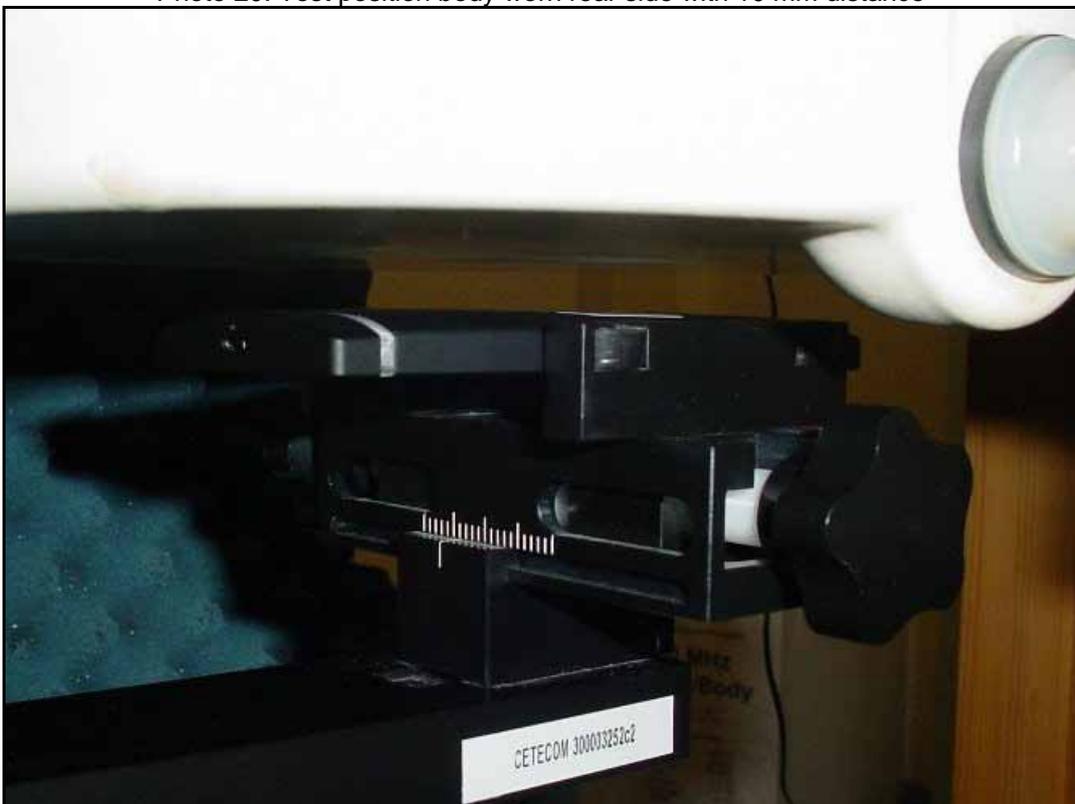
Photo 20: Test position body worn rear side with 10 mm distance

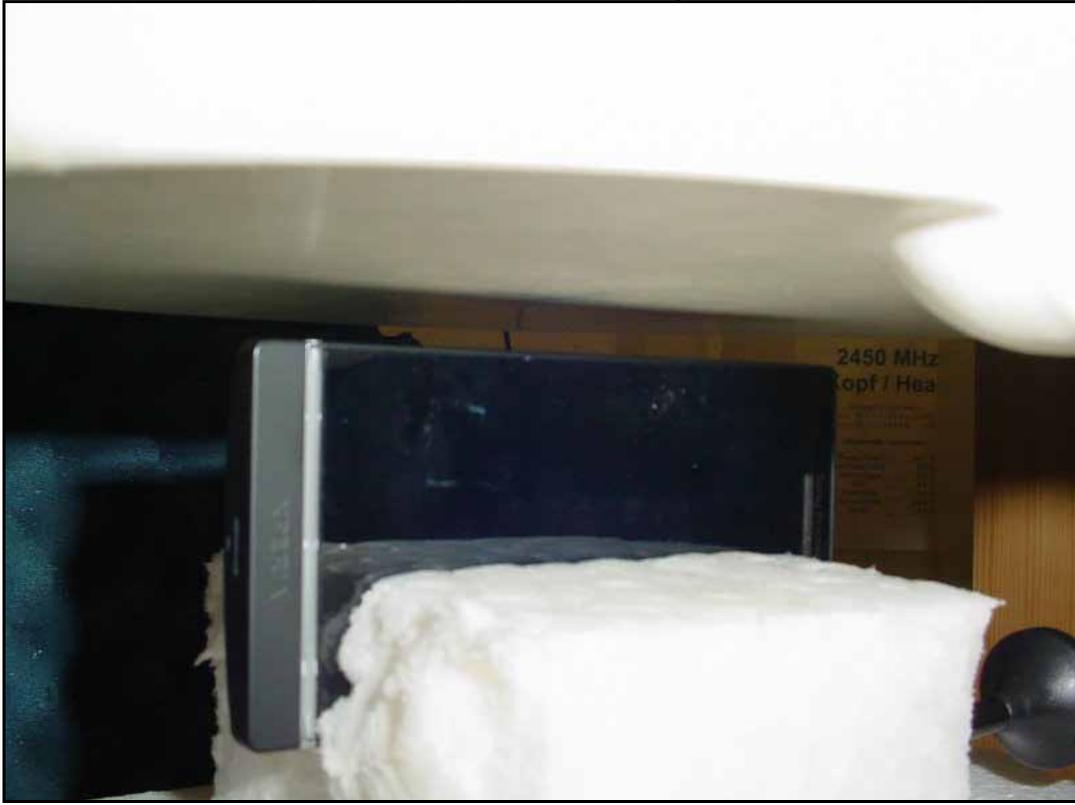
Photo 21: Test position body worn left side edge with 10 mm distance

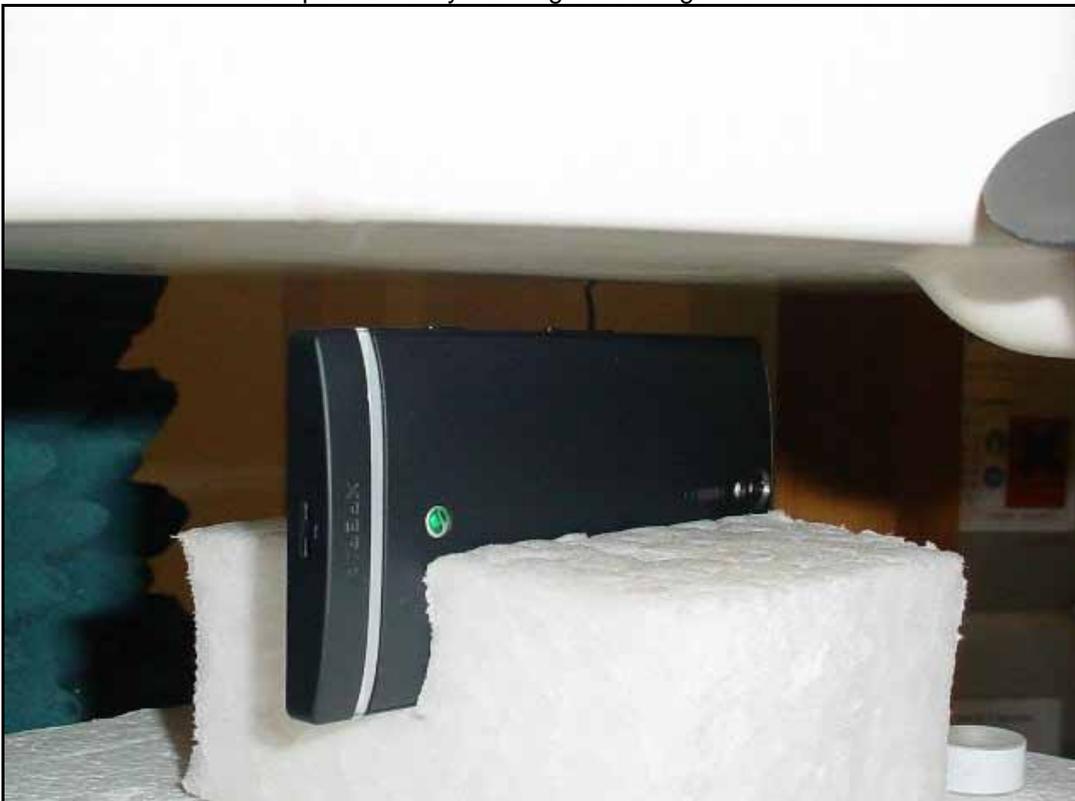
Photo 22: Test position body worn right side edge with 10 mm distance

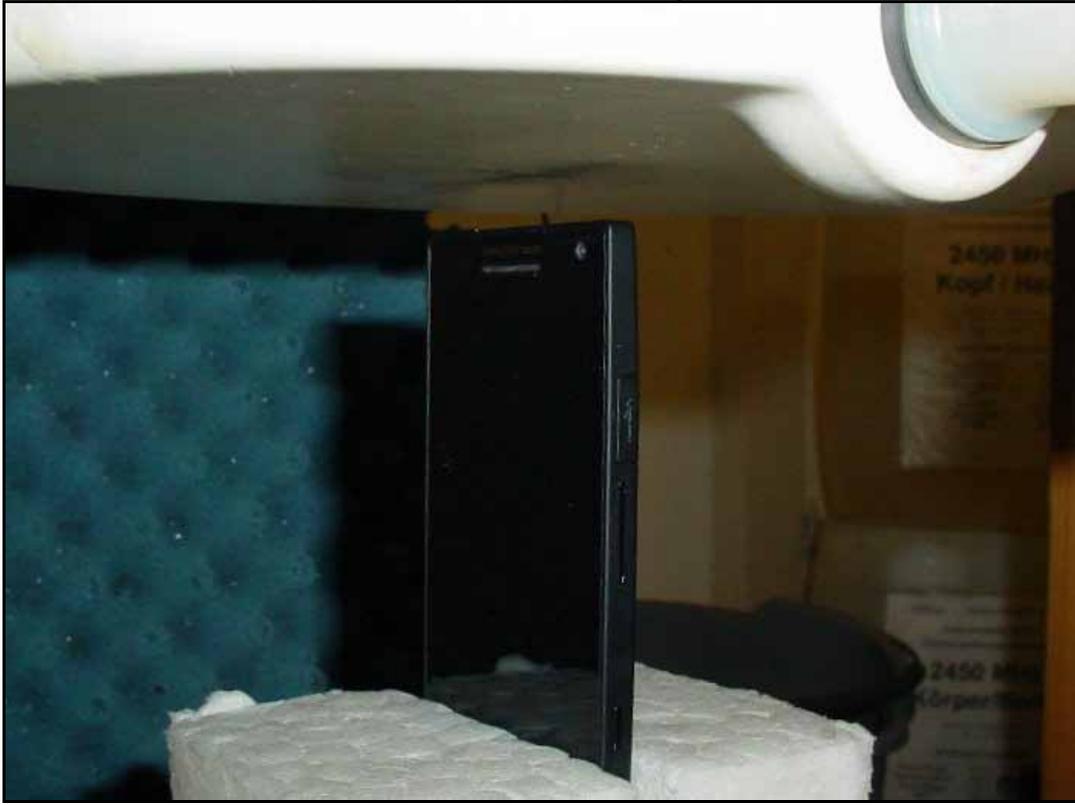
Photo 23: Test position body worn top side edge with 10 mm distance

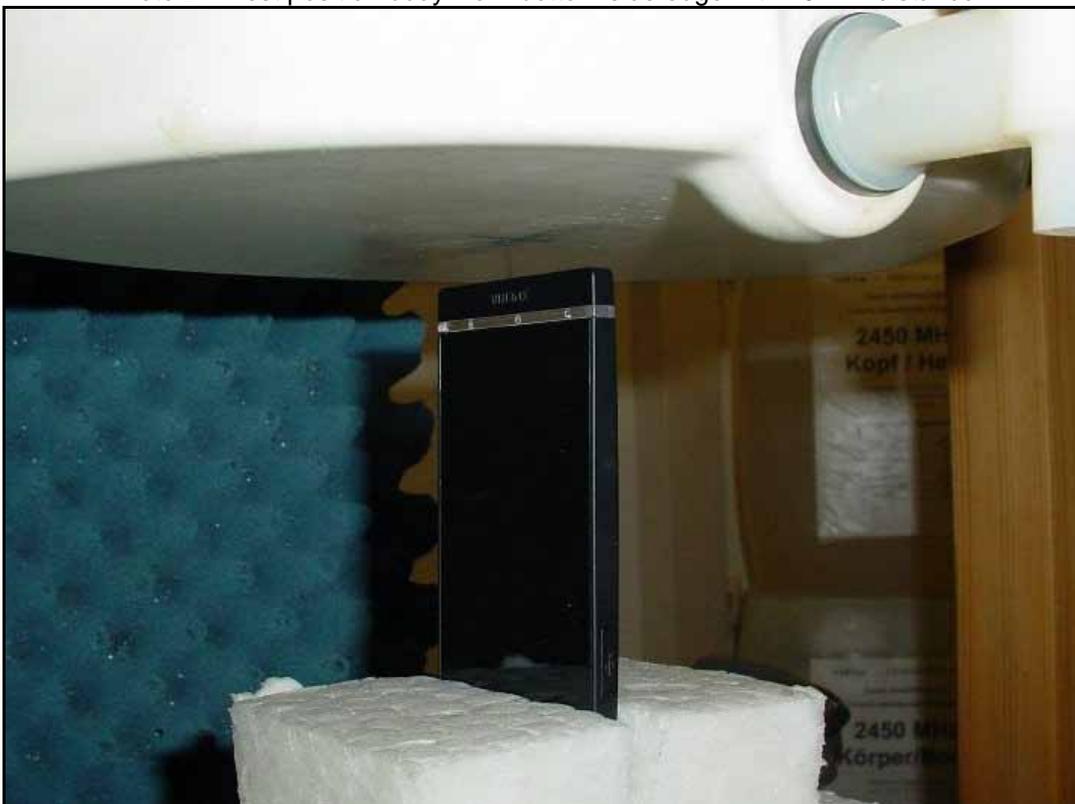
Photo 24: Test position body worn bottom side edge with 10 mm distance
