## Setup photos for HAC RF Emissions and T-Coil Test Report

| <b>Test report no.:</b> | HAC_Photo_RM-1065_03 | <b>Date of report:</b> | 2015-01-30 |
| <b>Tested devices:</b> | RM-1065, RM-1064 | | |

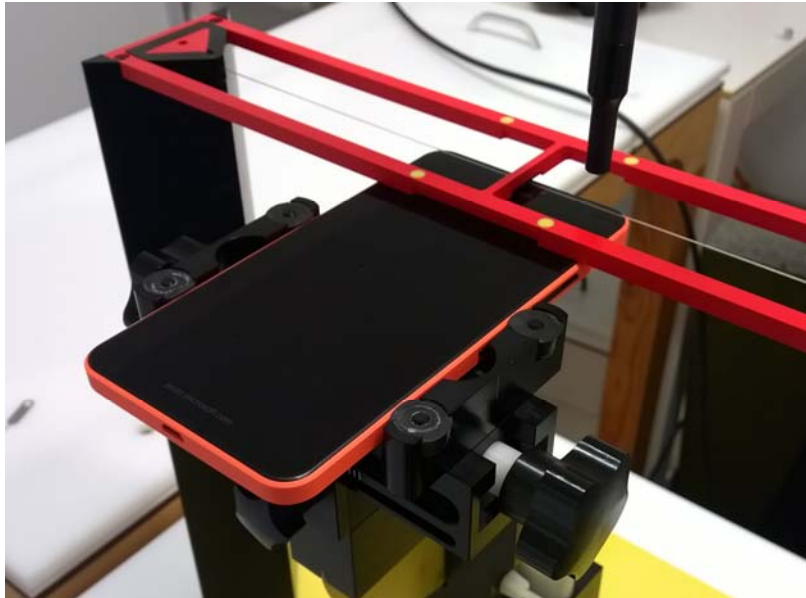
The device was positioned such that Device Reference plane was touching the bottom of the Test Arch. The scan is centered at the acoustic output by aligning the acoustic output with the intersection of the Test Arch's middle bar and dielectric wire.

Photo of the device positioned under Test Arch
