## Annex C Photo documentation

Appendix to Test Report No.: 1-7605/14-01-02-B

#### **CETECOM ICT Services GmbH**

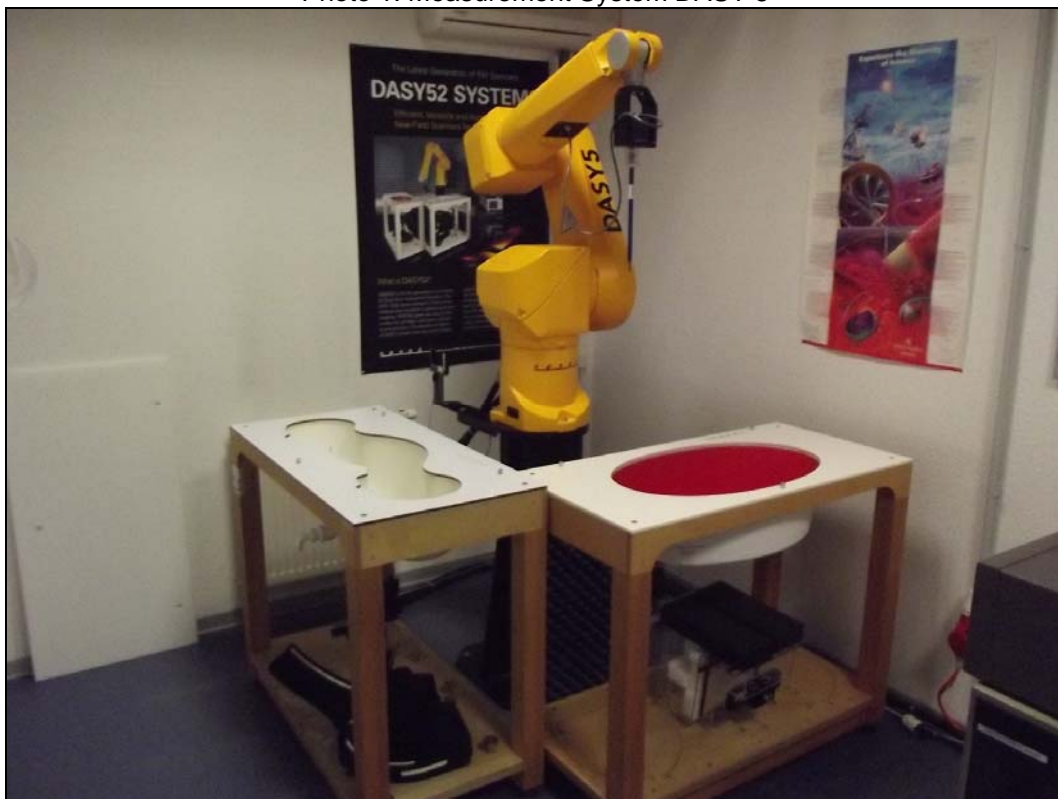
Photo 1: Measurement System DASY 5

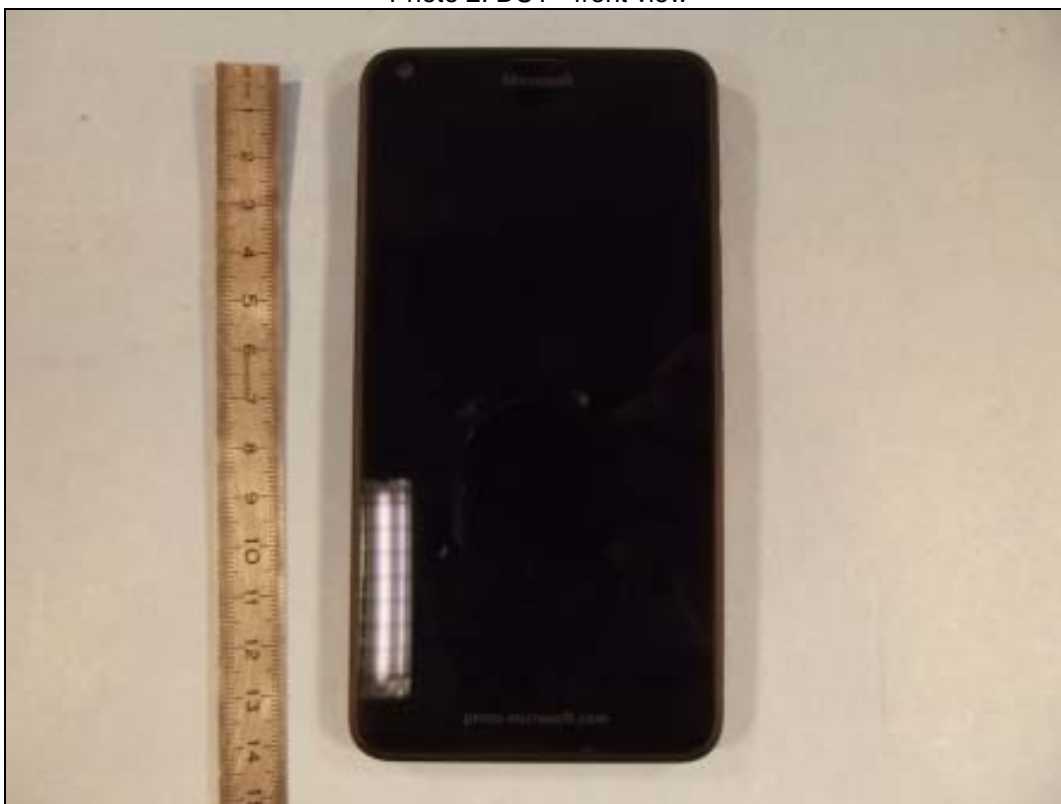
Photo 2: DUT - front view

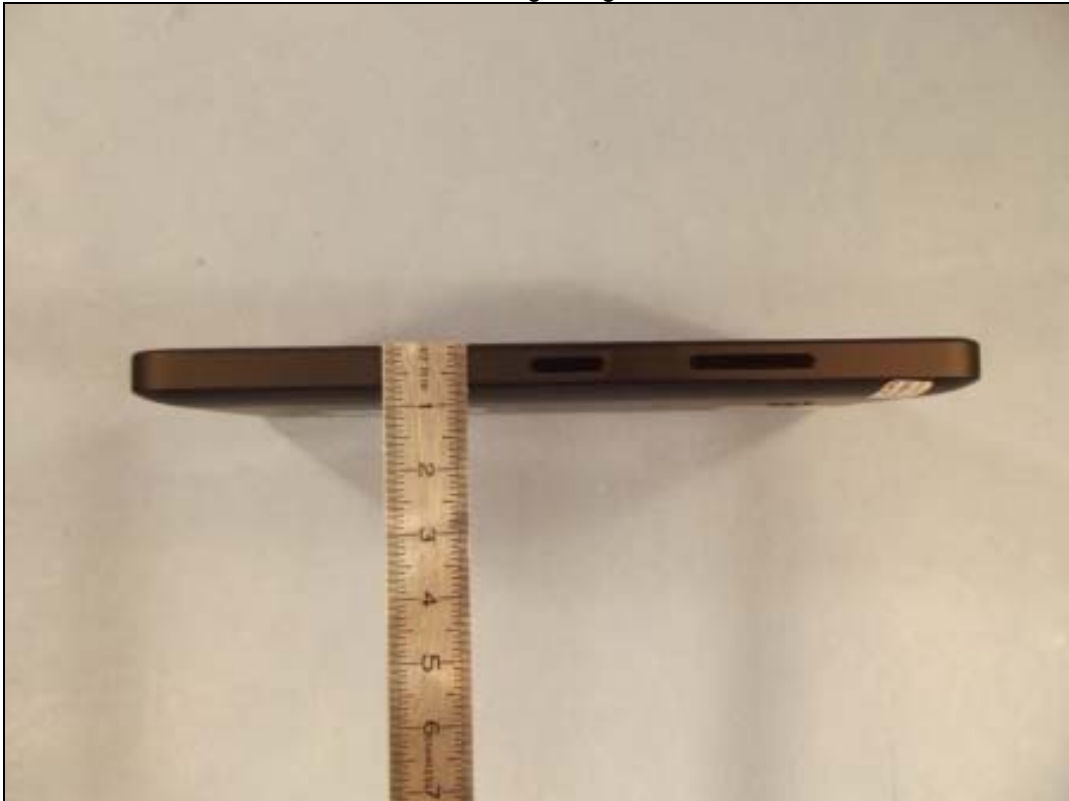
Photo 3: DUT - right edge side view

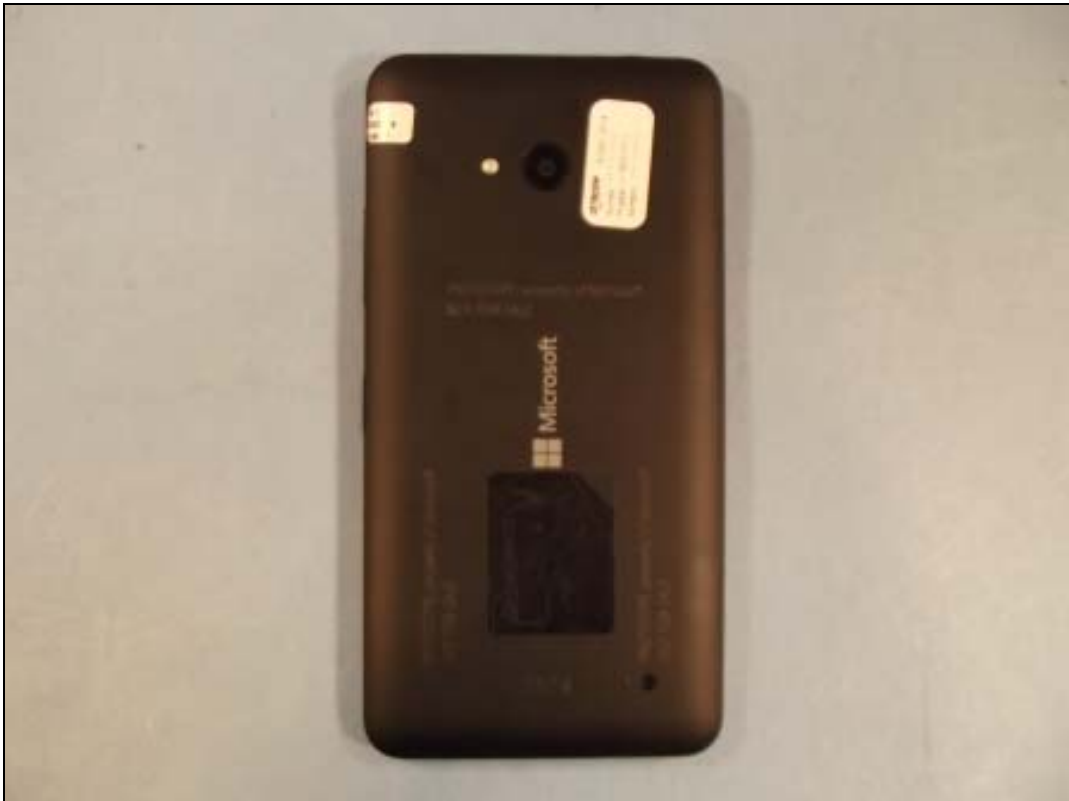
Photo 4: DUT - rear view

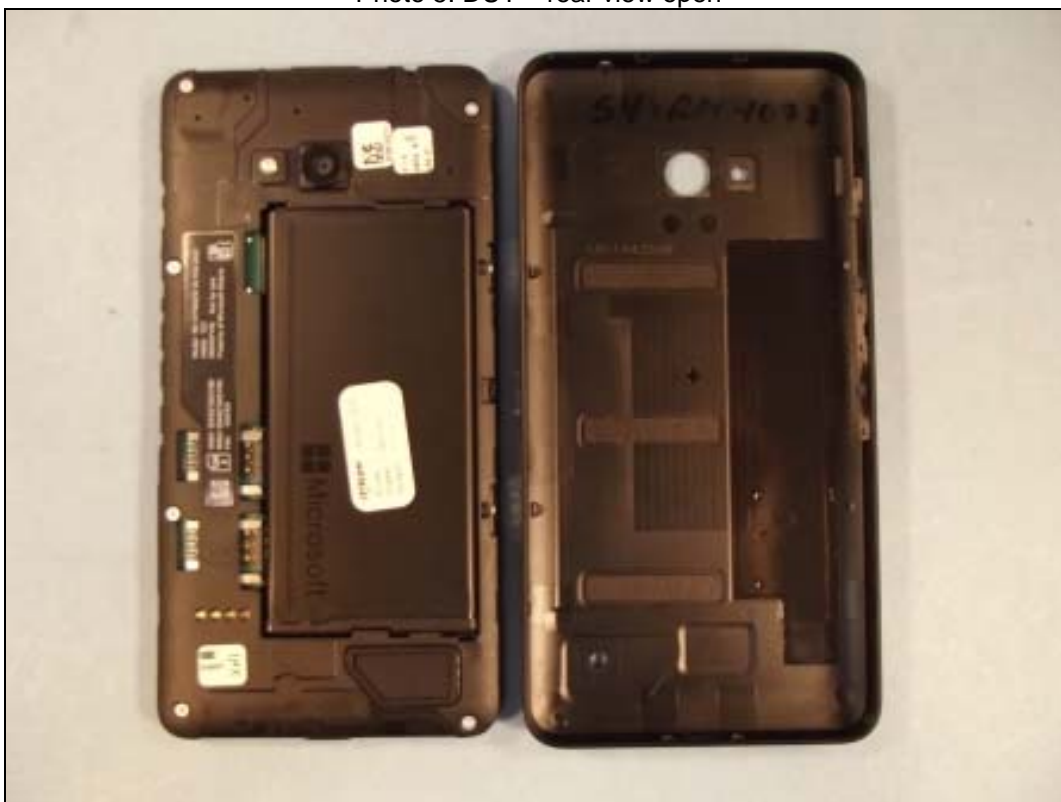
Photo 5: DUT – rear view open

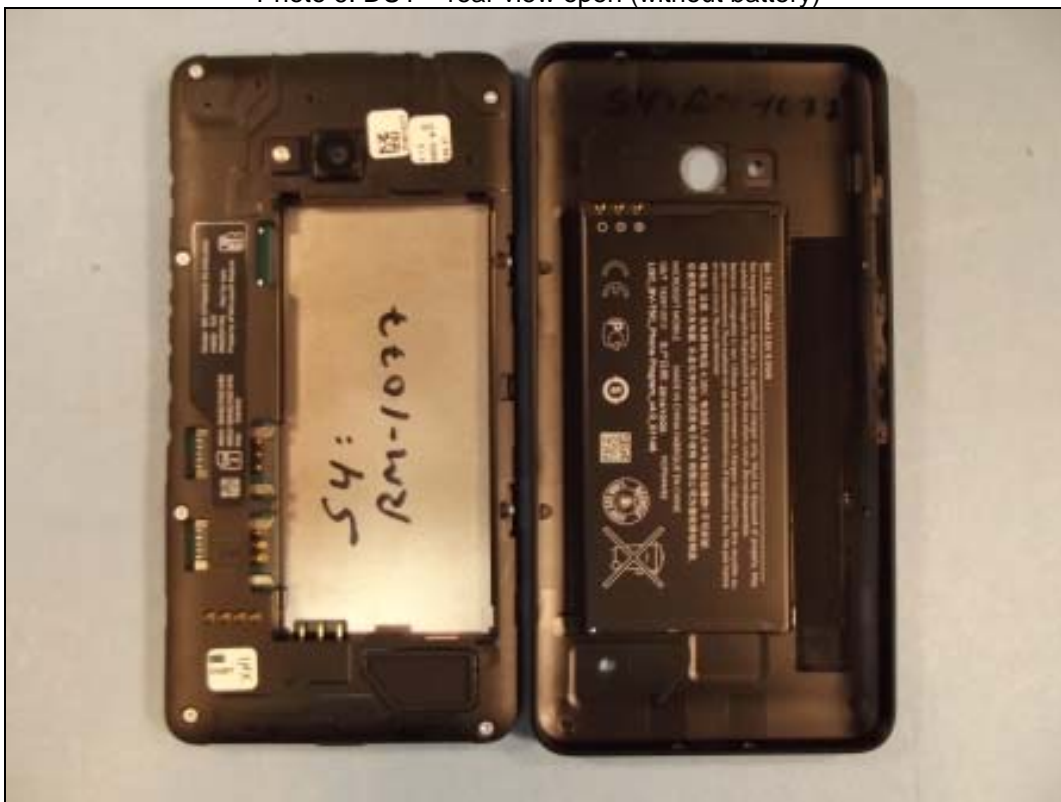
Photo 6: DUT – rear view open (without battery)

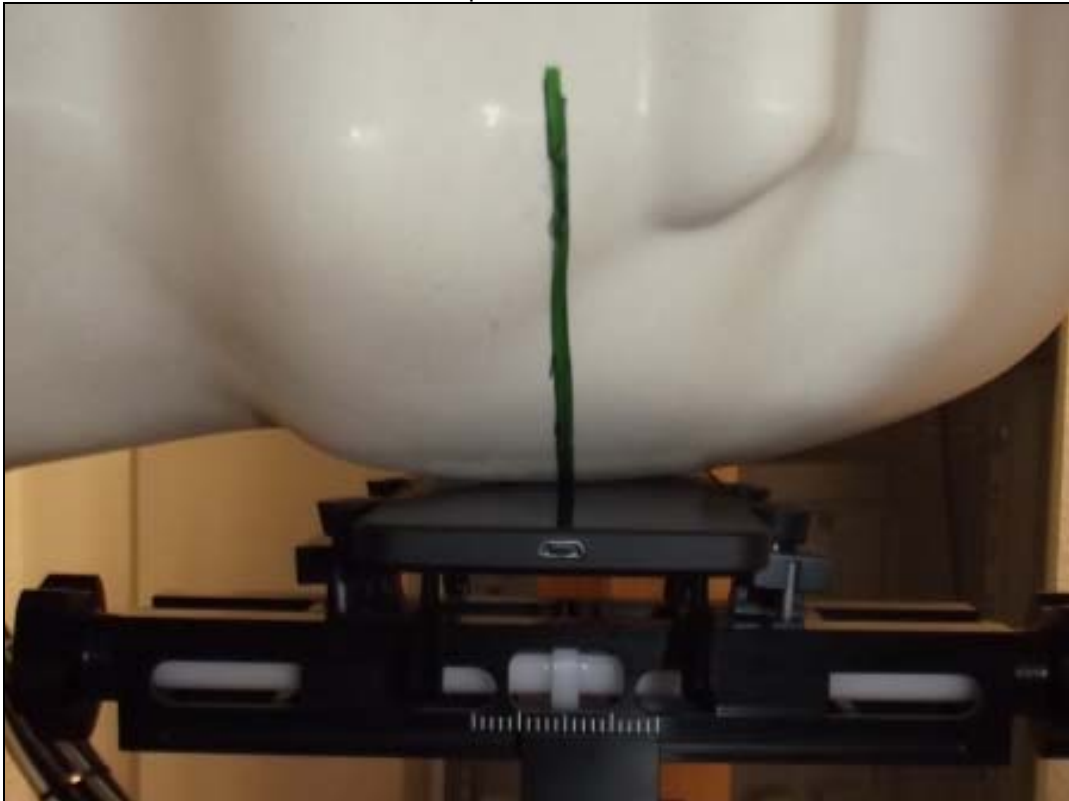
Photo 7: Test position left hand touched

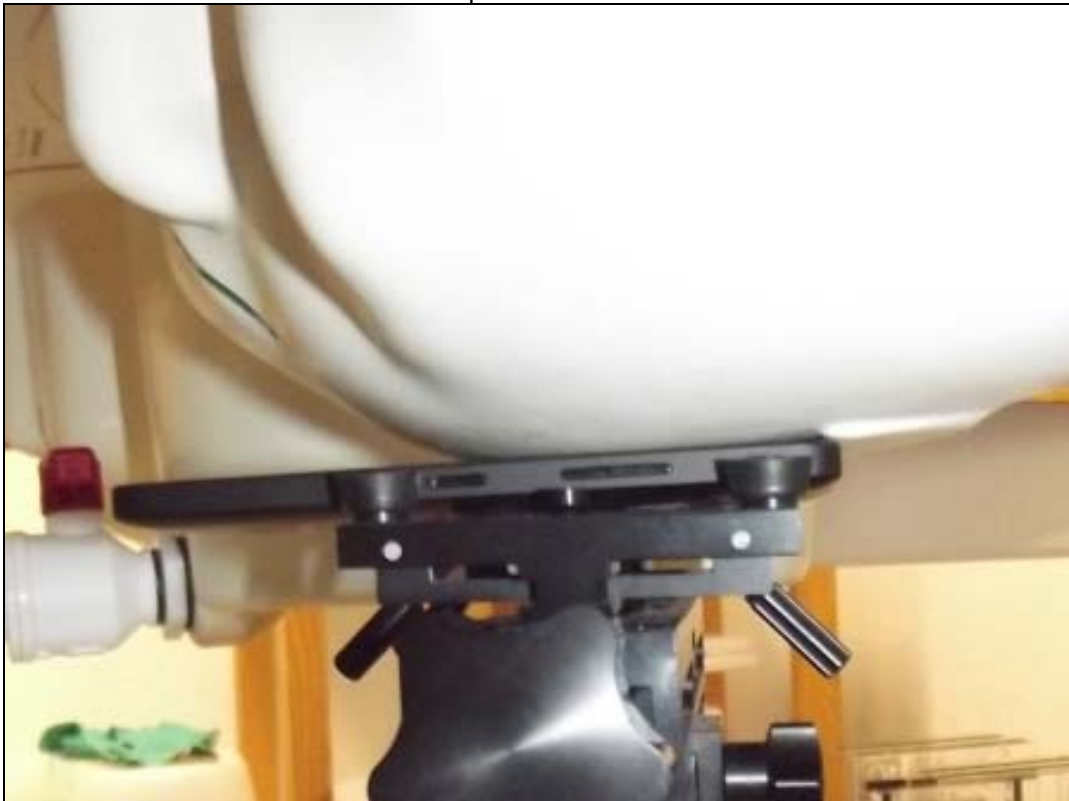
Photo 8: Test position left hand touched

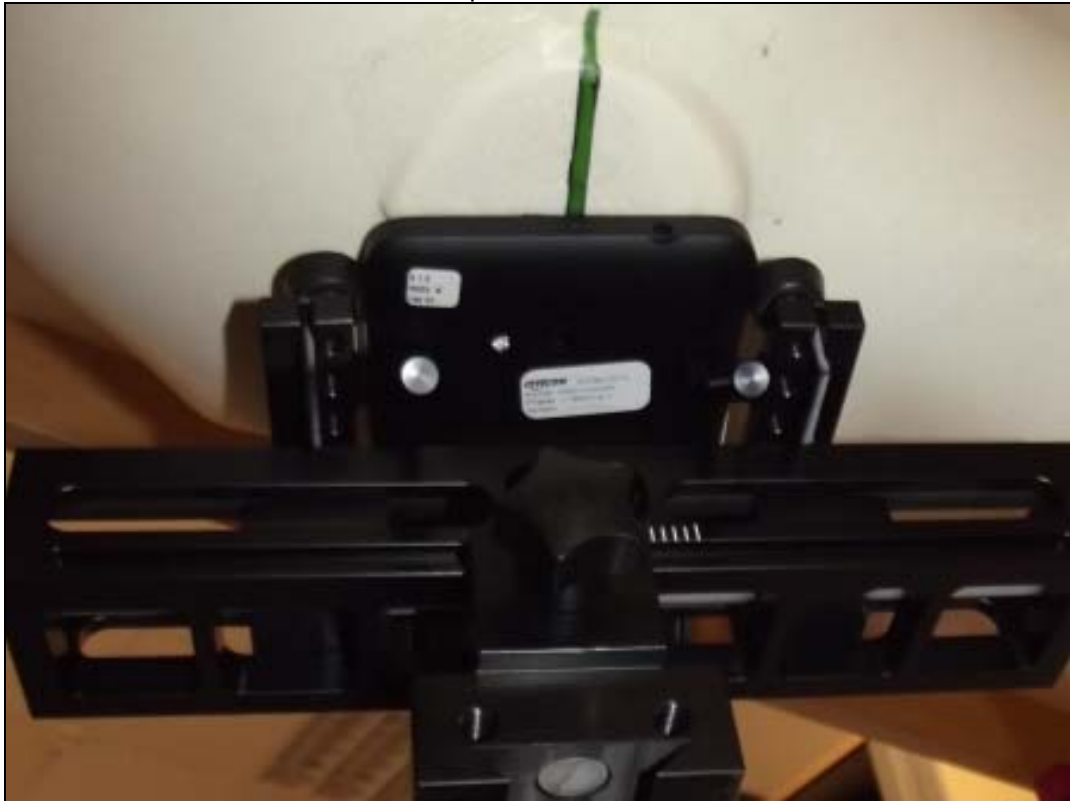
Photo 9: Test position left hand touched

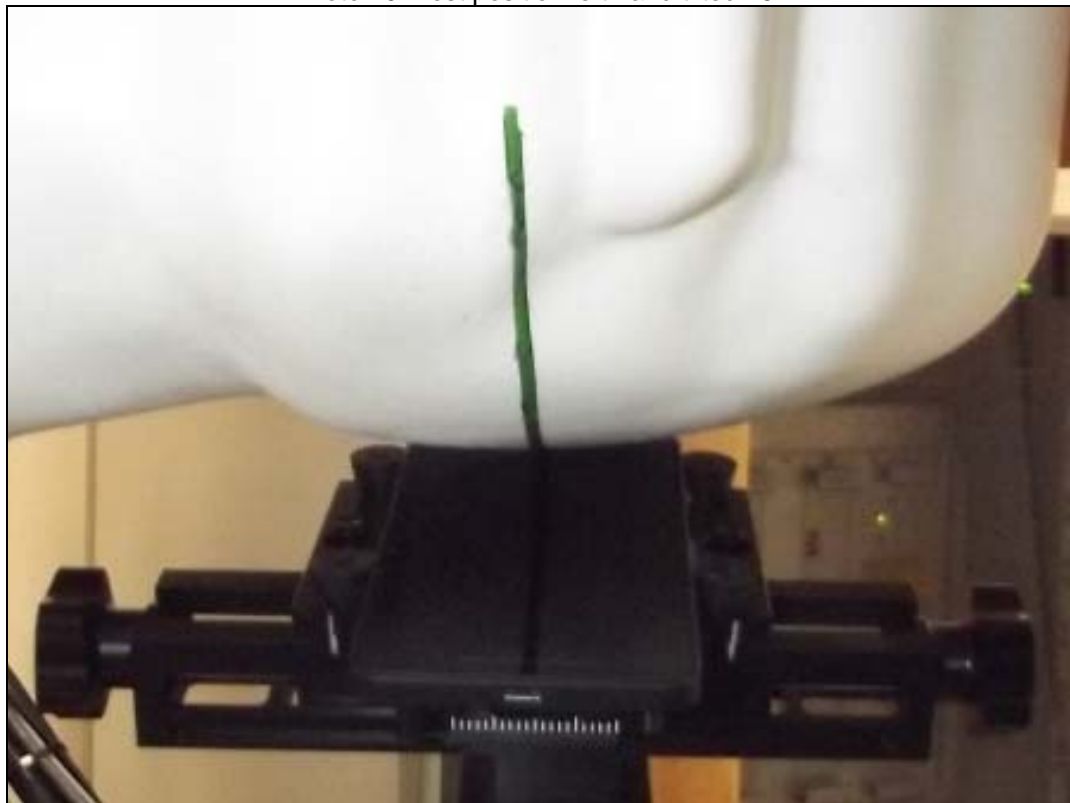
Photo 10: Test position left hand tilted 15°

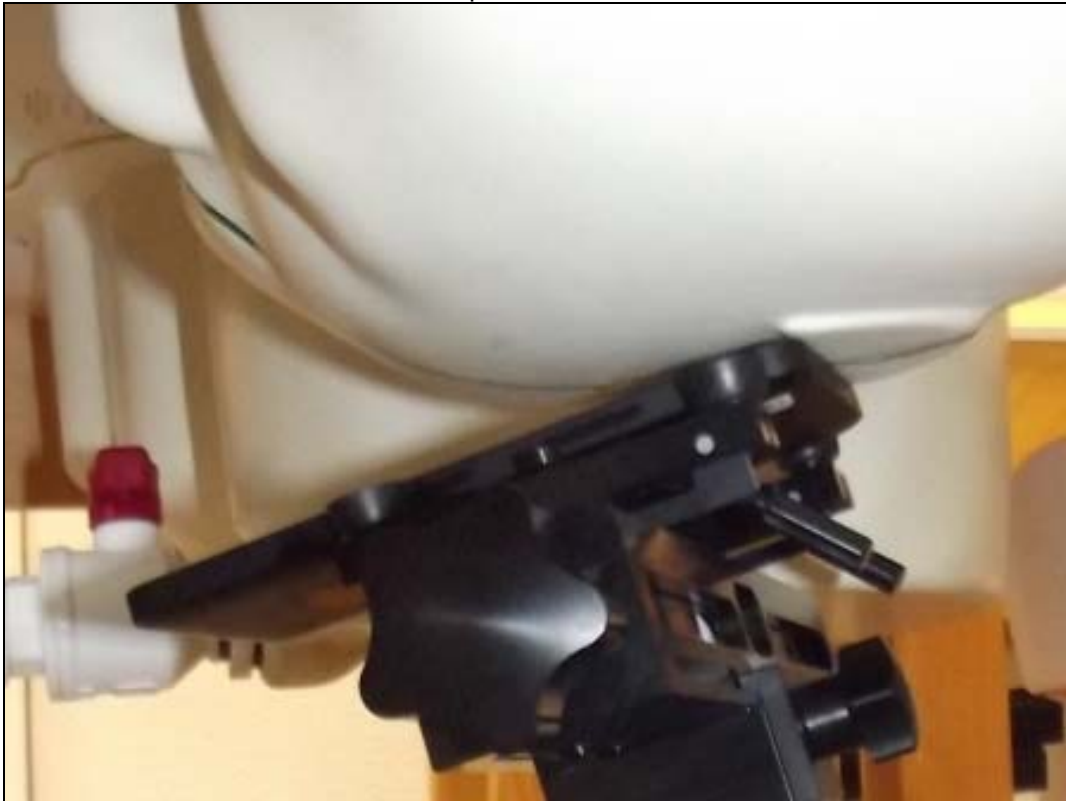
Photo 11: Test position left hand tilted 15°

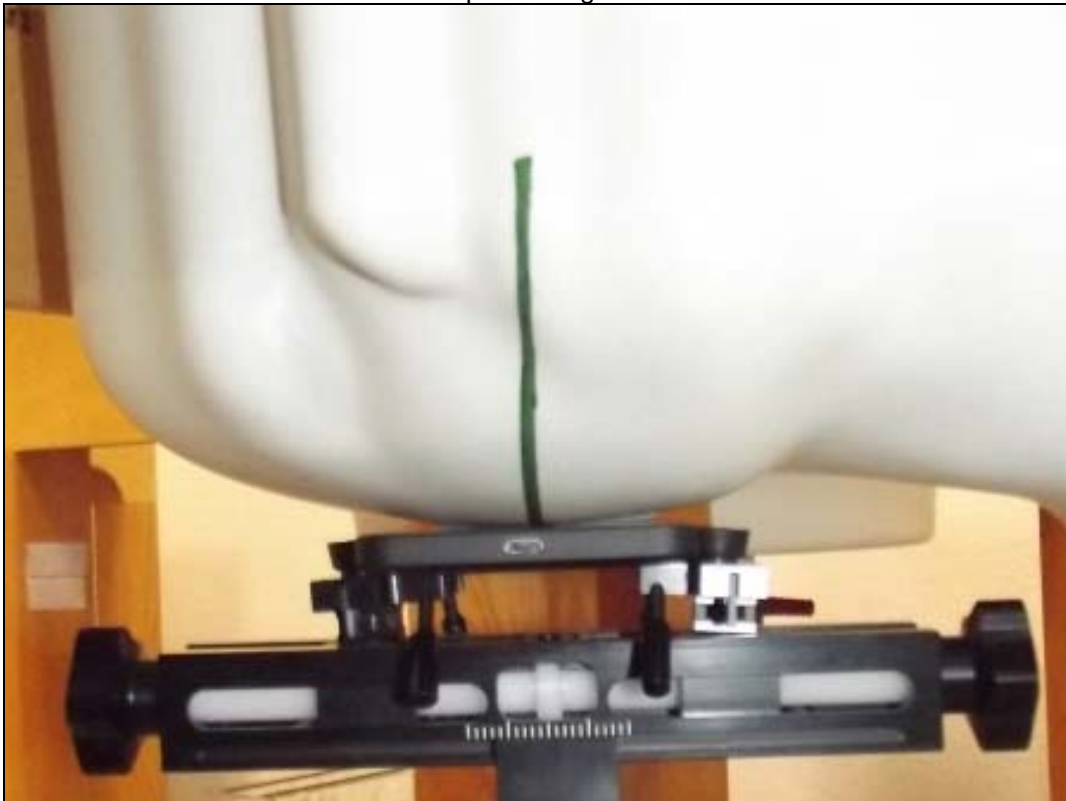
Photo 12: Test position right hand touched

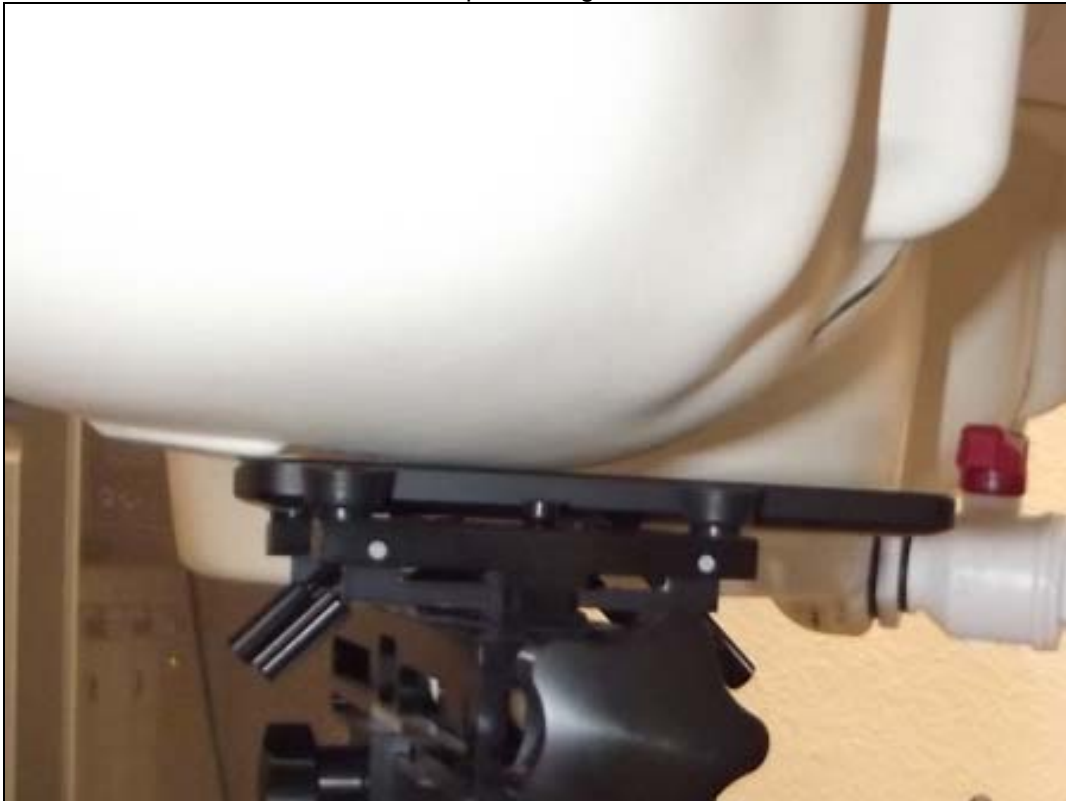
Photo 13: Test position right hand touched

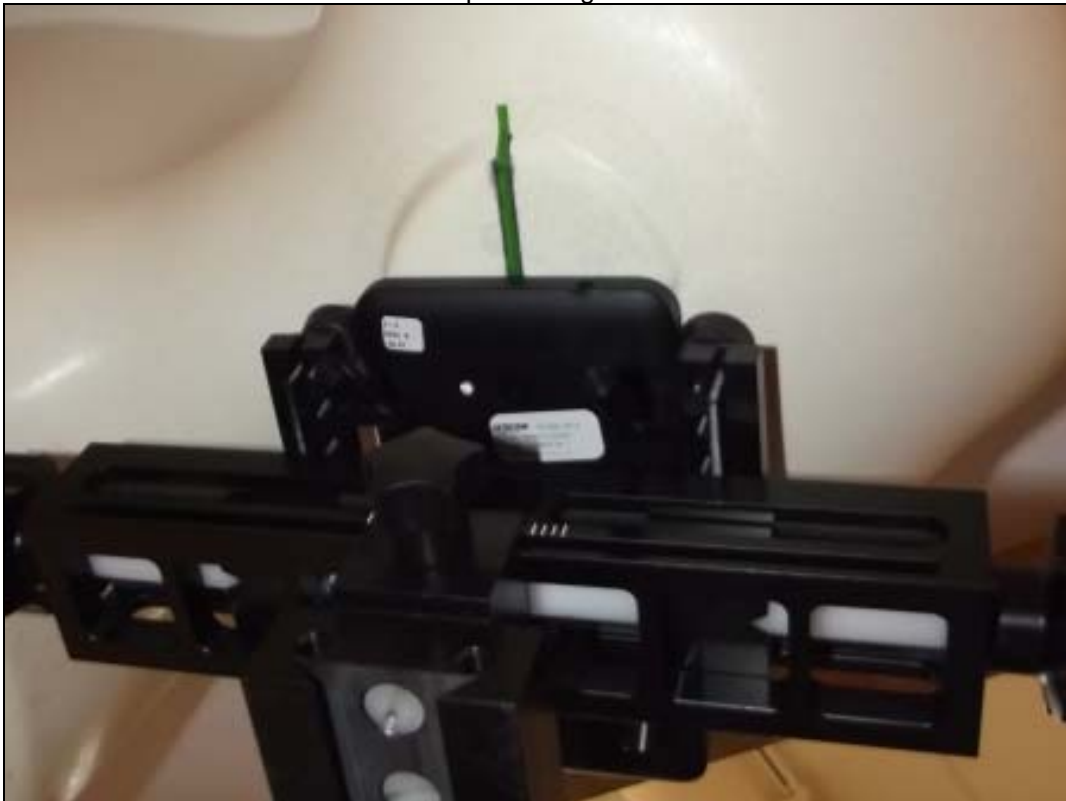
Photo 14: Test position right hand touched

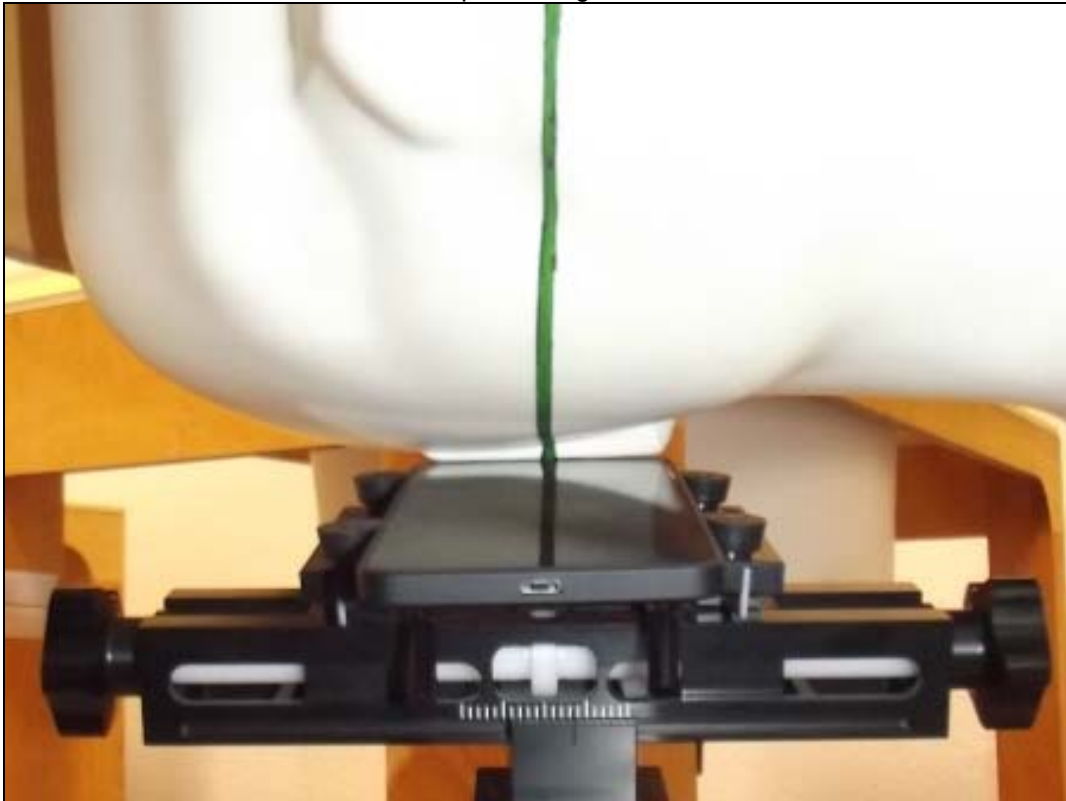
Photo 15: Test position right hand tilted 15°

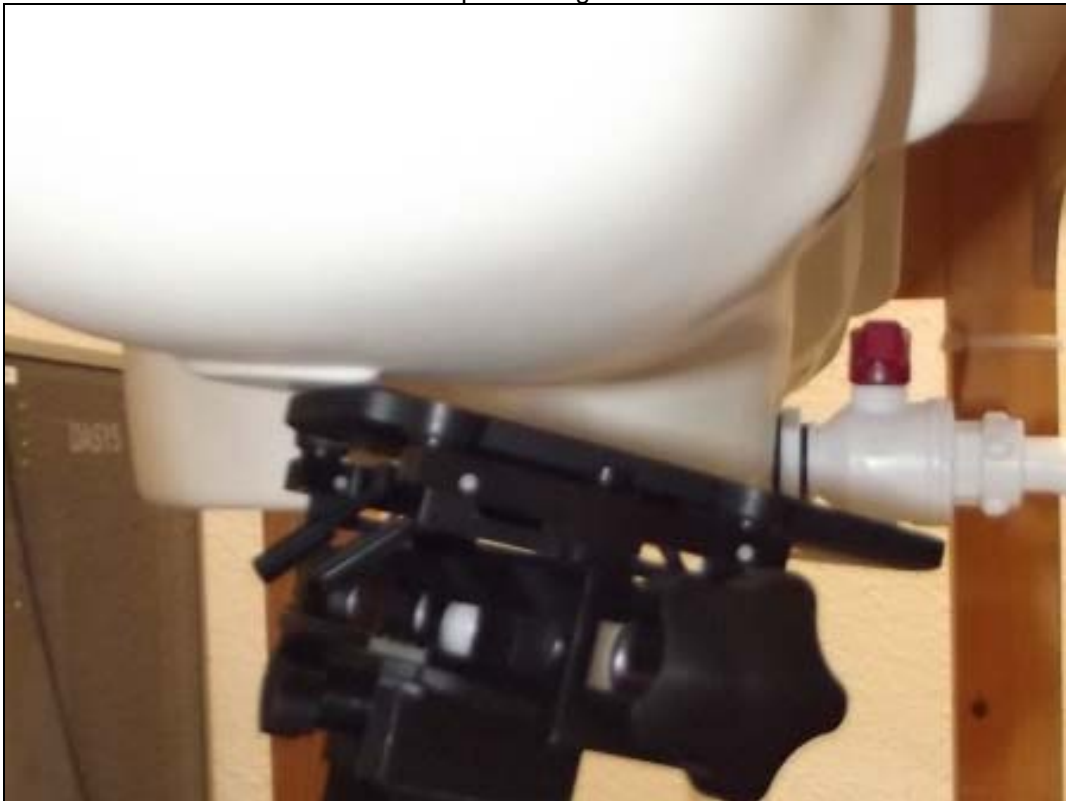
Photo 16: Test position right hand tilted 15°

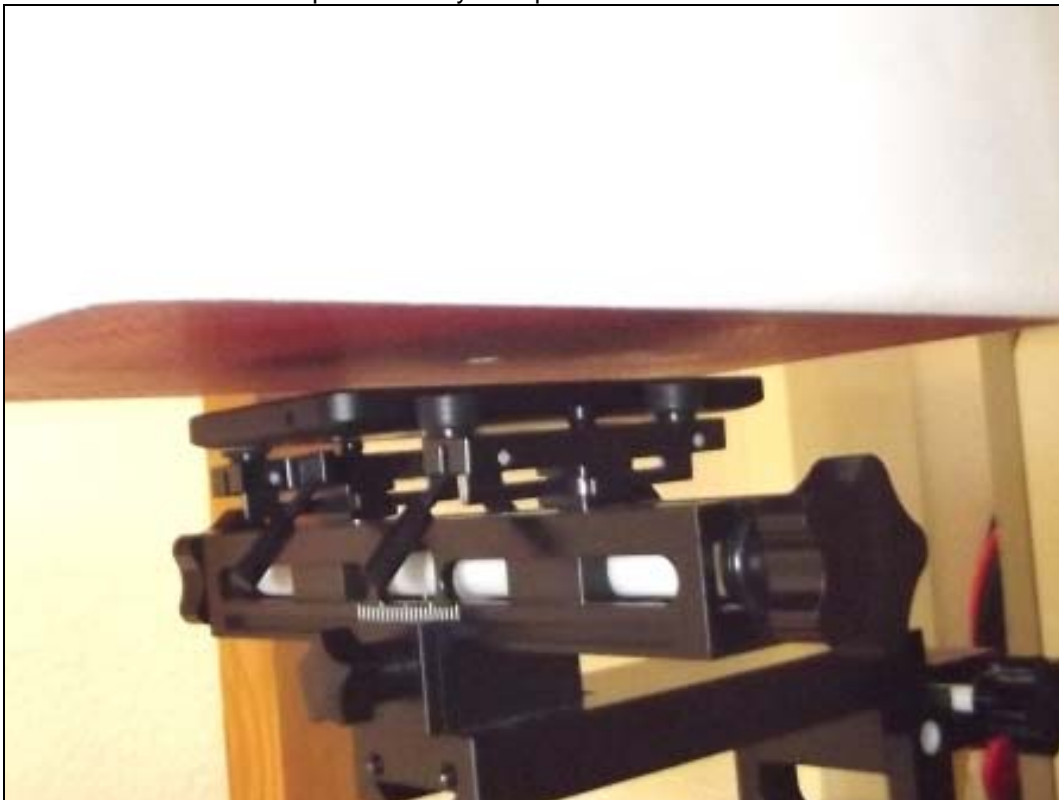
Photo 17: Test position body hot spot front side with 10 mm distance

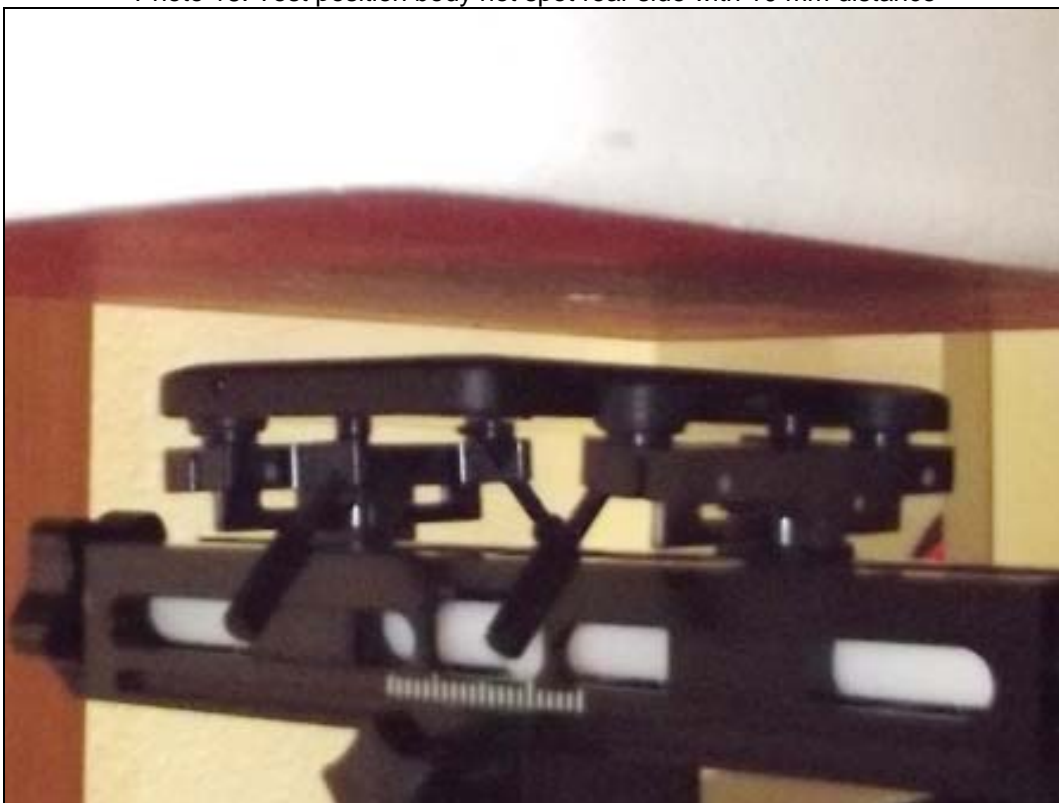
Photo 18: Test position body hot spot rear side with 10 mm distance

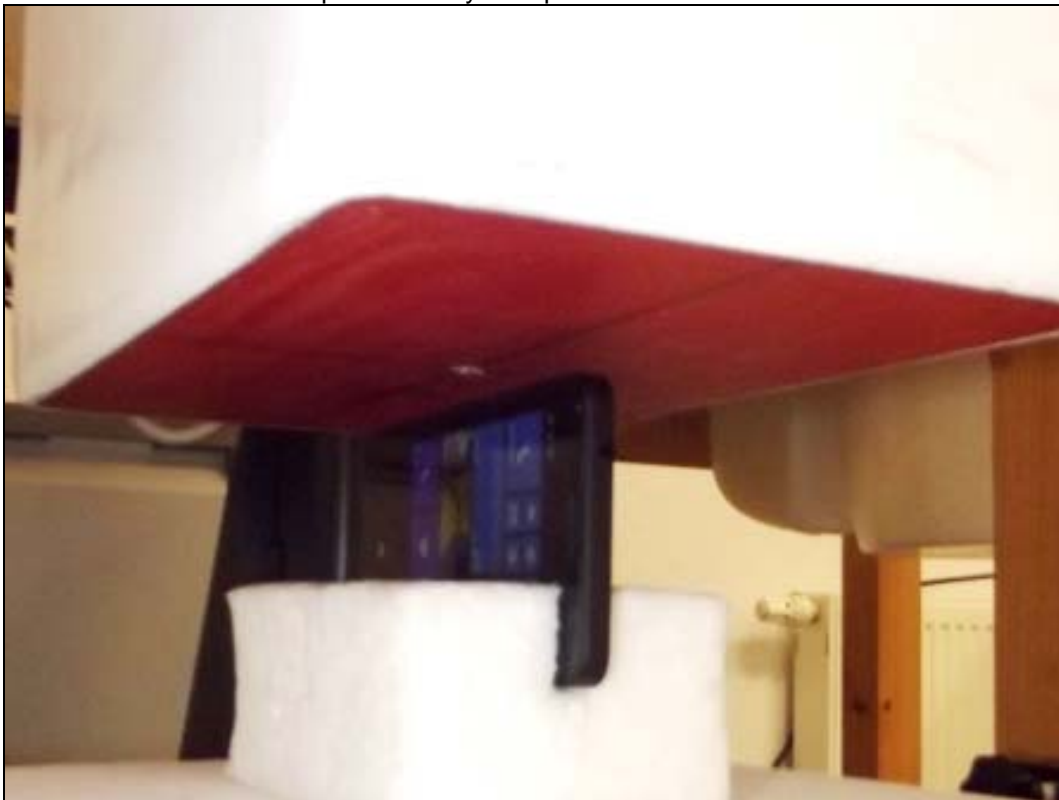
Photo 19: Test position body hot spot left side with 10 mm distance

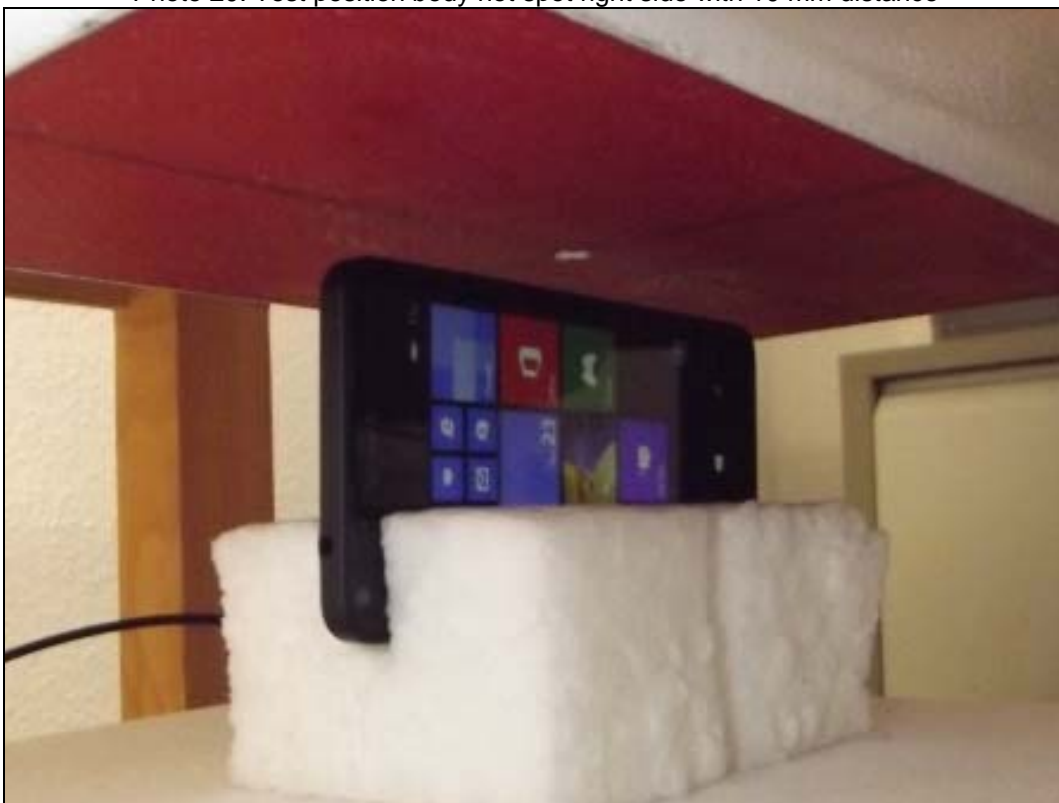
Photo 20: Test position body hot spot right side with 10 mm distance

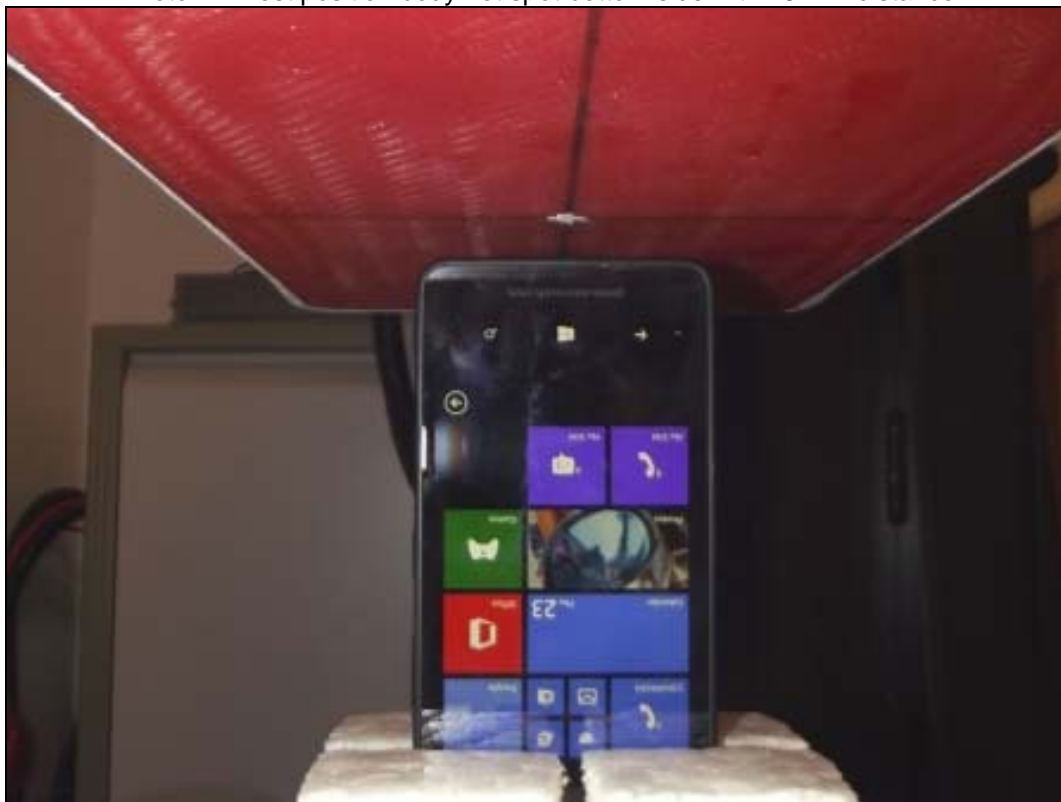
Photo 21: Test position body hot spot bottom side with 10 mm distance

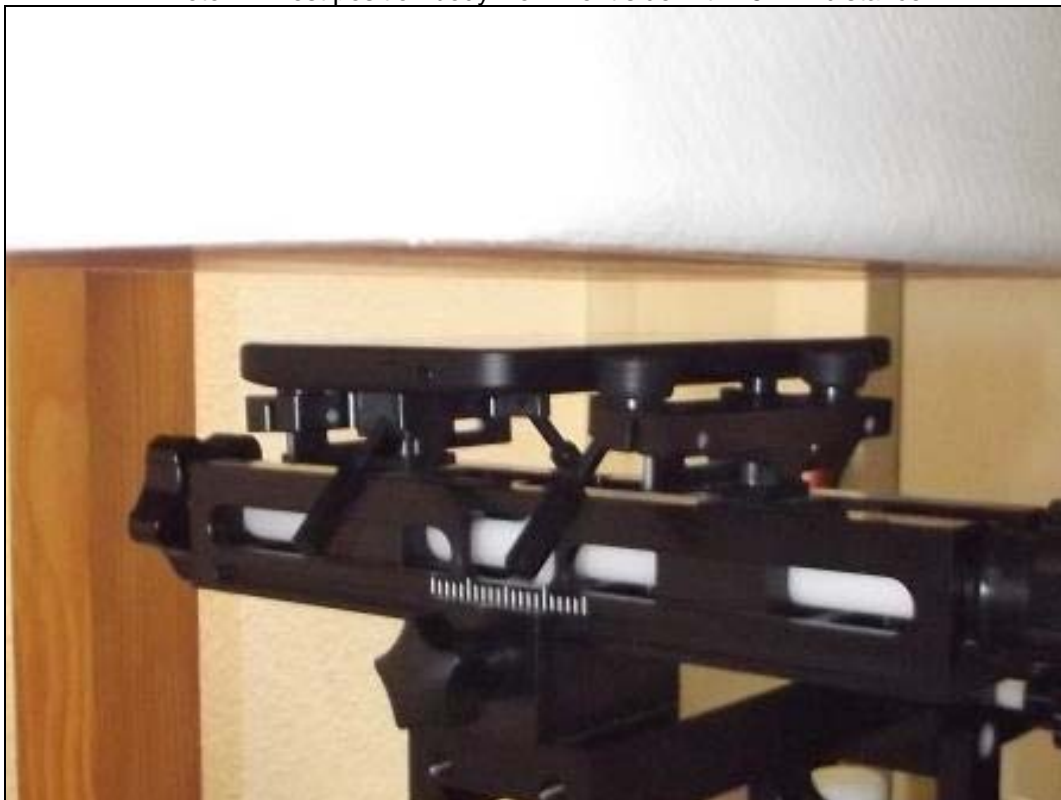
Photo 22: Test position body worn front side with 15 mm distance

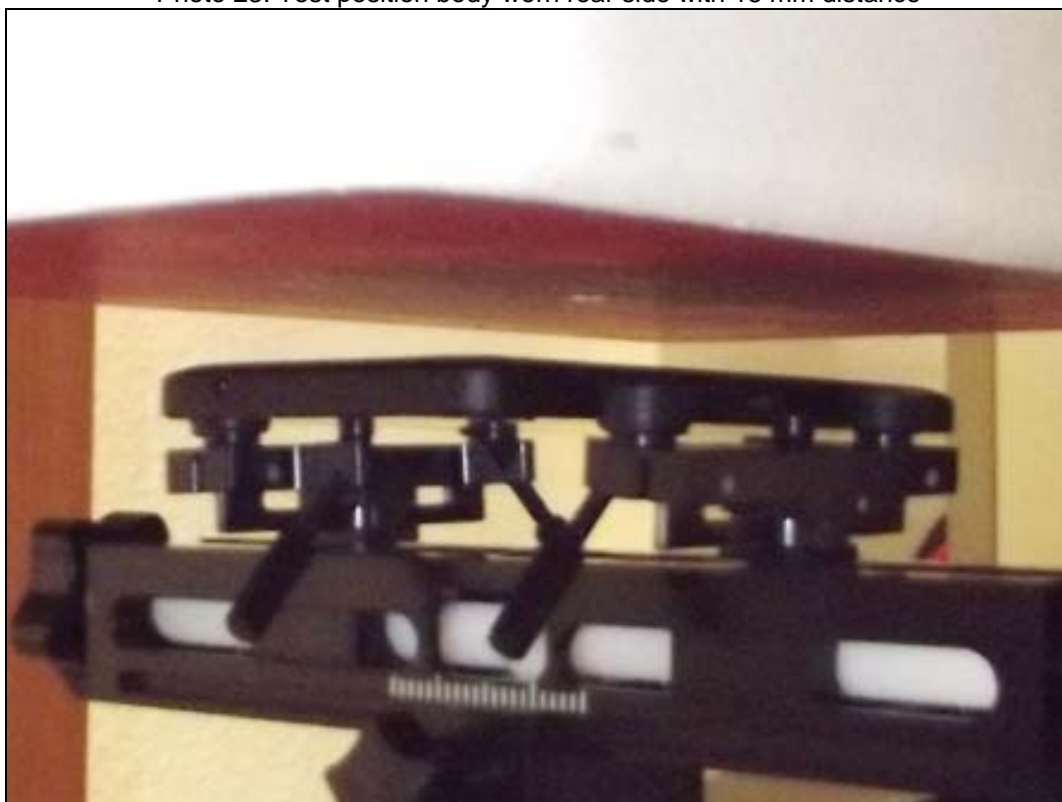
Photo 23: Test position body worn rear side with 15 mm distance

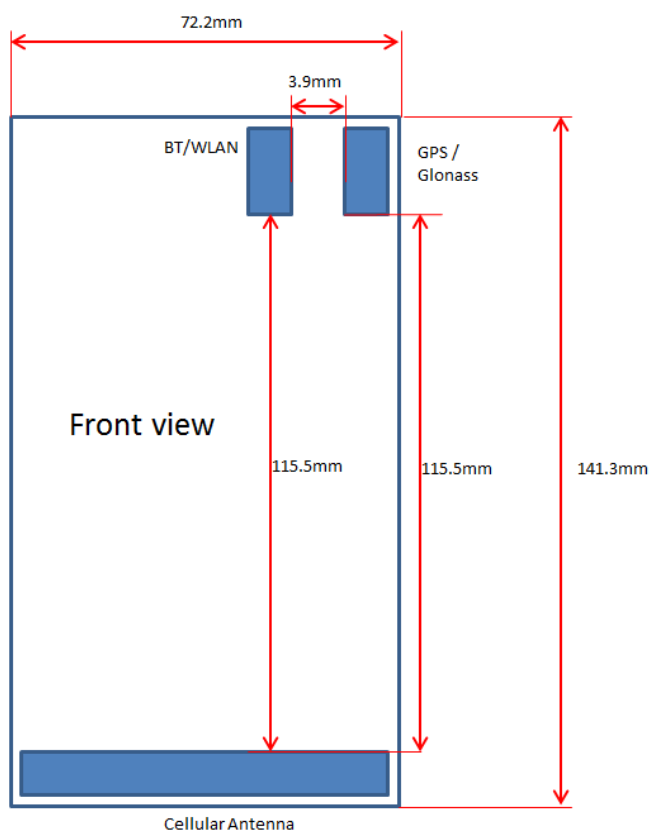
Photo 24: Antenna location
