## **APPENDIX 1: Photographs of test setup**

### **Radiated emission**

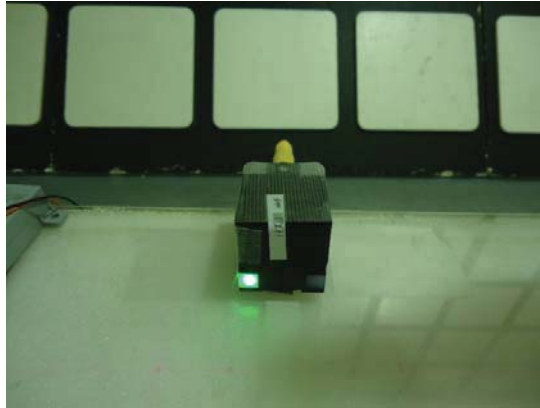
**X-axis**

### Worst Case Position

Below 30MHz      Y-axis  
Above 30MHz    Horizontal:X-axis / Vertical:Y-axis

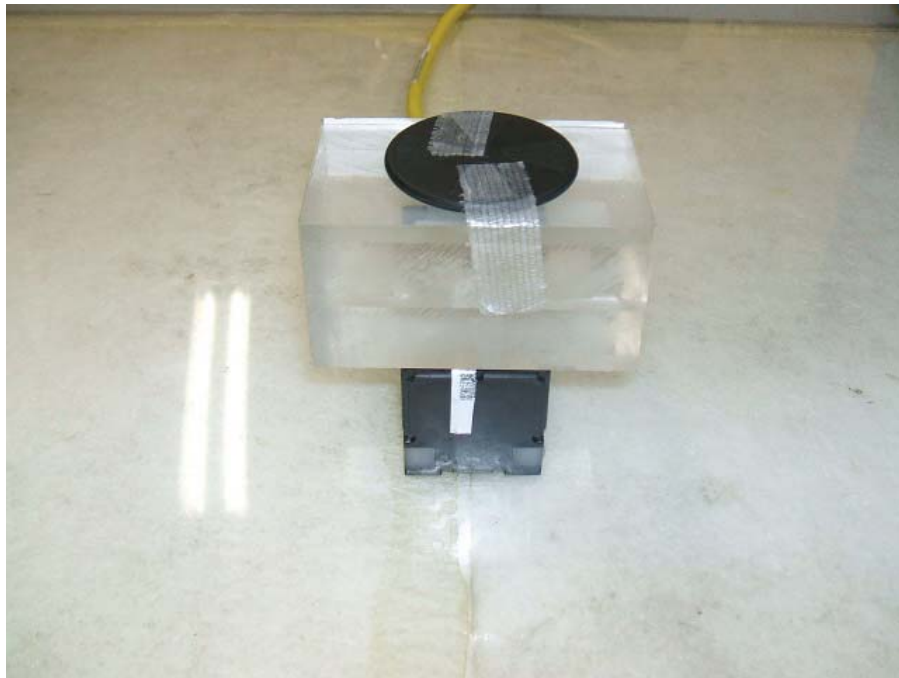
**With/Without Tag**

**With Tag (Worst)**

\* Spacer: 0mm was compared with Spacer: 45mm at the pre-check and the test was performed with higher emission level one.

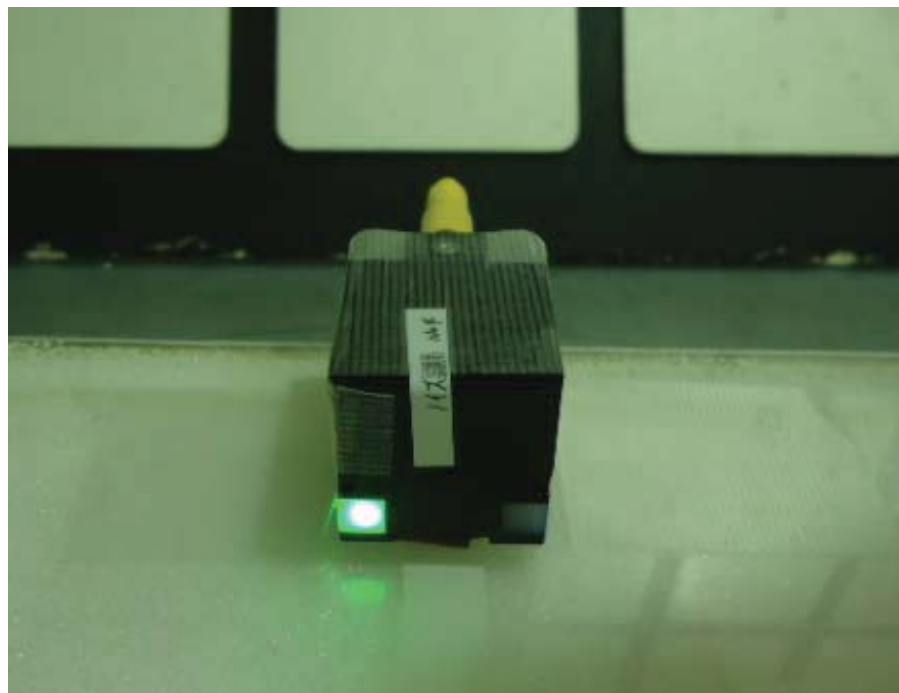
**Without Tag**
