### Annex C: Photographs of the test setup

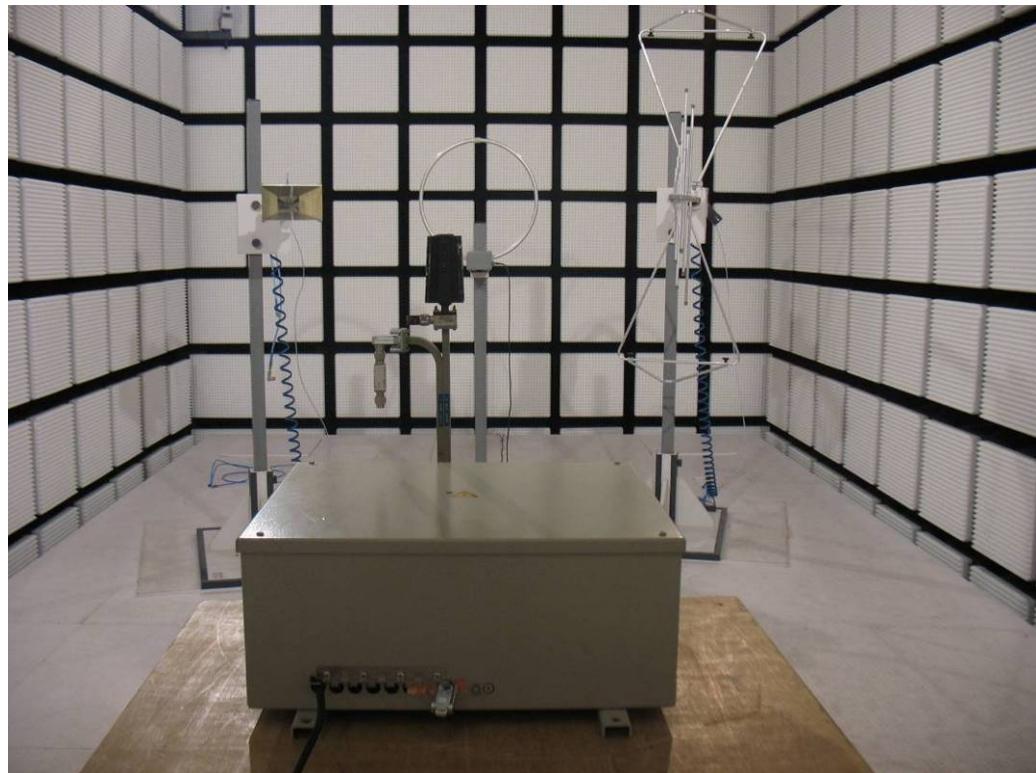
Photo No. 1: radiated spurious emissions up to 12 GHz

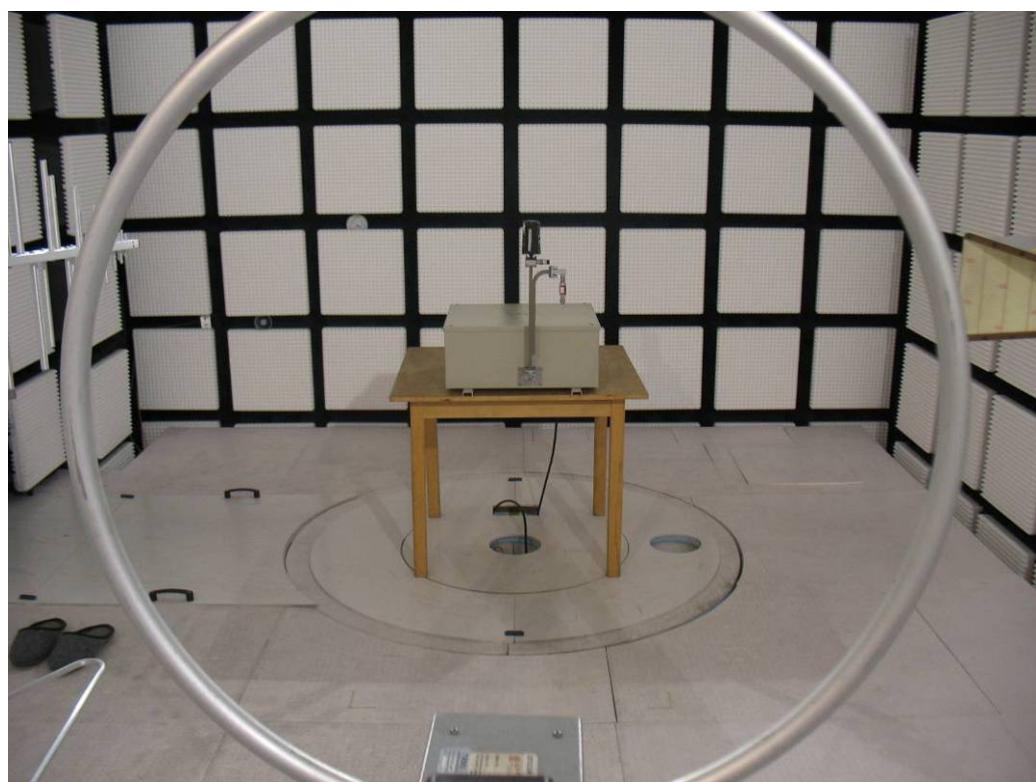
Photo No. 2: radiated spurious emissions up to 12 GHz

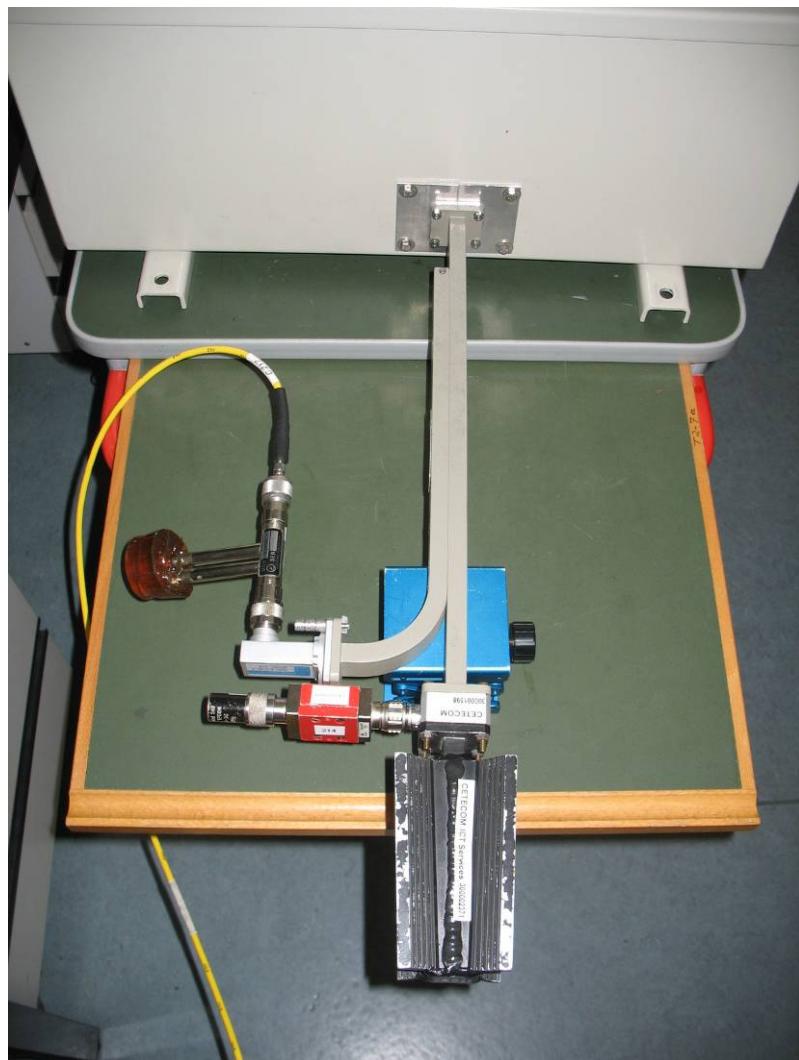
Photo No. 3: conducted measurements, spurious emissions (with stub tuner)

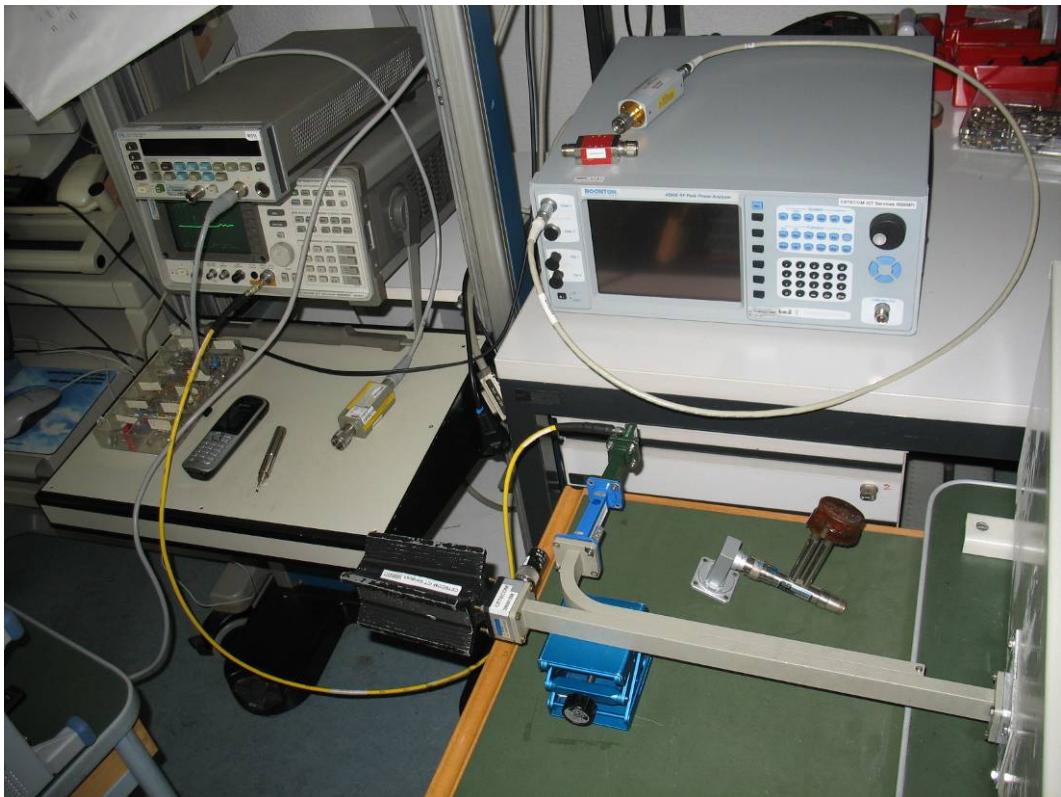
Photo No. 4: conducted measurements, spurious emissions > 15 GHz

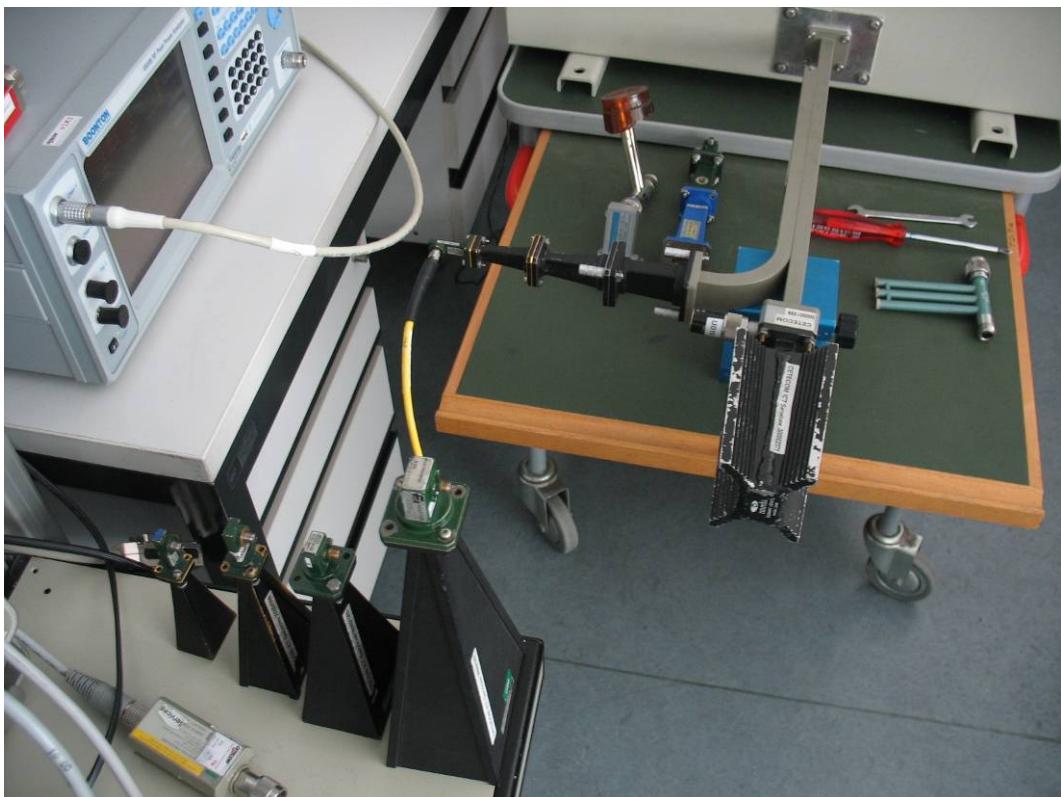
Photo No. 5: conducted measurements, spurious emissions up to 40 GHz
