**A.3 PHOTOGRAPHS**

**Telecommunication Metrology Center  
of Ministry of Information Industry**

**No. 2007OTA0031**

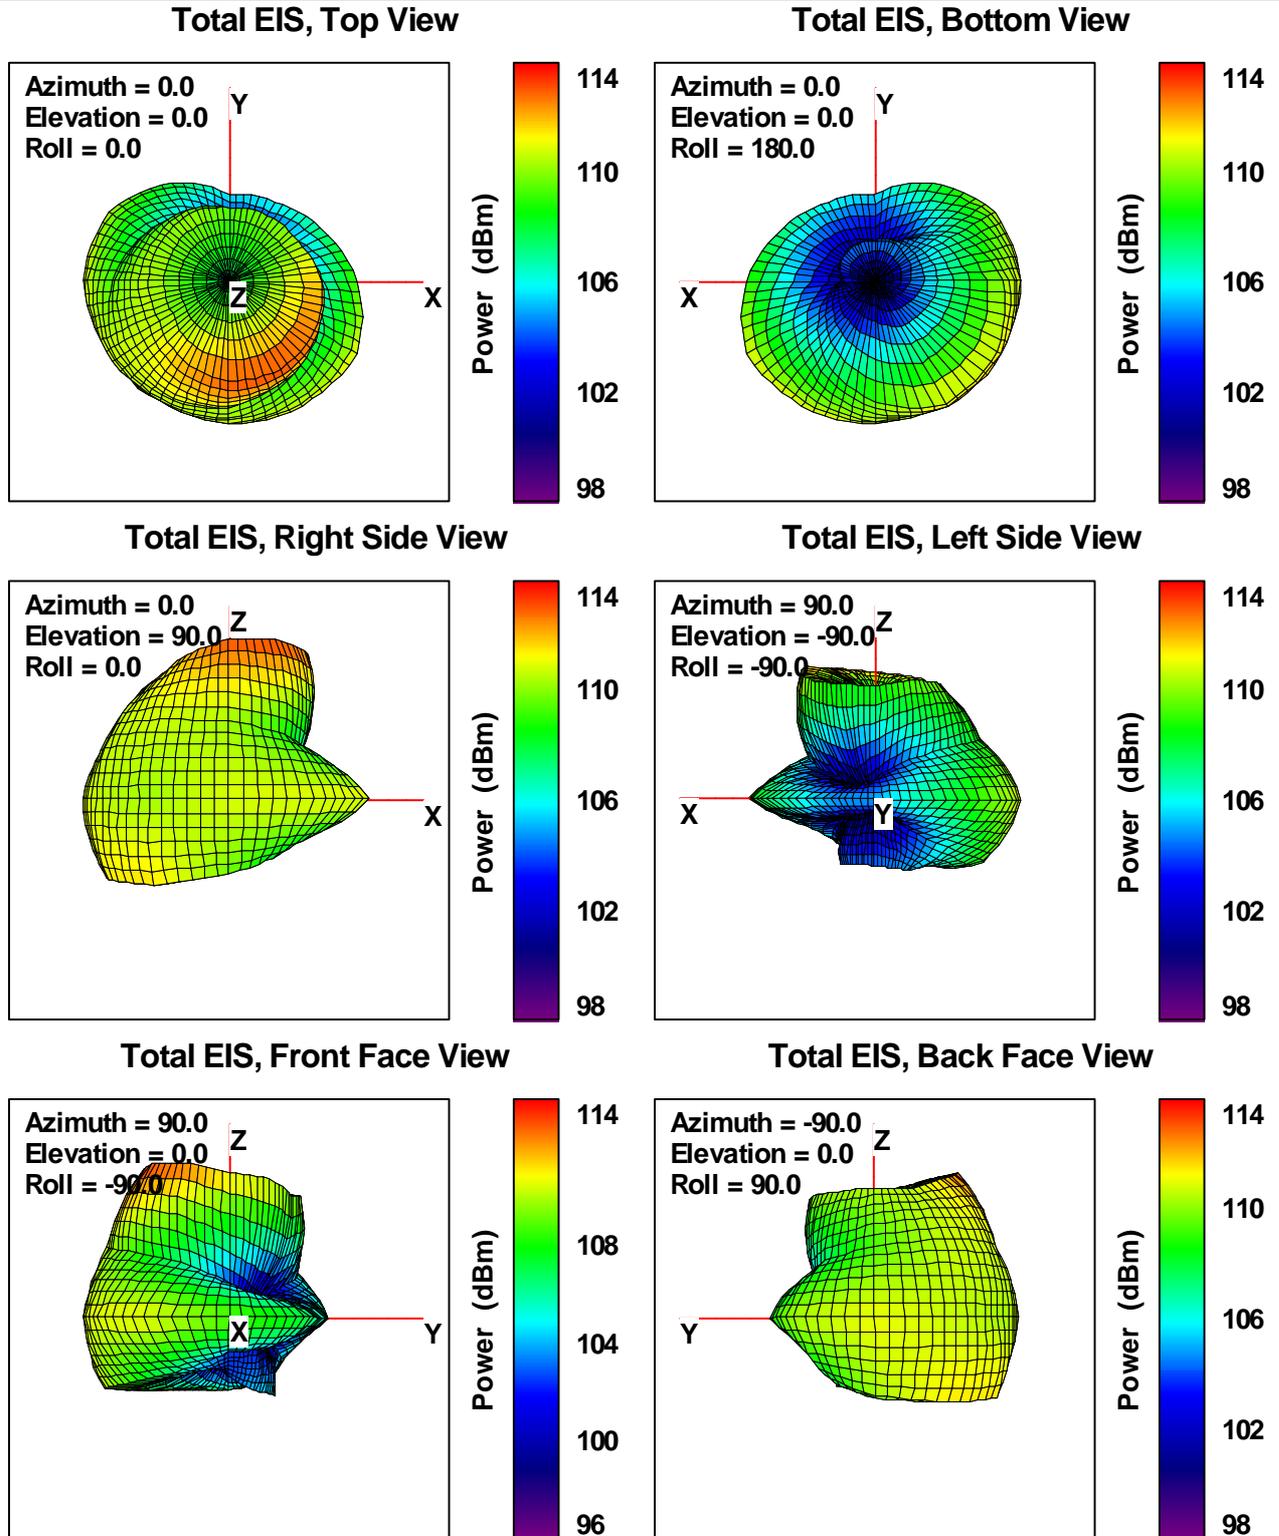
Plot 11. PCS 1900 Free-Space Total EIS, 1960MHz

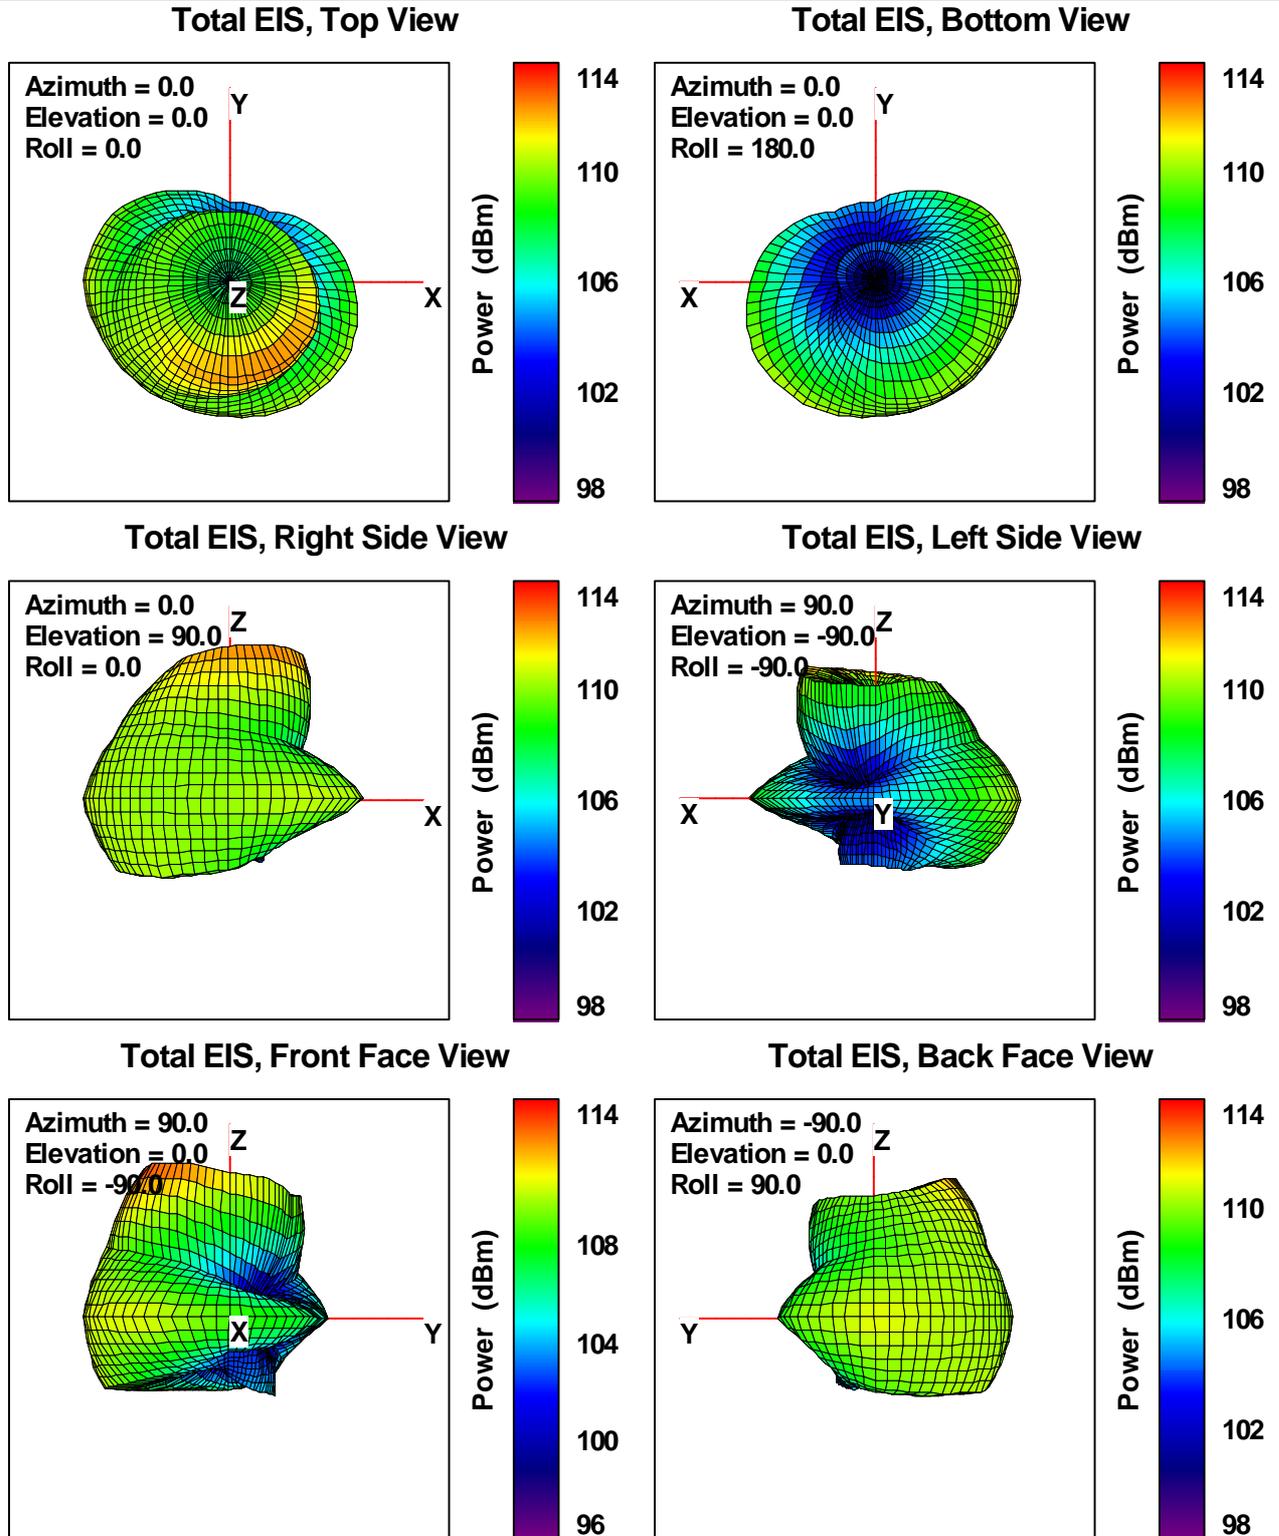
Plot 12. PCS 1900 Free-Space Total EIS, 1989.8 MHz

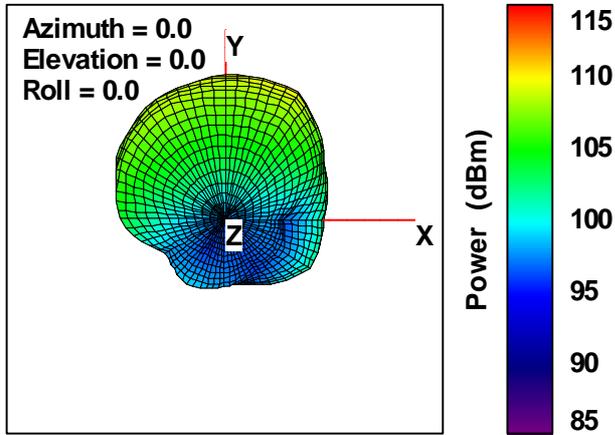
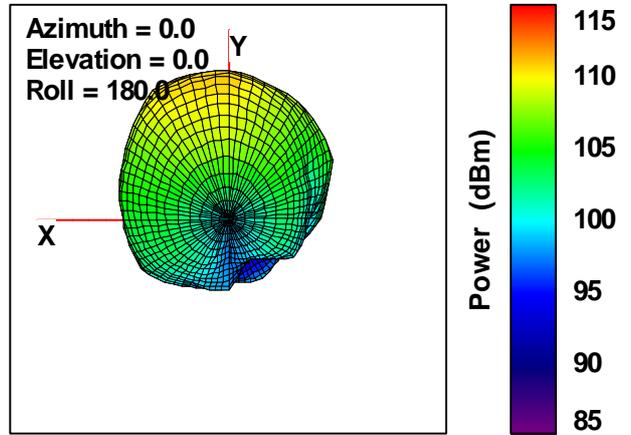
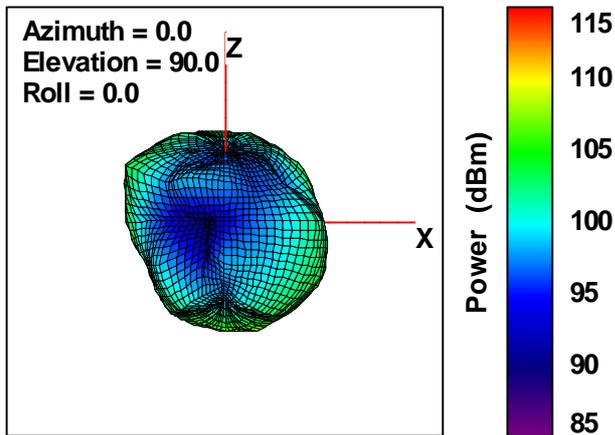
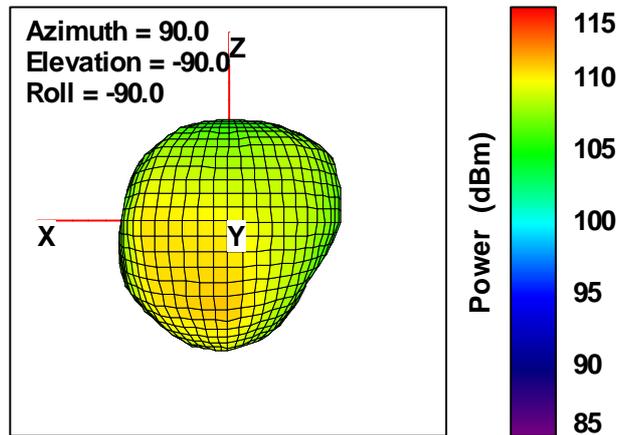
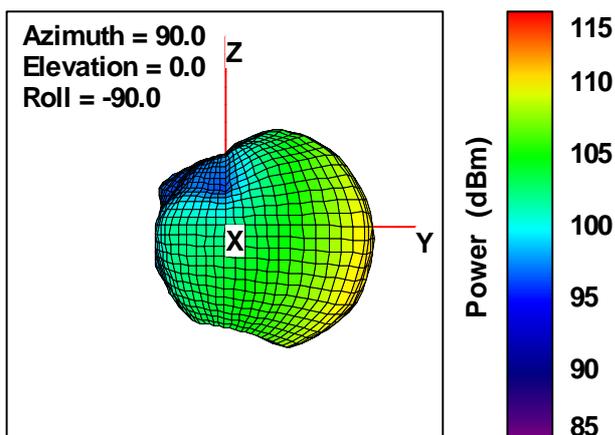
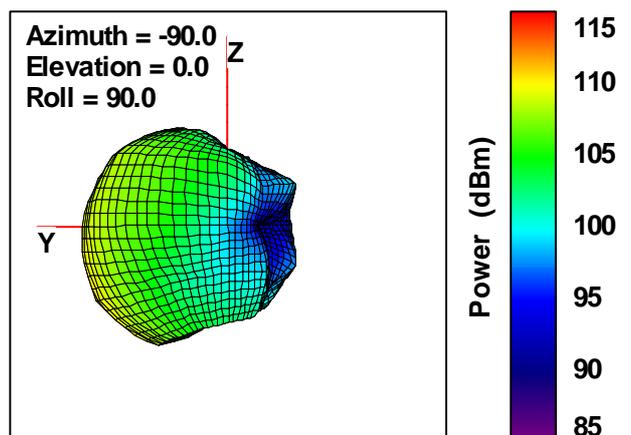
Plot 13. PCS 1900 SAM Phantom Head-Left Ear Total EIS, 1930.2 MHz

Total EIS, Top View

Total EIS, Bottom View

Total EIS, Right Side View

Total EIS, Left Side View

Total EIS, Front Face View

Total EIS, Back Face View

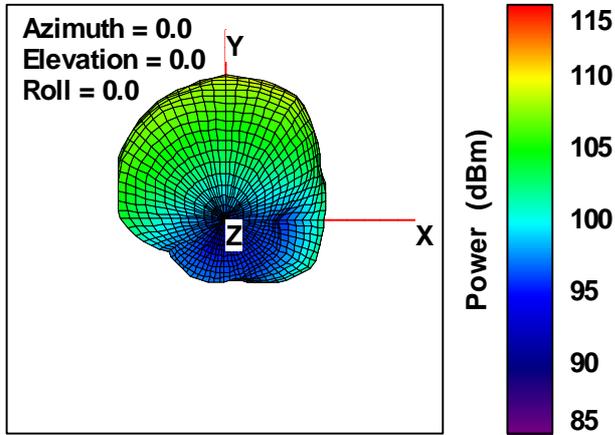
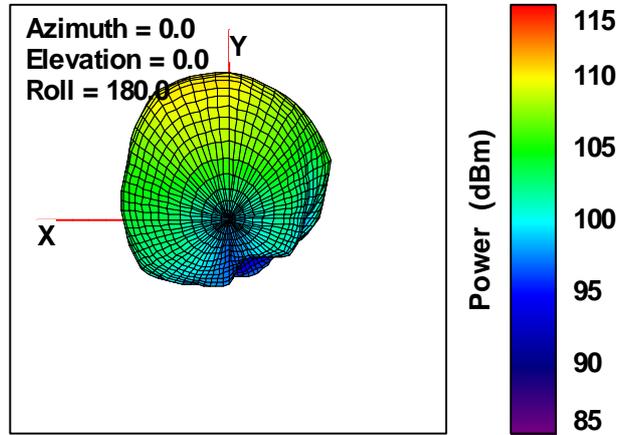
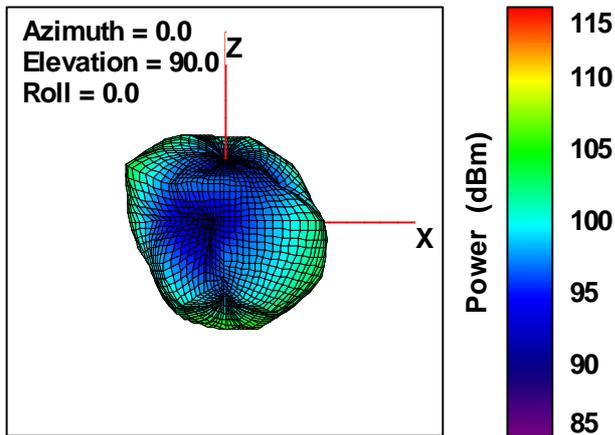
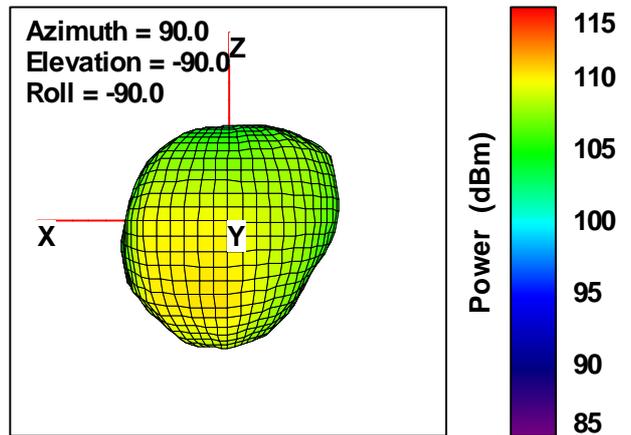
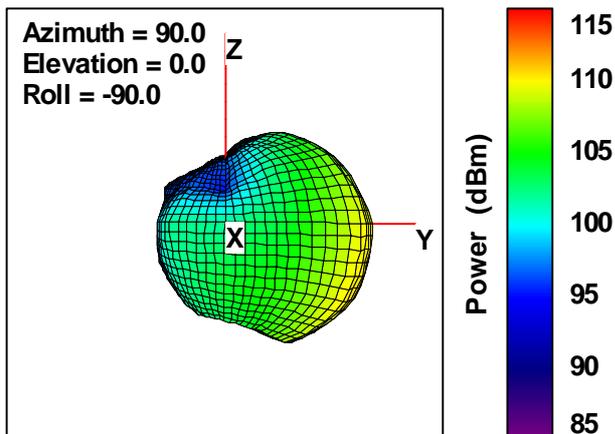
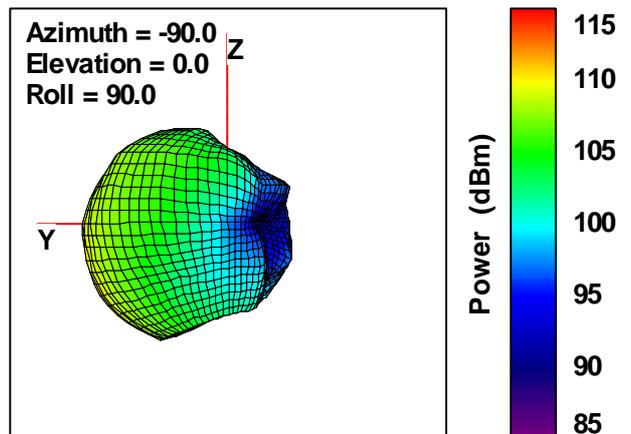
Plot 14. PCS 1900 SAM Phantom Head-Left Ear Total EIS, 1960MHz

Total EIS, Top View

Total EIS, Bottom View

Total EIS, Right Side View

Total EIS, Left Side View

Total EIS, Front Face View

Total EIS, Back Face View

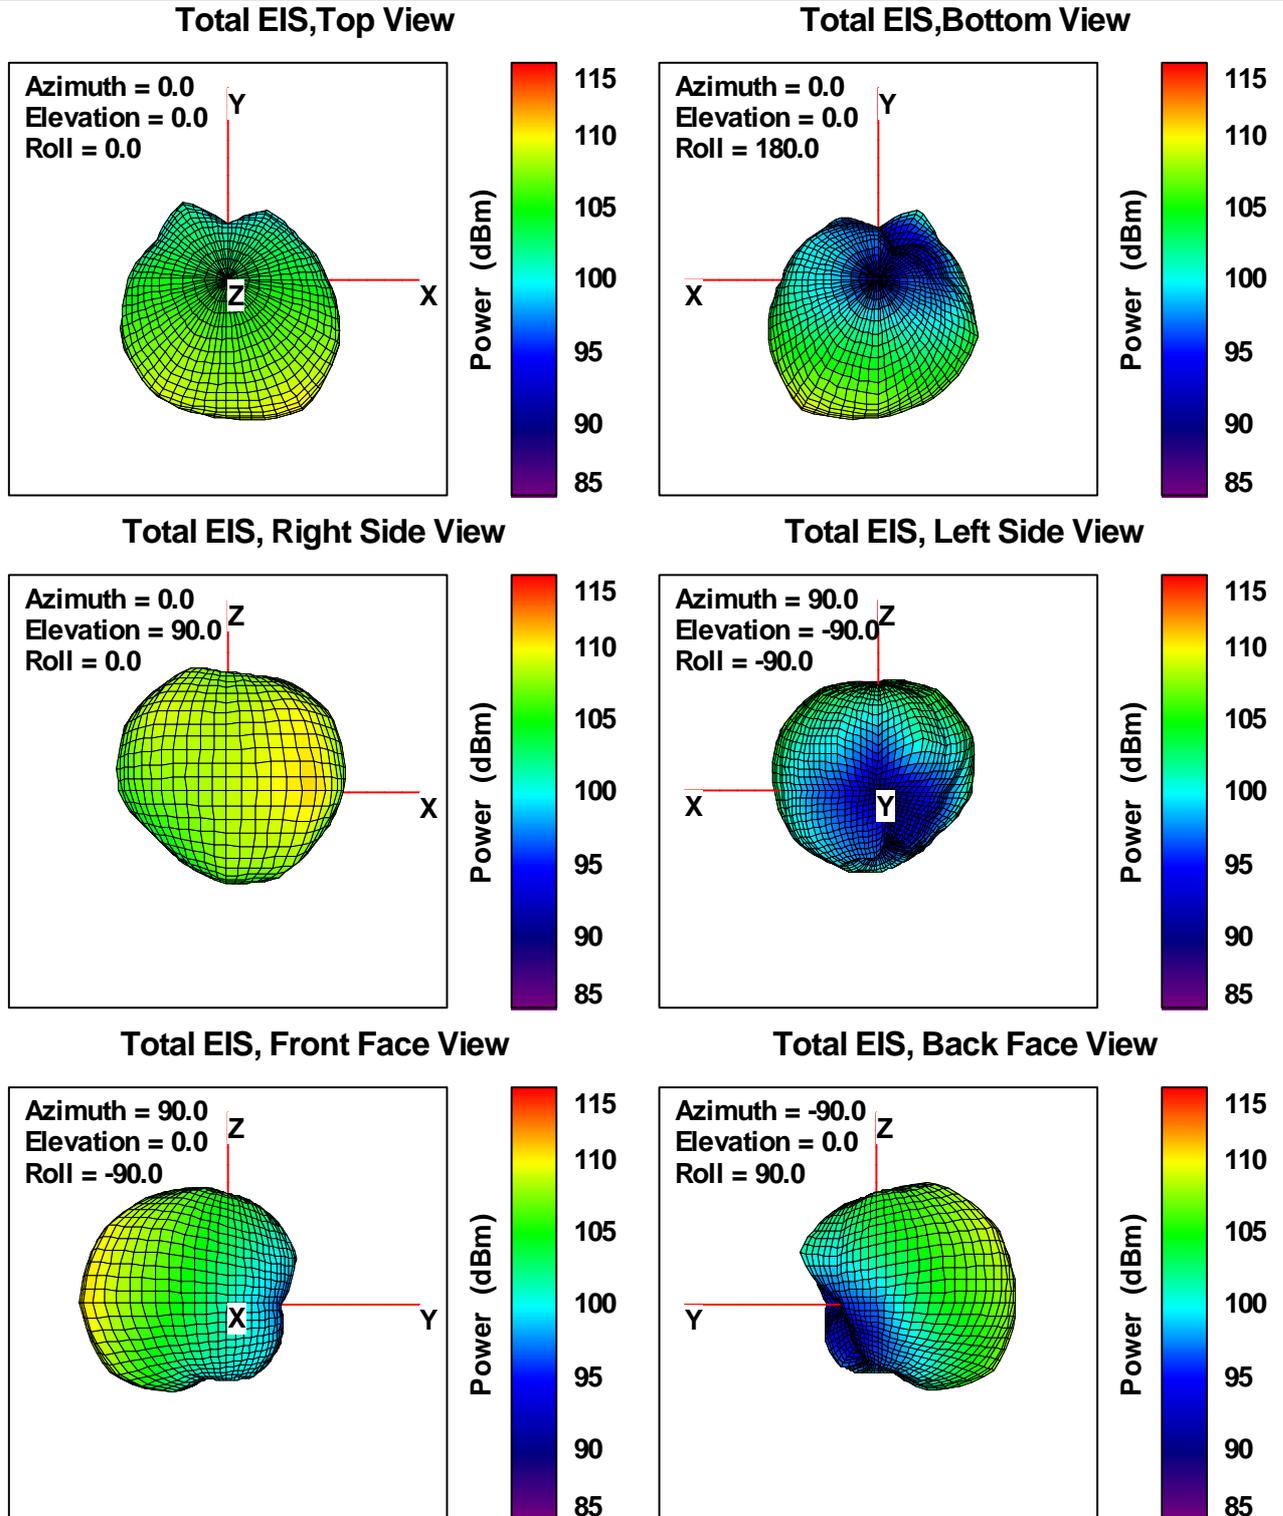
Plot 16. PCS 1900 SAM Phantom Head-Right Ear Total EIS, 1930.2MHz

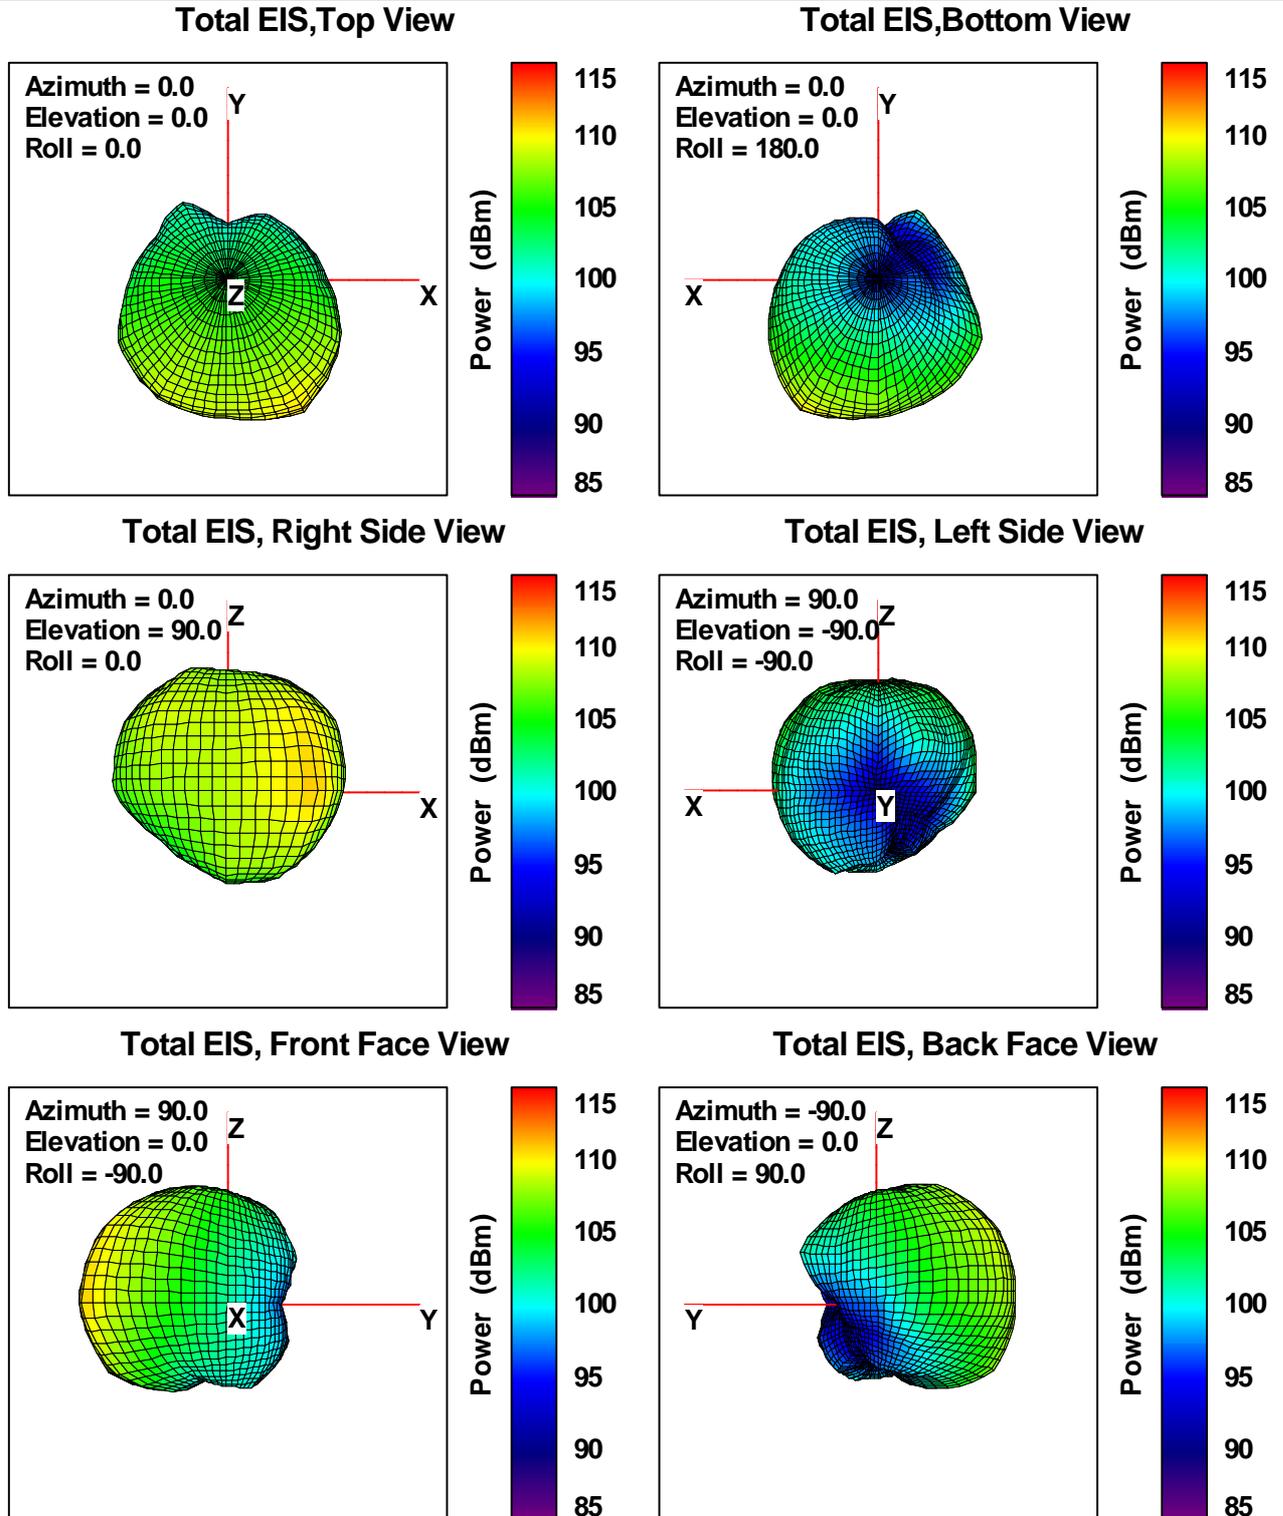
Plot 17. PCS 1900 SAM Phantom Head-Right Ear Total EIS, 1960 MHz

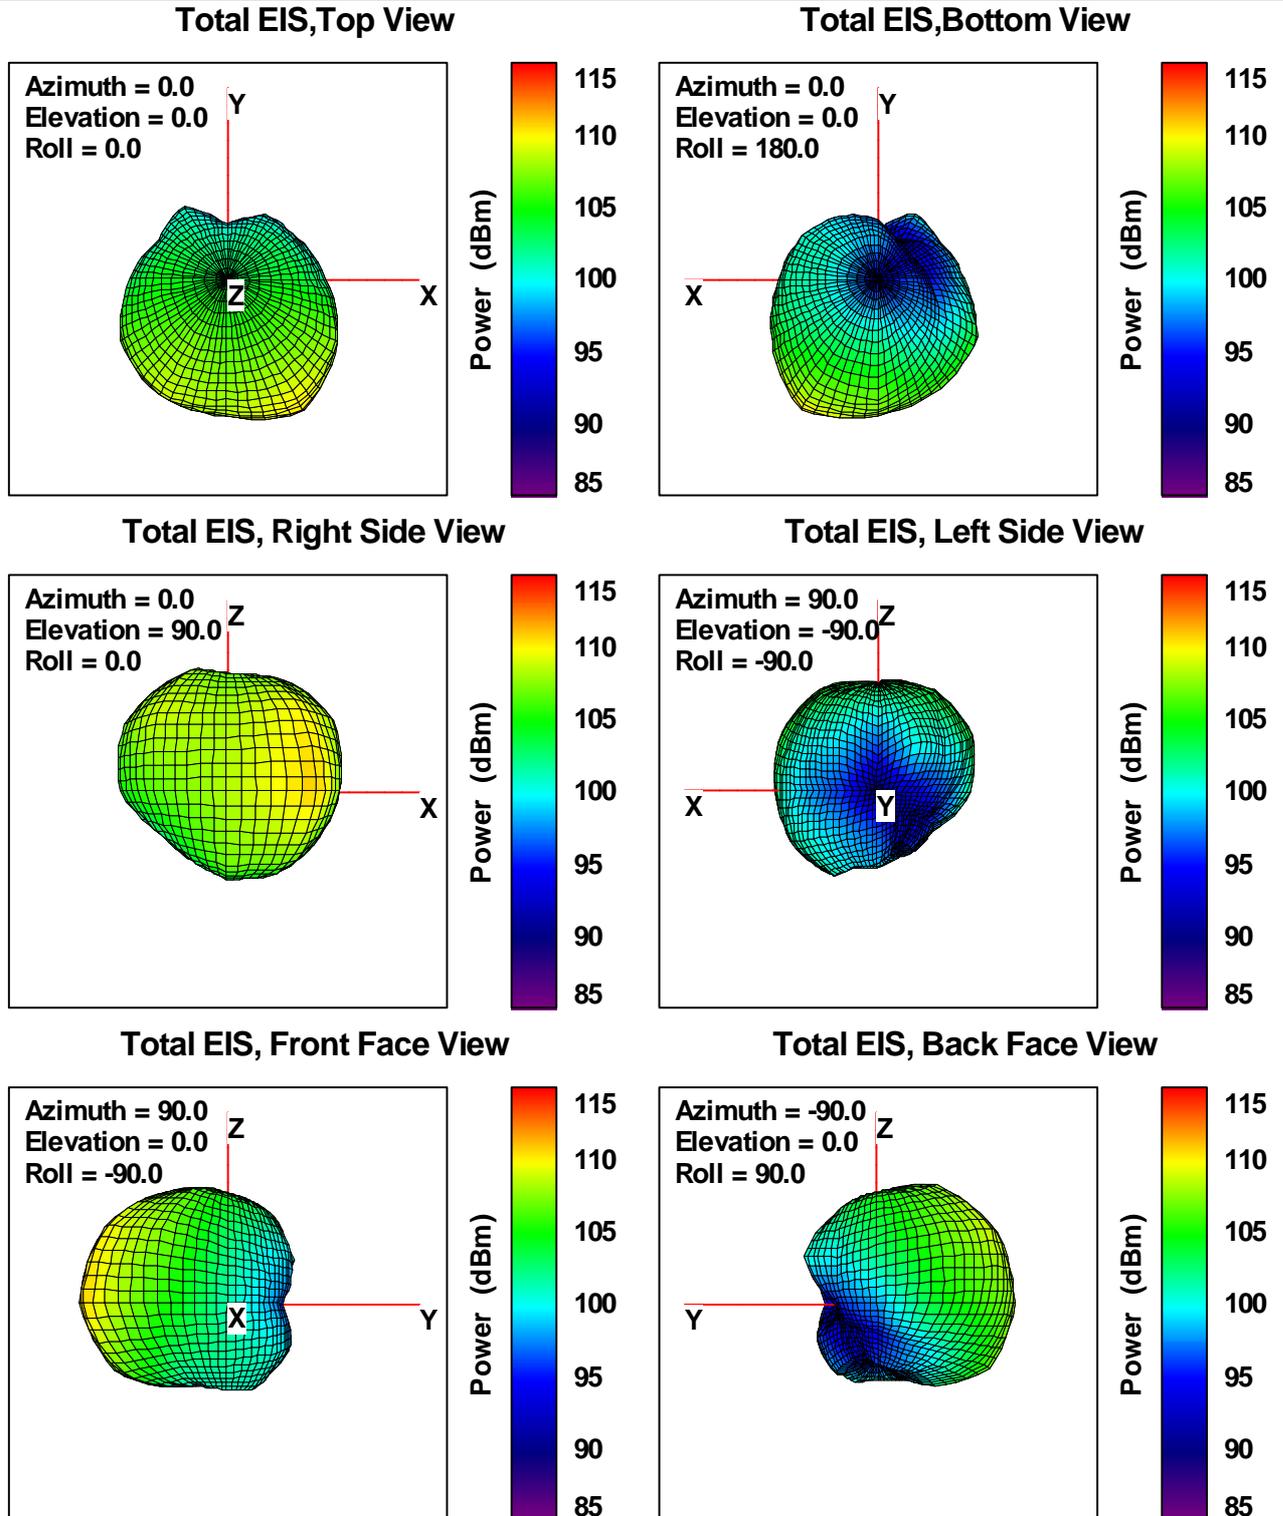
Plot 18. PCS 1900 SAM Phantom Head-Right Ear Total EIS, 1989.8 MHz

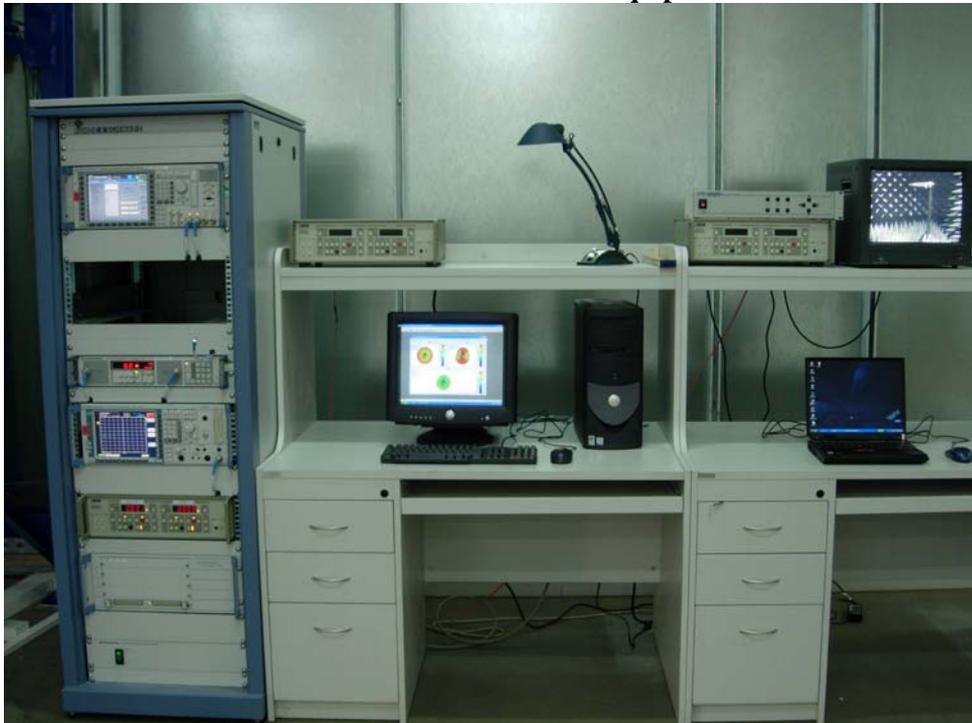
**Photo 2. TMC Wireless Test Equipment**

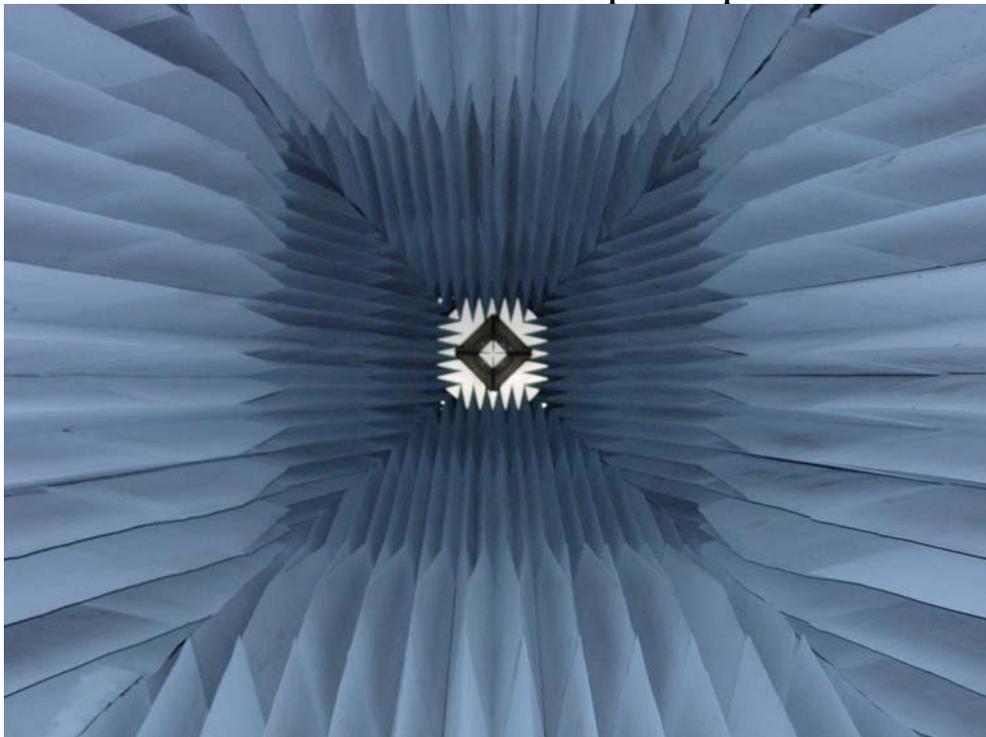
Photo 4. View of Dual Polarized Horn in Apex of Tapered Chamber

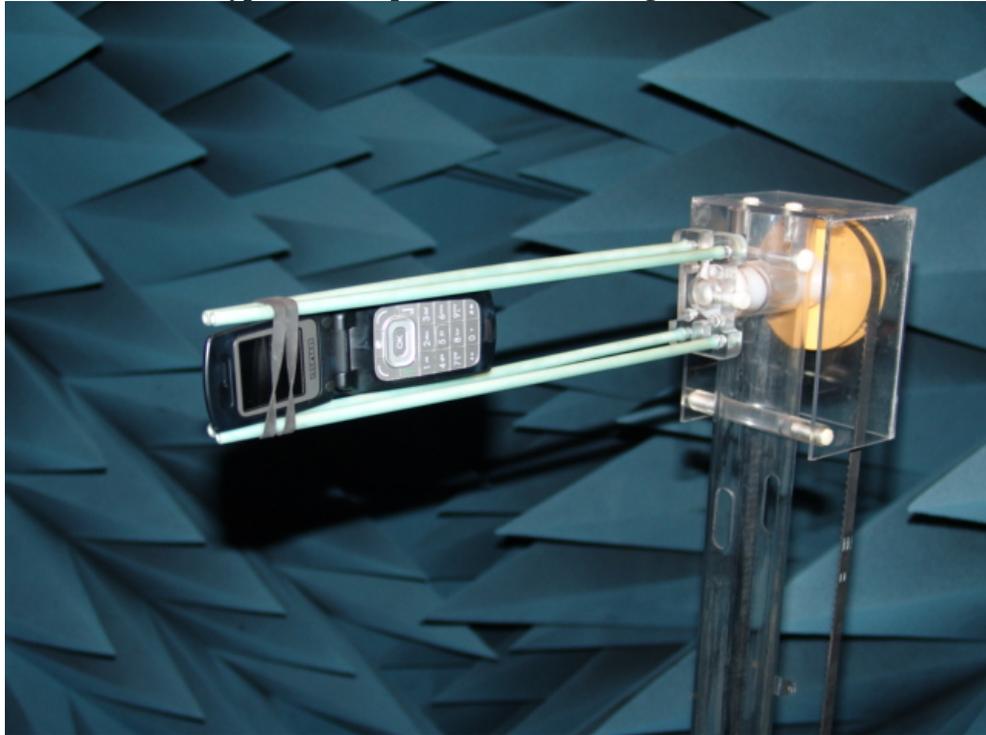
Photo 5. Typical Free-Space Phone Mounting of Customer Phone

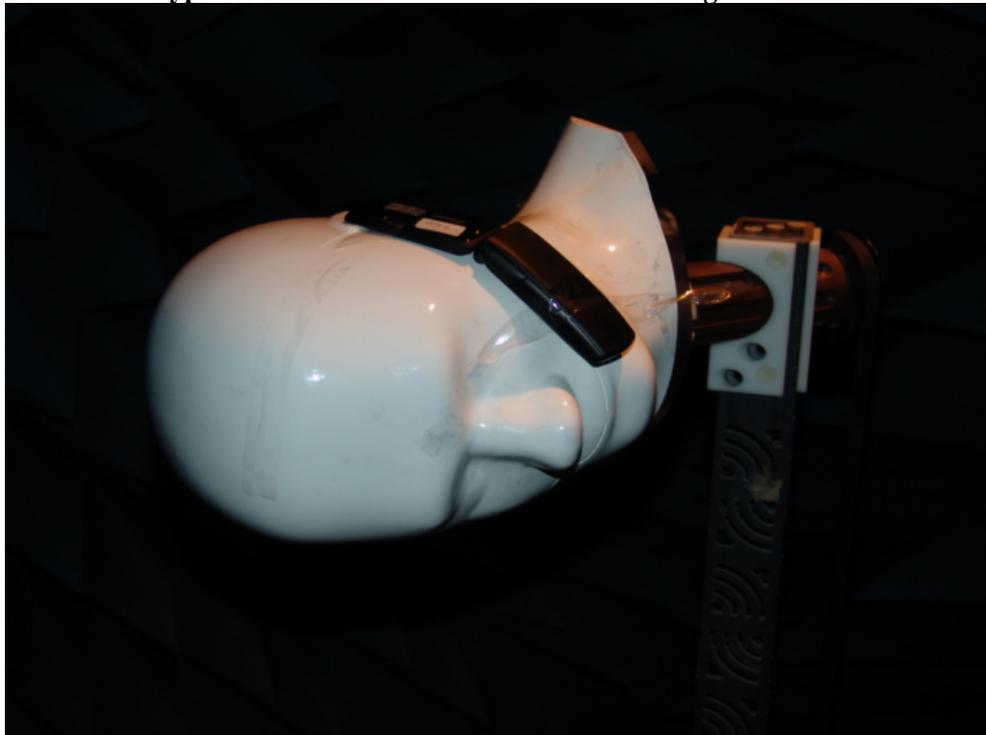
Photo 6. Typical SAM Phantom Head Phone Mounting of Customer Phone
